**UNITED STATES  
NUCLEAR REGULATORY COMMISSION  
REGION II  
SAM NUNN ATLANTA FEDERAL CENTER  
61 FORSYTH STREET SW SUITE 23T85  
ATLANTA, GEORGIA 30303-8931**

May 13, 2004

SUBJECT: NRC INSPECTION REPORT NO. 70-1151/2004-001

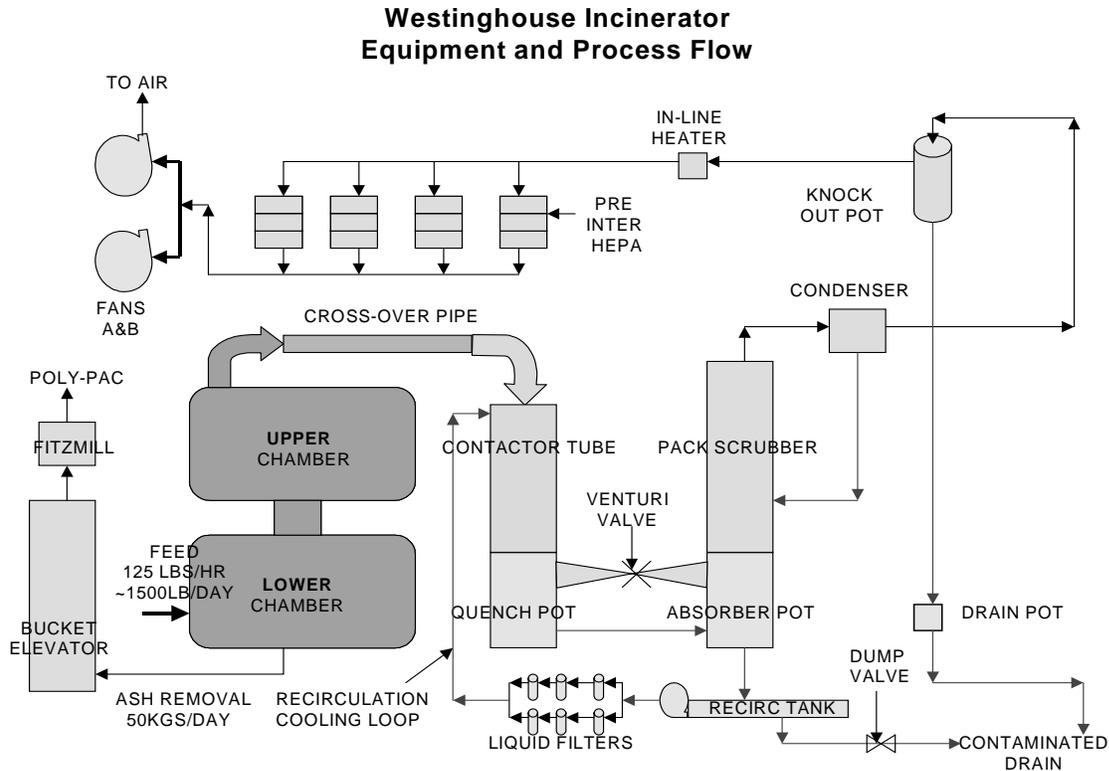
**Figure 1**

The incinerator lower combustion chamber operates at approximately 1000 degrees F and the upper combustion chamber operates at approximately 1300 degrees F. Off-gas cools several hundred degrees in the cross-over pipe and approaches the quench column at approximately 1000 degrees F where it is reduced to approximately 150 degrees F in the upper quench column contactor tube. Off-gas is directed through a condenser and knock-out pot to the final HEPA filter. Quench water is circulated through a filter and cooling loop and returned to the quench column contactor tube spray nozzles. Quench water is pH adjusted in the recirculation tank. City water at normal pressure is connected to the quench column to provide emergency cooling capacity to protect off-gas system components.

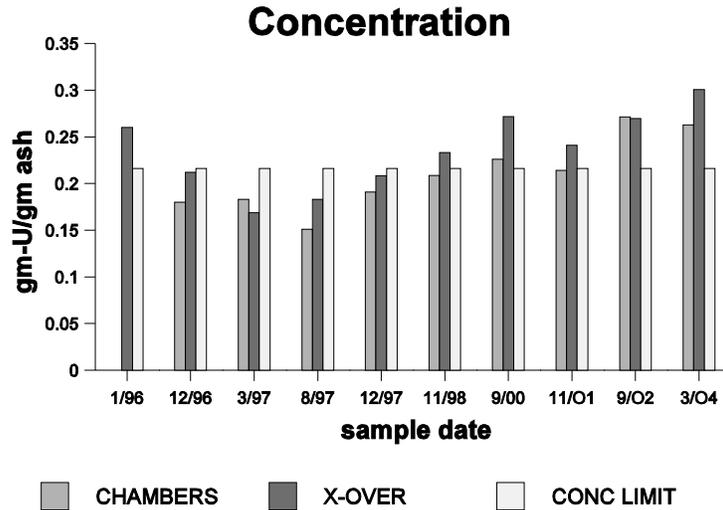
Figure 2

From September 1996 until March 5, 2004, the licensee increased control of burn residence time to improve compliance with environmental regulations and reduced burning of inert materials to reduce solids in the ash which were difficult to clean out of the incinerator. Longer residence time reduces carbon content of the resulting ash thus increasing uranium concentration and allows more time for fly-ash to carry over from the lower combustion chamber. Reduction of inert materials into the incinerator also increases the uranium concentration in the ash. These steady and uncontrolled process changes resulted in gradually increasing uranium concentration throughout the system as shown in Figure #2:

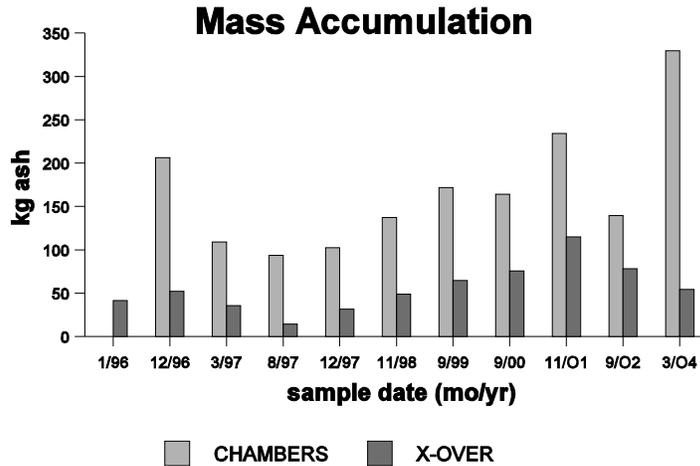
**Figure 3**

The process changes also resulted in a gradual increase in the amount of ash deposited particularly in the upper combustion chamber and cross-over pipe as shown in Figure #3:
