DOCUMENT NO.: 00003-23-0084-F16-005 REV.: 0 Page: i* of 30*
DOCUMENT TITLE: Duke Power Cure Time Fire Test Analysis
PROJECT NAME: Cure Time Fire Test
PROJECT NO.: 00003.23.0084
CLIENT: Duke Power QA CONDITION: 3

**Duke Power Company
Corporate Fire Protection**

**Duke Power Cure Time
Fire Test Analysis**

**Technical Document:
00003-23-0084-F16-005
Revision 0**

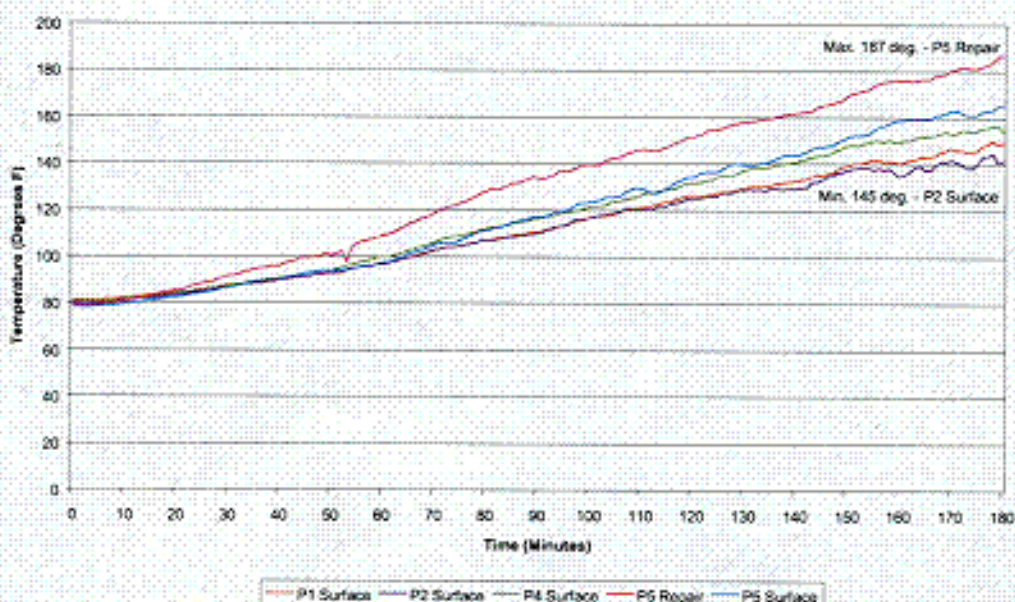
Figure 4.1-1
Seal Surface Temperatures (Pens. 1, 2, 4 and 5)

This graph clearly shows that the temperature on the unexposed seal surface of each of the seal assemblies increased gradually throughout the test. The fact that the temperature recorded for the repair area of Penetration 5 was slightly higher than the other seal surface temperatures (187°F as compared to the range of 145°F-166°F) is attributed to the thermocouple's proximity to the pipe. The seal surface thermocouples for Penetrations 1, 2, 4 and 5 were placed at the midpoint between the pipe and edge of the sleeve. This placement resulted in the thermocouples being located about 2-1/2" away from the pipe. The thermocouple over the surface of the repair area was placed near the center of the repair. Since the repair was approximately 3" in diameter and extended out from the pipe, the repair area thermocouple was located about 1-1/2" from the pipe. This determination is further supported by a comparison of this thermocouple (187°F) to the temperature recorded at the interface of the pipe for Penetration 5 which was monitored on the seal surface 1" away from the pipe (194°F for TC#16).

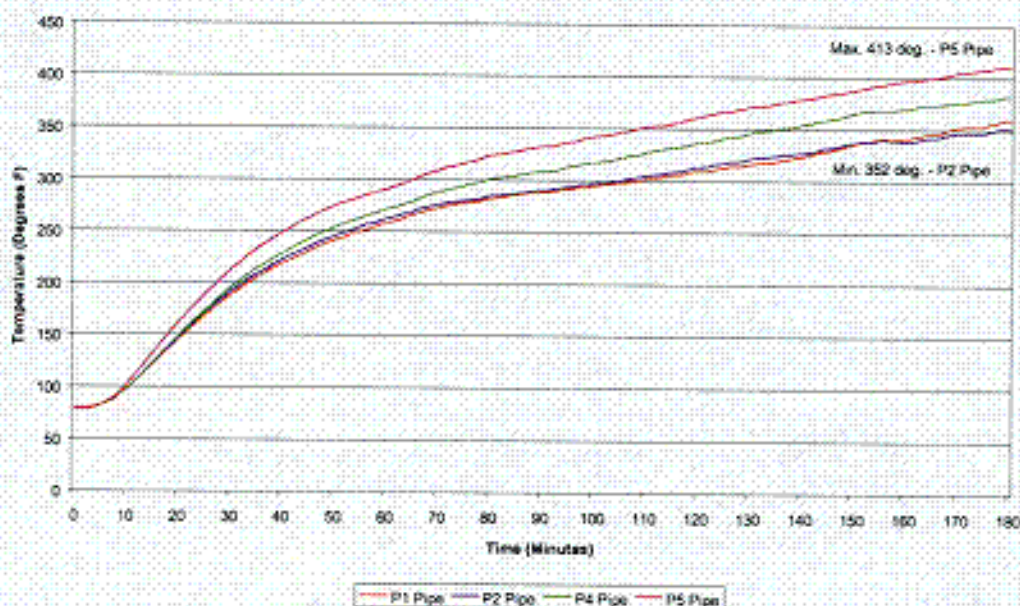
Figure 4.1-2
Pipe Temperatures (Pens. 1, 2, 4 and 5)

A comparison of penetrating item temperatures (monitored on the pipe at a point 1" above the seal surface) for these penetrations yielded similar results. Throughout the 3-hour test, temperatures monitored on the penetrating pipe for each of these penetrations gradually increased and were in the same general range (see Figure 4.1-2).

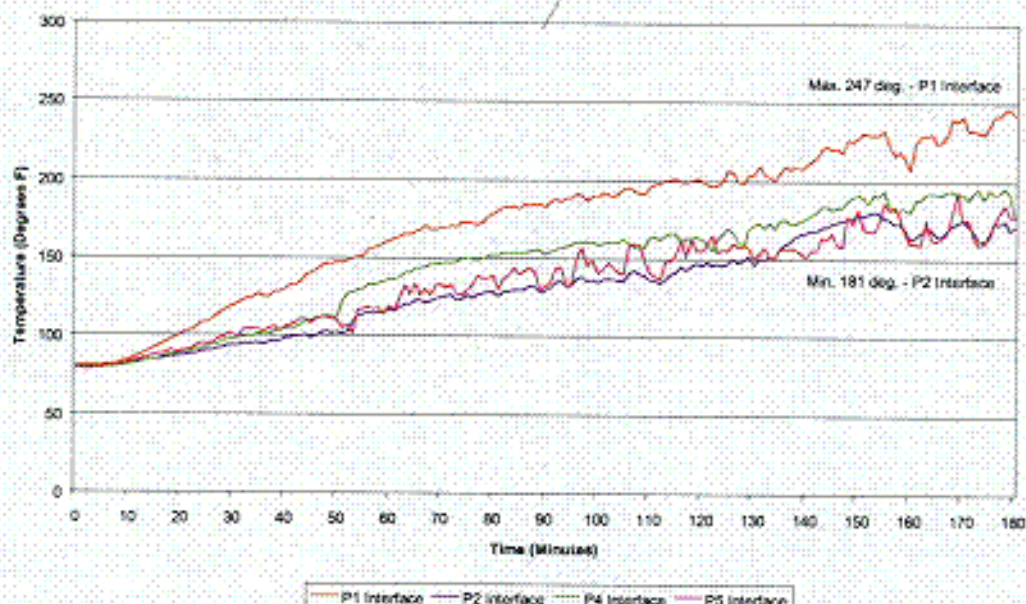
Figure 4.1-3
Interface Temperatures (Pens. 1, 2, 4 and 5)

Interface temperatures (monitored on the seal surface at a point 1" away from the penetrating item) were also consistent for these penetrations as indicated in Figure 4.1-3 below.

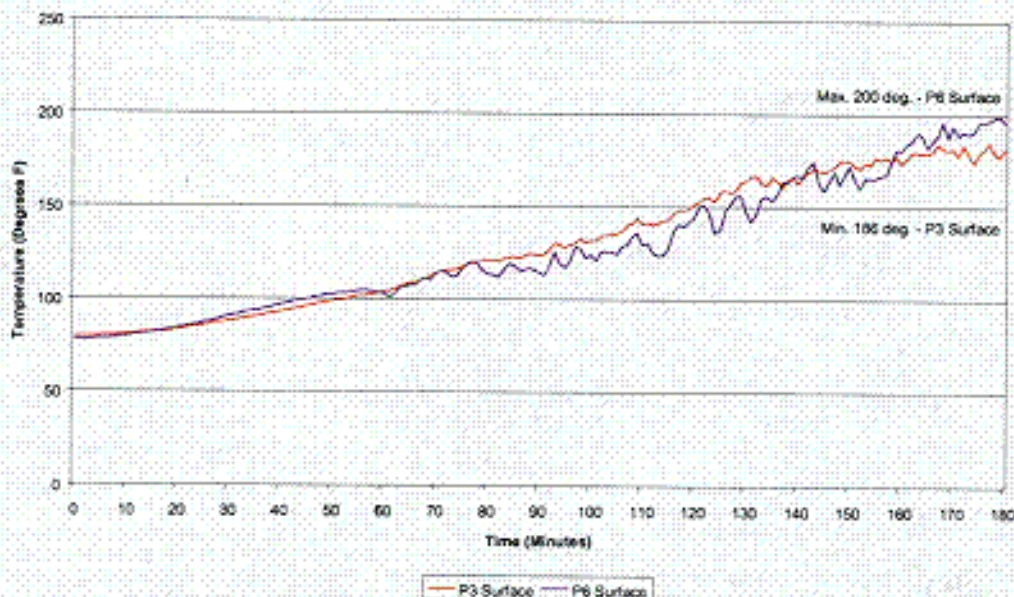
Figure 4.2-1
Seal Surface Temperatures (Pens. 3 and 6)

This graph clearly shows that the temperature on the unexposed seal surface of both of the seal assemblies increased gradually throughout the test and remained well below the acceptance limits.

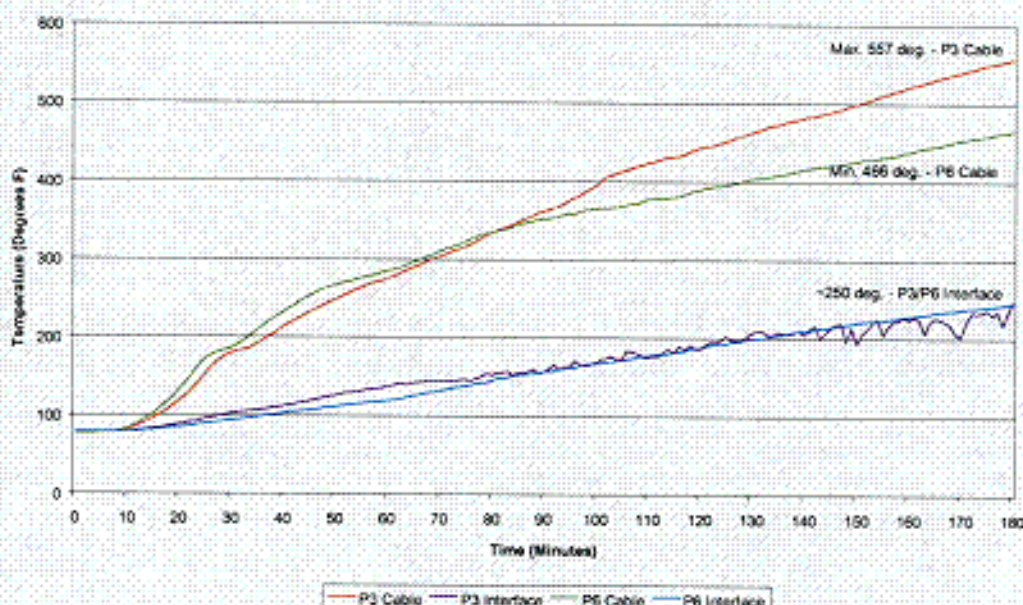
Figure 4.2-2
Cable & Interface Temperatures (Pens. 3 and 6)

A comparison of penetrating item temperatures (monitored on the largest diameter cable at a point 1" above the seal surface) and interface temperatures (monitored on the seal surface at a point 1" away from the penetrating item) were also consistent for these penetrations as indicated in Figure 4.2-2 below.

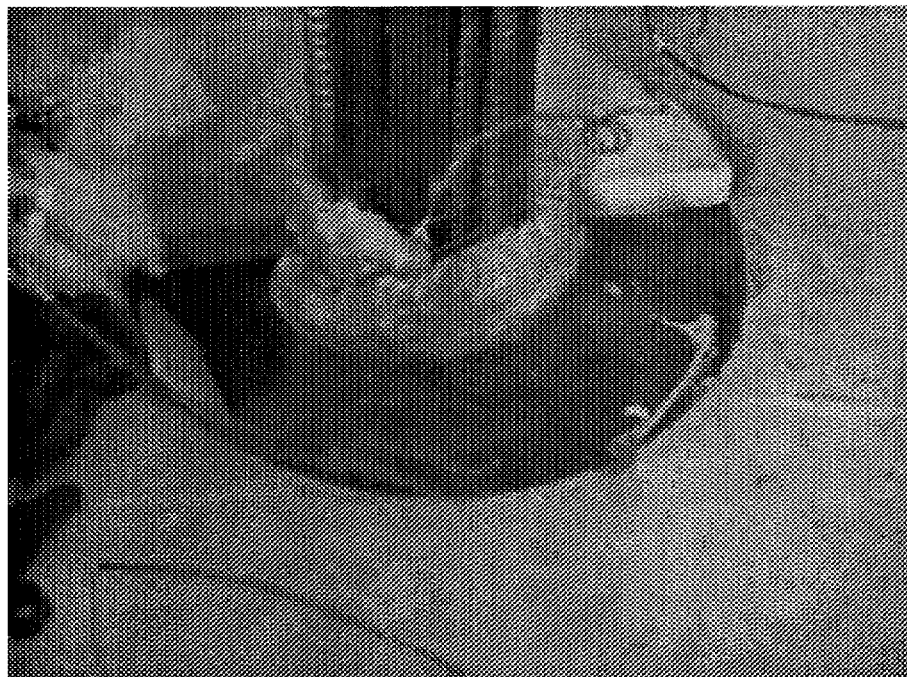
Generally, a post-test examination is performed a few hours after the hose-stream test, once the test specimen has cooled slightly. The time-critical sequence associated with conducting this test necessitated that the fire endurance and hose-stream portions of the test be concluded in late afternoon. Because of this, the post-test examination was scheduled for the next morning. However, immediately following the hose-stream test, it was observed that Penetration 3 was emitting a significant amount of smoke. Because Penetration 3 was only a 6" thick silicone foam seal and a cable bundle was the only penetrating item through this seal, it was believed that if this specimen was allowed to smolder overnight, an accurate post-test examination might not be possible. With this in mind, the top side dam was removed from Penetration 3. With the dam removed it was visually confirmed by personnel from Duke Power, DE&S and Promatec Technologies that a thin layer of resilient foam did indeed remain intact beneath the damming board (see digital photos below taken at 4:34pm on 3/2/00).

Penetration 3 With Partial Top Side Dam Removed

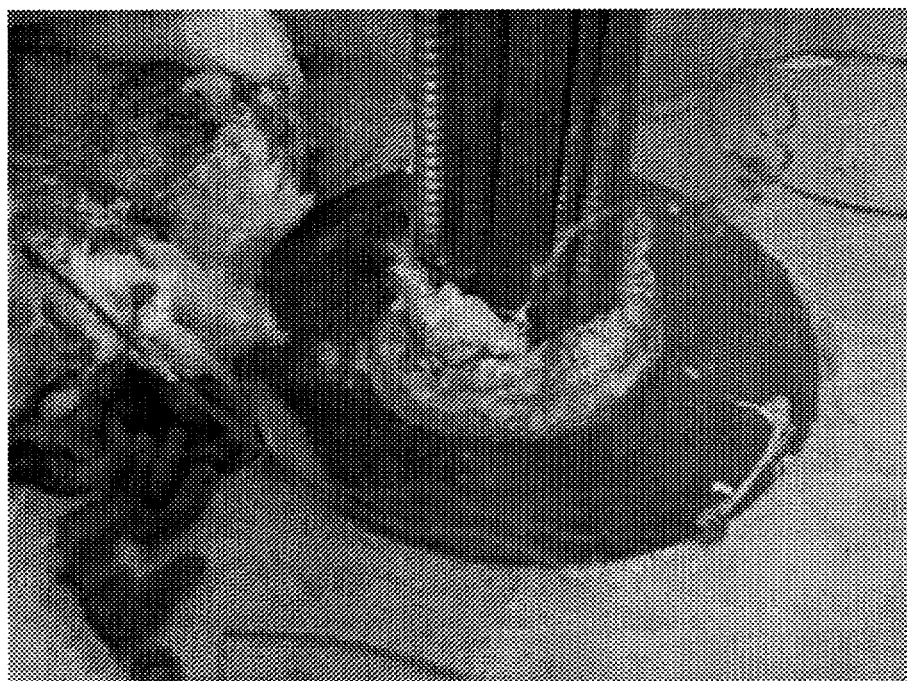
Penetration 3 With All Top Side Damming Removed

Approximately 30 minutes later flaming occurred inside Penetration 3. Omega Point Laboratory personnel extinguished the fire by means of a dry chemical extinguisher. Upon returning to the lab the next morning, it was observed that no material was remaining inside Penetration 3.

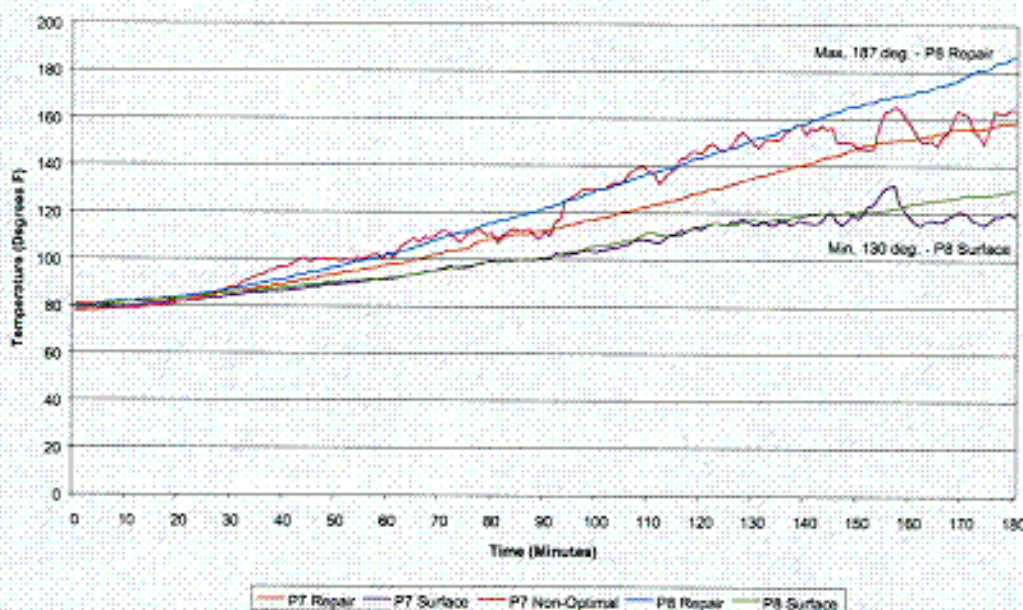
Figure 4.3-1
Seal Surface Temperatures (Pens. 7 and 8)

This graph clearly shows that the temperature on the unexposed seal surface of both of the seal assemblies increased gradually throughout the test and remained well below the acceptance limits. Additionally, a review of these thermocouple readings confirms that non-optimal cell structure silicone foam performs thermally in a manner similar to silicone foam that exhibits optimal cell structure.

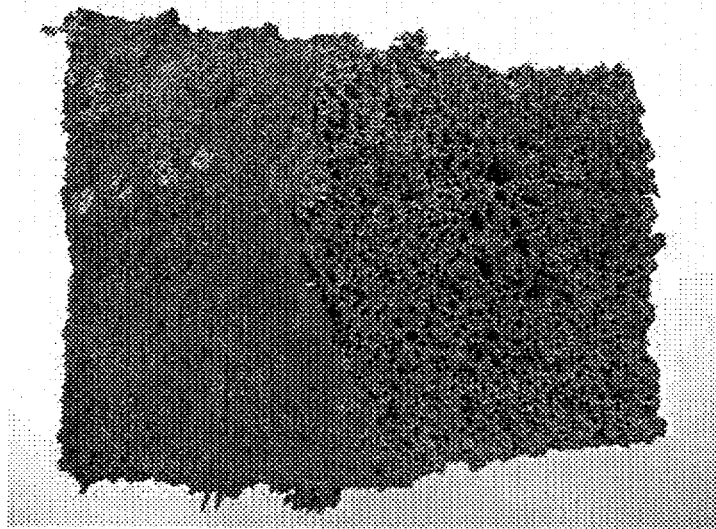
Post-test examination of these penetrations revealed that each of these seals displayed similar characteristics. In both cases both top and bottom side damming boards were intact with 4"-5" of resilient foam remaining. Consistent throughout both of these seals was the fact that slightly more foam was charred along the cable interface than the blockout interface. The non-optimal cell structure foam contained in Penetration 7 appeared to char at the same rate as the silicone foam exhibiting optimal cell structure (see photographs below).

**Penetration 7 - Plan View
(Optimal / Non-Optimal Interface)**

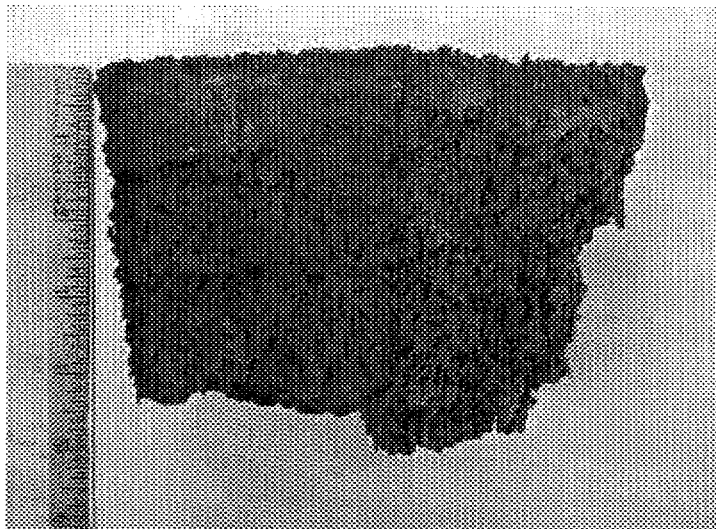
**Penetration 7 - Section View
(Optimal / Non-Optimal Char Depth)**

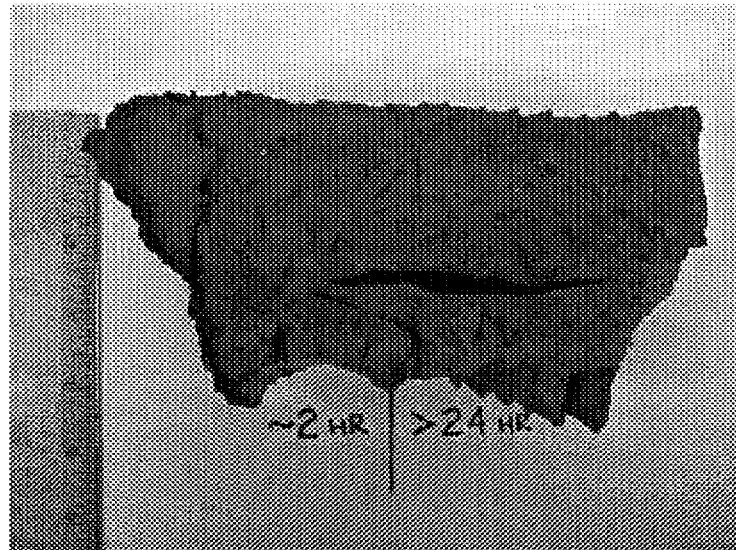
Additionally, there appeared to be no difference in the char depth between the silicone foam that was allowed to cure for more than 24-hours and the reduced cure time foam (~ 2-hour cure for Penetration 7 and < 30-minute cure time for Penetration 8). The photograph below depicts a section of the material removed from Penetration 7. A similar char depth was observed in the corresponding area of Penetration 8.

**Penetration 7 Section View
(~ 2-Hour Cure/ > 24-Hour Cure)**

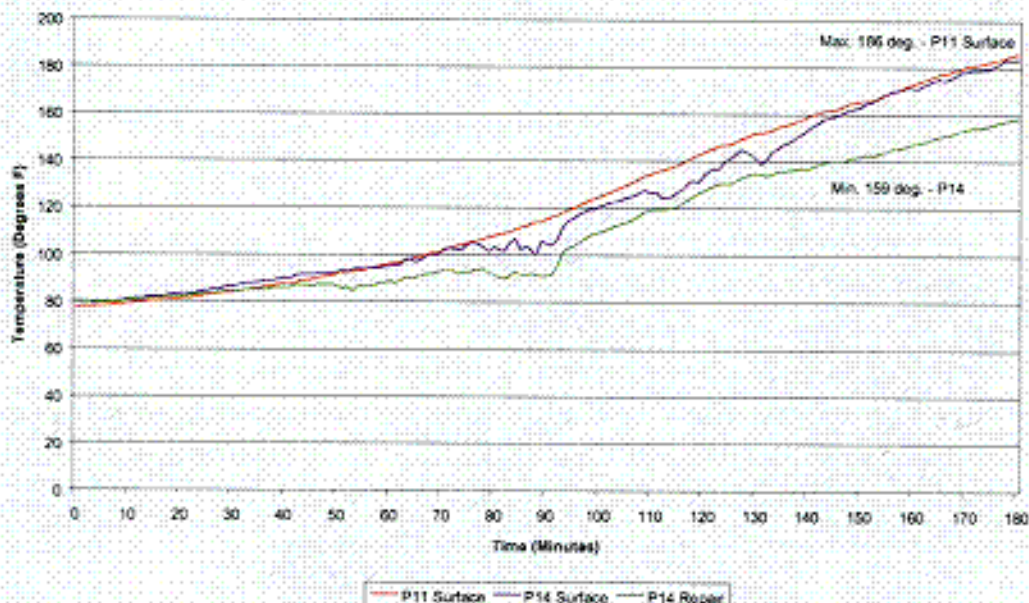
Figure 4.6-1
Seal Surface Temperatures (Pens. 11 and 13)

This graph clearly shows that the temperature on the unexposed seal surface of both of the seal assemblies increased gradually throughout the test and remained well below the acceptance limits. Additionally, the repair area of Penetration 14 (< 30-minute cure time) performed slightly better than the surrounding baseline seals, as evident by the lower endpoint temperature (159°F at 3-hours into the test).

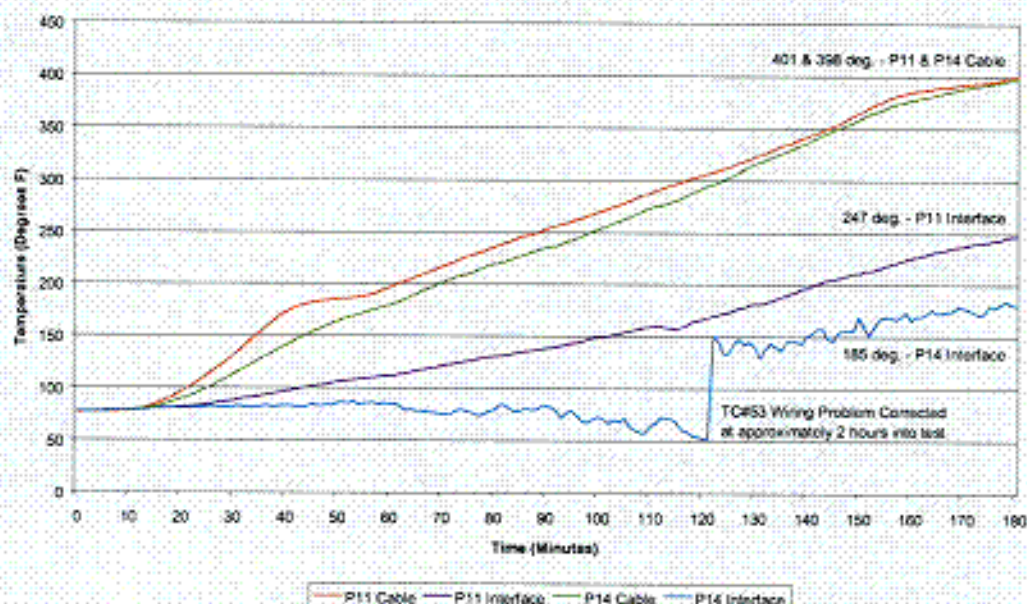
Figure 4.6-2
Cable & Interface Temperatures (Pens. 11 and 14)

A comparison of penetrating item temperatures (monitored on the largest diameter cable at a point 1" above the seal surface) and interface temperatures (monitored on the seal surface at a point 1" away from the largest penetrating cable) were also consistent for these penetrations as indicated in Figure 4.6-2 below.

It should be noted that the thermocouple leads for TC #53 were inadvertently crossed. Omega Point Laboratory personnel identified this condition at approximately 2 hours into the fire endurance test. Upon correcting the wiring error, TC #53 began to record accurate data. Based on relatively low endpoint temperature for this thermocouple, and considering the temperature profile of the corresponding thermocouple for Penetration 11, there is no reason to believe that temperatures near the acceptance limits were approached at any time during this test at this location. Therefore, this error has no adverse impact on the validity of the test results.

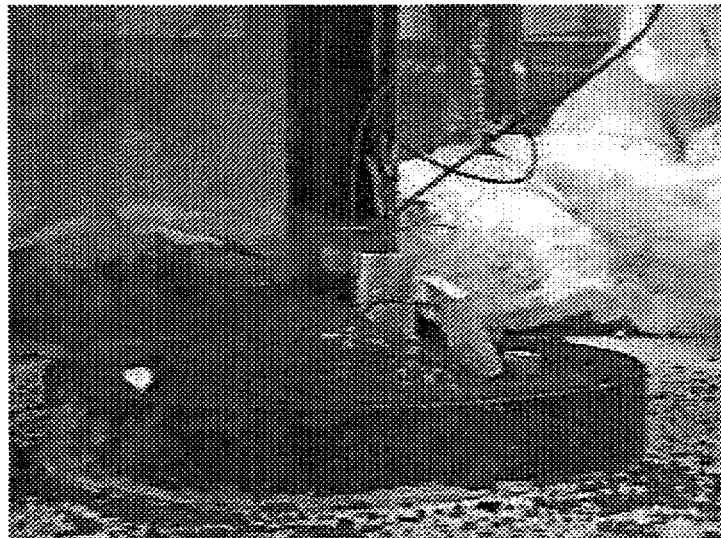
Approximately 2-hours into the fire endurance test, it became obvious that Penetration 9 was going to fail due to passage of flame. The unexposed side of the seal had formed an inverted cone extending several inches above the original seal surface on the pipe (see photograph below).

**Penetration 9
(Unexposed Side At ~2 Hours)**

At 2-hours and 17-minutes the temperature monitored on the pipe exceeded the 680°F acceptance limit. Cracks had developed on the surface of the seal material, and an orange glow could be seen illuminating from the cracks. A few minutes later (approximately 2-hours and 20-minutes into the test), intermittent flaming occurred along the cracks in the seal surface. Penetration 9 was declared a failure. Fire resistant ceramic blanket material was placed over Penetration 9 to allow the fire test to continue.

There were essentially two failure modes associated with Penetrations 9 and 12. First, the penetrating pipes exceeded the limiting endpoint temperature of 680°F at 2:13 (hr:min) for Penetration 12 and 2:17 (hr:min) for Penetration 9. The second failure mode associated with Penetrations 9 and 12 was the flaming which occurred on the unexposed side of the penetrations (~2:20 for Penetration 9 and ~2:30 for Penetration 12). The failure of these penetrations is attributed to two conditions; 1) the presence of seal material inside a sleeve extension immersed in the furnace, and 2) the fact that the fire test was conducted at positive pressure.

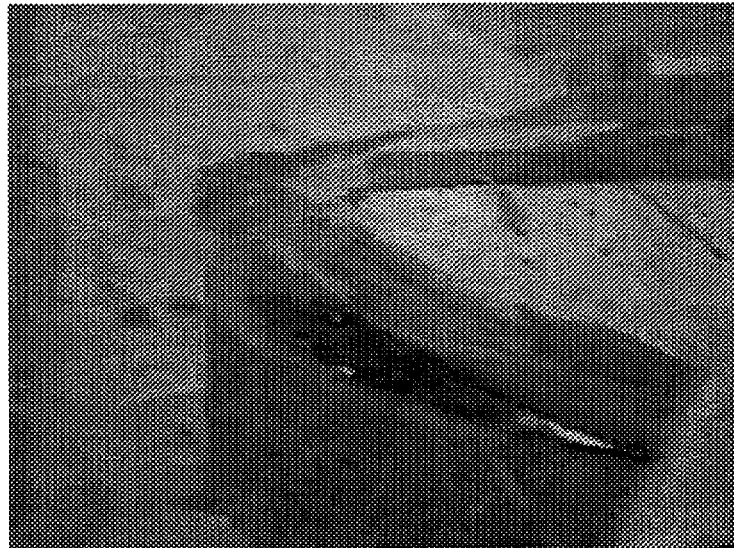
Approximately 2-hours into the fire endurance test, it became obvious that Penetration 13 was going to fail due to passage of flame. The unexposed side damming board had lifted above the sleeve due to thermal expansion of the silicone foam material. At 2:06 (hr:min) into the test, the temperature monitored on the pipe exceeded the 680°F acceptance limit. A few minutes later (approximately 2-hours and 10-minutes into the test), intermittent flaming occurred beneath the top side damming board. Penetration 13 was declared a failure. Fire resistant ceramic blanket material was placed over Penetration 13 to allow the fire test to continue.

**Penetration 13
(Unexposed Side At Failure ~2hrs. 40 mins.)**

There were essentially two failure modes associated with Penetrations 10 and 13. First, the penetrating pipes exceeded the limiting endpoint temperature of 680°F at 2:06 (hr:min) for Penetration 13 and 2:38 (hr:min) for Penetration 10. The second failure mode associated with Penetrations 10 and 13 was the flaming which occurred on the unexposed side of the penetrations (~2:10 for Penetration 13 and ~2:40 for Penetration 10). The failure of these penetrations is attributed to three conditions; 1) the presence of seal material inside a sleeve extension immersed in the furnace, 2) premature catastrophic loss of the bottom side damming board, and 3) the fact that the fire test was conducted at positive pressure.

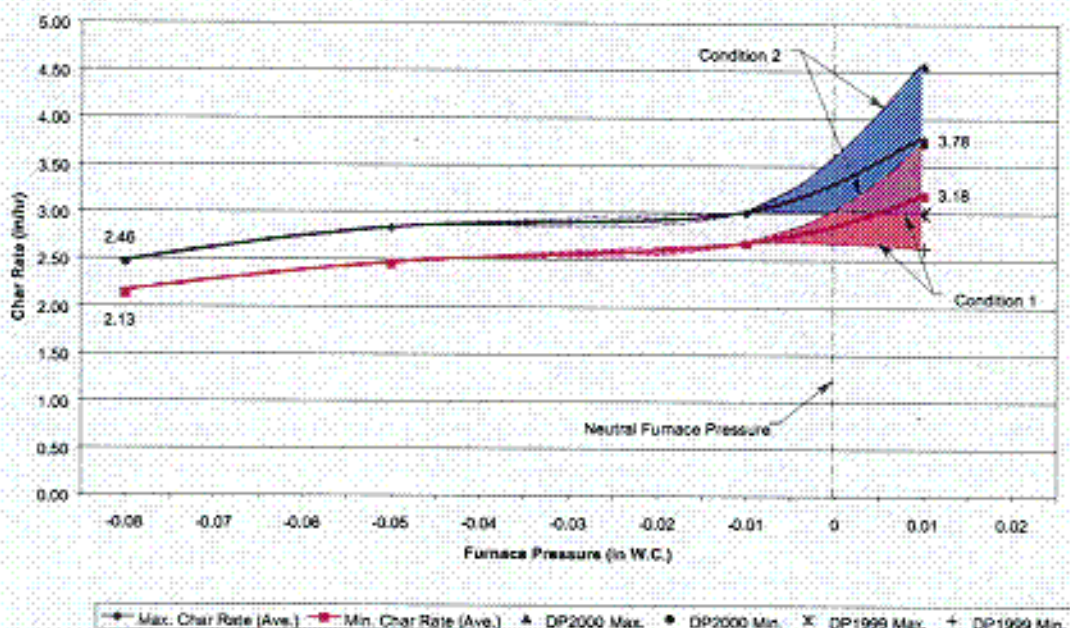
Figure 5.3-4
Char Rate vs. Furnace Pressure

From Figure 5.3-4 it is apparent that the rate at which silicone foam chars increases as furnace pressure increases. Because a majority of test data available within the industry was conducted in negative furnace pressure environments, the graph is clearly defined to the left of the neutral furnace pressure plane. However, only the Duke Power fire tests from 1999 and 2000 provide data points from tests exposed to positive furnace pressure environments, and each of these tests contained an anomaly. Therefore, the graph to the right of the neutral furnace pressure plane requires further explanation.

The Figure 5.3-4 lines associated with **Condition 1** represent the minimum and maximum char rate profiles if the data from the March 1999 Duke Power test is used. Char rate profiles following Condition 1 lines are known to be lower than actual char rates based on the fact that the 1999 Duke Power test was terminated at 2 hours and forty minutes. Actual char rates would be higher based on the intensity of an E-119 exposure during the final twenty minutes of a three-hour fire endurance test. Additionally, Penetration 6 from this test consisted of a 4" silicone foam build-out that overlapped the sleeve by a minimum of 4" in all directions on the exposed side of the test slab. This condition resulted in the steel sleeve being shielded from the furnace environment for a considerable portion of the fire endurance test, thereby slowing the silicone foam char rate. This condition was unlike any other configuration from the tests used to collect comparison data.

The Figure 5.3-4 lines associated with **Condition2** represent the minimum and maximum char rate profiles if the data from the March 2000 Duke Power Test is used. Char rate profiles following Condition 2 are known to be higher than actual char rates based on the fact that a 2" portion of the seal was contained inside a 2" length of the steel sleeve that protruded into the furnace. This condition resulted in the initial 2" of the seal being subjected to the extreme furnace environment from essentially 5 sides as opposed to a seal within the plane of the test slab that is exposed to the furnace environment from 1 side only. Thereby accelerating the rate at which the initial 2" of the seal was consumed. Similar to Condition 1, this condition was unlike any other configuration from the test data used for comparison.

Ultimately, the portion of the Figure 5.3-4 graph to the right of the neutral furnace pressure plane was based on the mid-point between Condition 1 and Condition 2 data. Arbitrarily selecting the mid-point of each data set to complete the Figure 5.3-4 graphs only serves to show that char rates continue to increase as furnace pressure increases (at least through +.01" W.C.). The actual char rate profile would fall within the shaded areas of the graph. In fact, silicone foam char rates may actually increase dramatically when tested in a positive furnace pressure environment due to the positive furnace pressure continually fanning the char layer of the seal. The fanning phenomenon has been credited in recent testing of wooden fire doors as a probable factor in the failure of door assemblies tested at positive furnace pressure.
