Subject: Arkansas Nuclear One - Unit 2
Docket No. 50-368
License No. NPF-6
2P00 Steam Generator Tube Inspection

2P00 STEAM GENERATOR TUBE INSPECTION

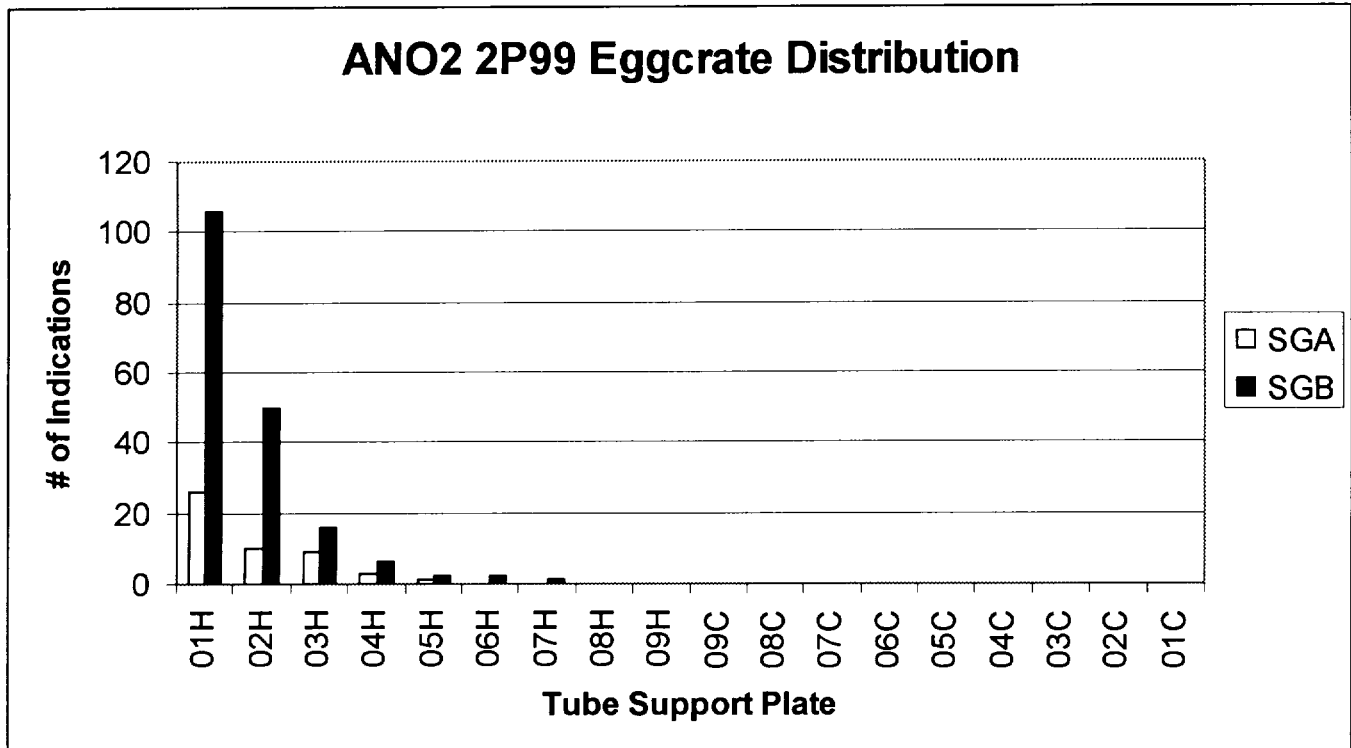
Figure 1

A review was performed to identify the locations of the indications detected in the previous inspection (2P99). As shown in Figure 1, the majority of the indications at the TSPs have been found in the lower sections of the hot leg side of the SG. This is due to the higher temperature effect on the flaw initiation and growth rate. The 2P99 inspection results are consistent with those of previous inspections. Because the lower hot leg tube sections have had the majority of axial indications, as well as the largest indications, these areas are of primary interest for the mid-cycle inspection.
