H. B. ROBINSON STEAM ELECTRIC PLANT, UNIT NO. 2
DOCKET NO. 50-261/LICENSE NO. DPR-23

LICENSEE EVENT REPORT NO. 2000-001-00
MANUAL REACTOR TRIP DUE TO TURBINE
ELECTRO-HYDRAULIC CONTROL TUBING FAILURE

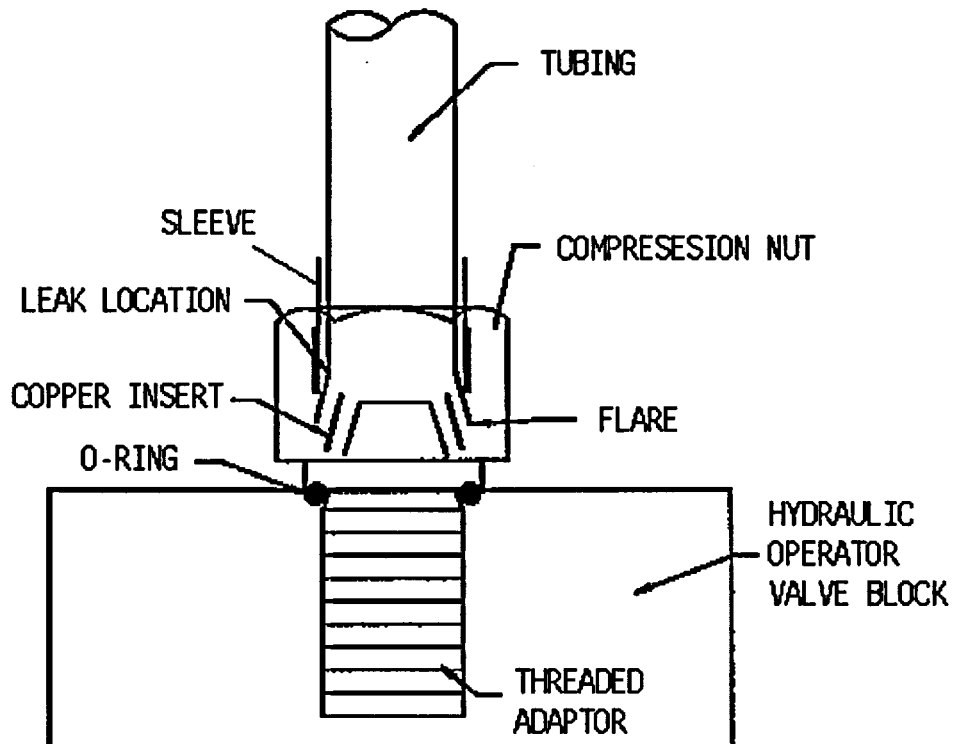
Investigation of the leak revealed a circumferentially oriented crack in the EH fluid tubing [TBG] (extending approximately 2/3 of the tubing circumference) at the EH system supply line connection to the hydraulic actuator for the Moisture Separator Reheater 2A Reheat Intercept Valve [V]. The failed section of tubing [TBG] was repaired prior to restart of the unit. Figure 1 shows a diagram of the tubing connection and the approximate location of the tubing leak. An investigation to determine the cause of the tubing failure was initiated on June 21, 2000. Metallurgical examination of the failure was conducted to assist the investigation. The investigation and metallurgical examination discovered evidence of both corrosion and vibration and that a material defect in the tubing was present at the failure location. The investigation also discovered that two copper inserts had been inadvertently installed in the fitting where only one is expected. The investigation concluded that the extra copper insert did not significantly contribute to this tubing failure.

The fitting used to attach the tubing [TBG] to the valve [V] is a Parker-Hannifin Corporation, Triple-Lok 37-degree Flared Tube Fitting.

FIGURE 1: PARKER-HANNIFIN
TRIPLE-LOK 37° FLARED TUBE FITTING
WITH COPPER INSERT
