Subject: Licensee Event Report

In accordance with 10 CFR 50.73(a)(2)(iv), Commonwealth Edison (ComEd) Company is submitting Licensee Event Report #00-003-00, Docket No. 050-374.

FACILITY NAME (1): LaSalle County Station, Unit 2

TITLE (4) Scram on Low Reactor Water Level Due to Loss of 2A Turbine Driven Reactor Feed Pump Flow

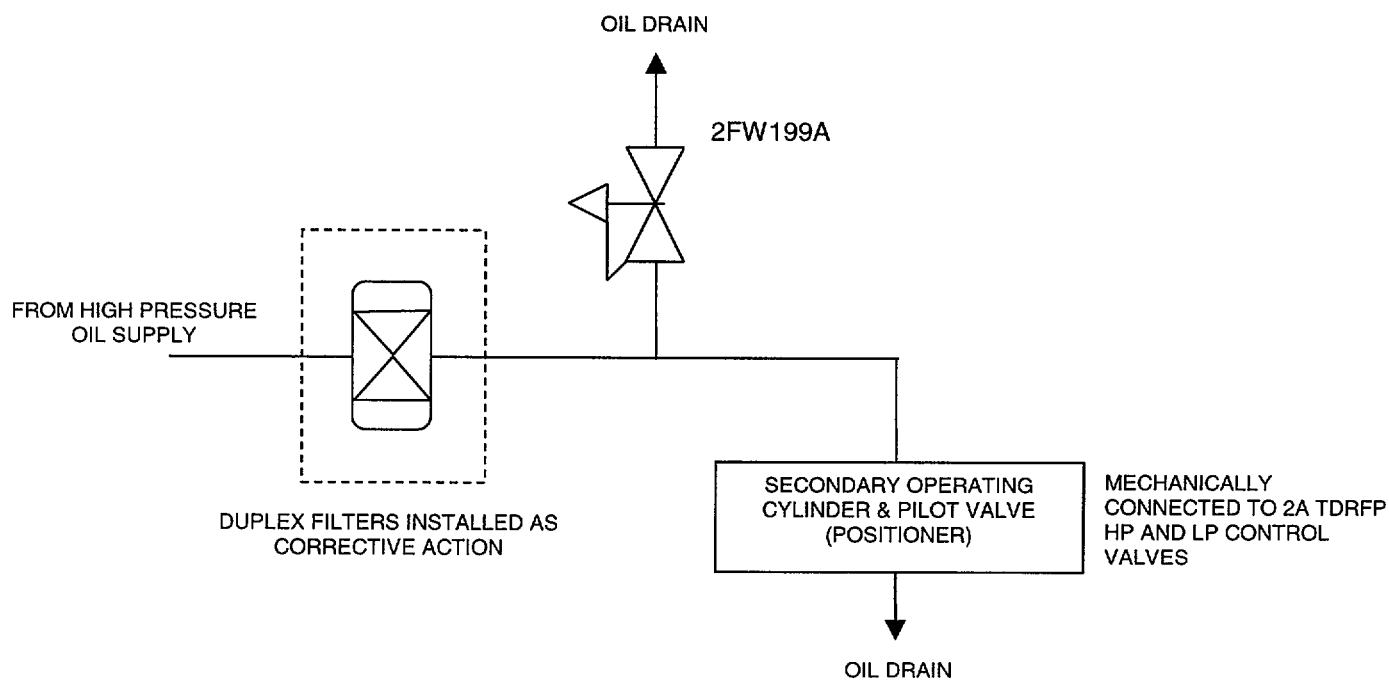
Figure 1

The root cause of the event was the intrusion of wear products into the high pressure control oil pressure regulating relief valve (2FW199A). The wear products became lodged between the relief valve seat and disk, which allowed the oil system pressure to be relieved. This caused the 2A TDRFP control valve to close, and the loss of flow from the 2A TDRFP. The resulting reactor water level transient led to the automatic scram.

The root cause of the event was the intrusion of wear products into the high pressure control oil pressure regulating relief valve (2FW199A) that were in excess of the valve's tolerances. The wear products became lodged between the valve seat and disk, allowing the high pressure control oil supply to drain. With an inadequate oil supply to the secondary operating cylinder of the 2A TDRFP control valve, the valve closed, resulting in the 2A TDRFP ramping down in speed (see Figure 1).

Wear products of sufficient size were found in the control oil system, although none was found on the seating surface of the 2FW199A valve. It is suspected that the material was flushed out of the valve during the transient.

The corrective action was to install in-line duplex filters on the 2A and 2B TDRFP high pressure control oil system supply lines. Filters for the high pressure control oil had been previously installed on Unit 1, but had not been installed on Unit 2.

In-line duplex filters were installed on the 2A and 2B TDRFP high pressure control oil system supply lines (Complete).
