SUSQUEHANNA STEAM ELECTRIC STATION
LICENSEE EVENT REPORT 50-387/99-006-01
PLA - 5211 FILE R41-2

Susquehanna Steam Electric Station - Unit 1

'C' And 'D' ESW Pumps Inoperable Greater Than 7 Days Due To Interaction With 'A' And 'B' Pumps

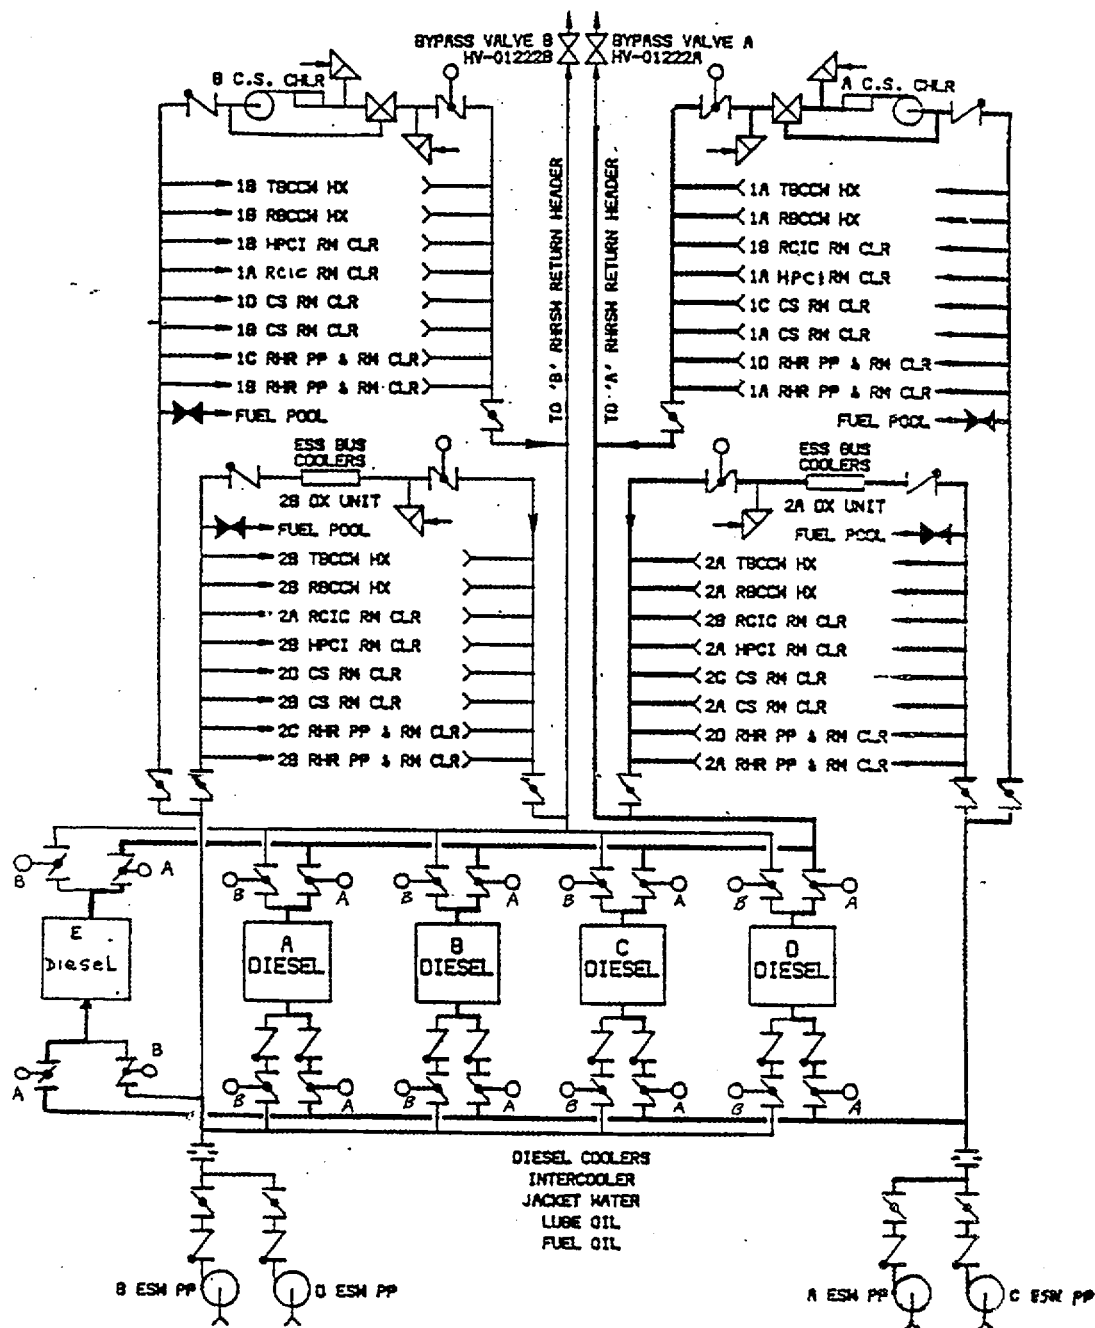
FIGURE 1
EMERGENCY SERVICE WATER

The ESW system is designed to take water from the spray pond, pump it to various heat exchangers and return the water to the spray pond by way of a network of sprays that dissipate the heat to the atmosphere. The system consists of two loops with two pumps per loop. The system is designed to supply 100 percent of the ESW cooling flow to the required heat exchangers in both Units and to the common Diesel Generators during design basis accidents. See Figure 1.

To better understand the condition of the 'C' and 'D' pumps, a quarterly flow In-Service Test (IST) was performed on August 27, 1999 to assess the performance of the individual pumps. The purpose of the IST is to trend a pump's individual performance by monitoring discharge pressure while operating within a predetermined flow range. Each ESW pump was tested at a flow range of 5500 gpm to 5700 gpm while the system is aligned for normal power operations. System alignment for normal power operations included the following loads for each ESW loop respectively (See Figure 1):
