**UNITED STATES
NUCLEAR REGULATORY COMMISSION
REGION IV
611 RYAN PLAZA DRIVE, SUITE 400
ARLINGTON, TEXAS 76011-8064**

July 31, 2000

SUBJECT: DIABLO CANYON INSPECTION REPORT NO. 50-275/00-09; 50-323/00-09

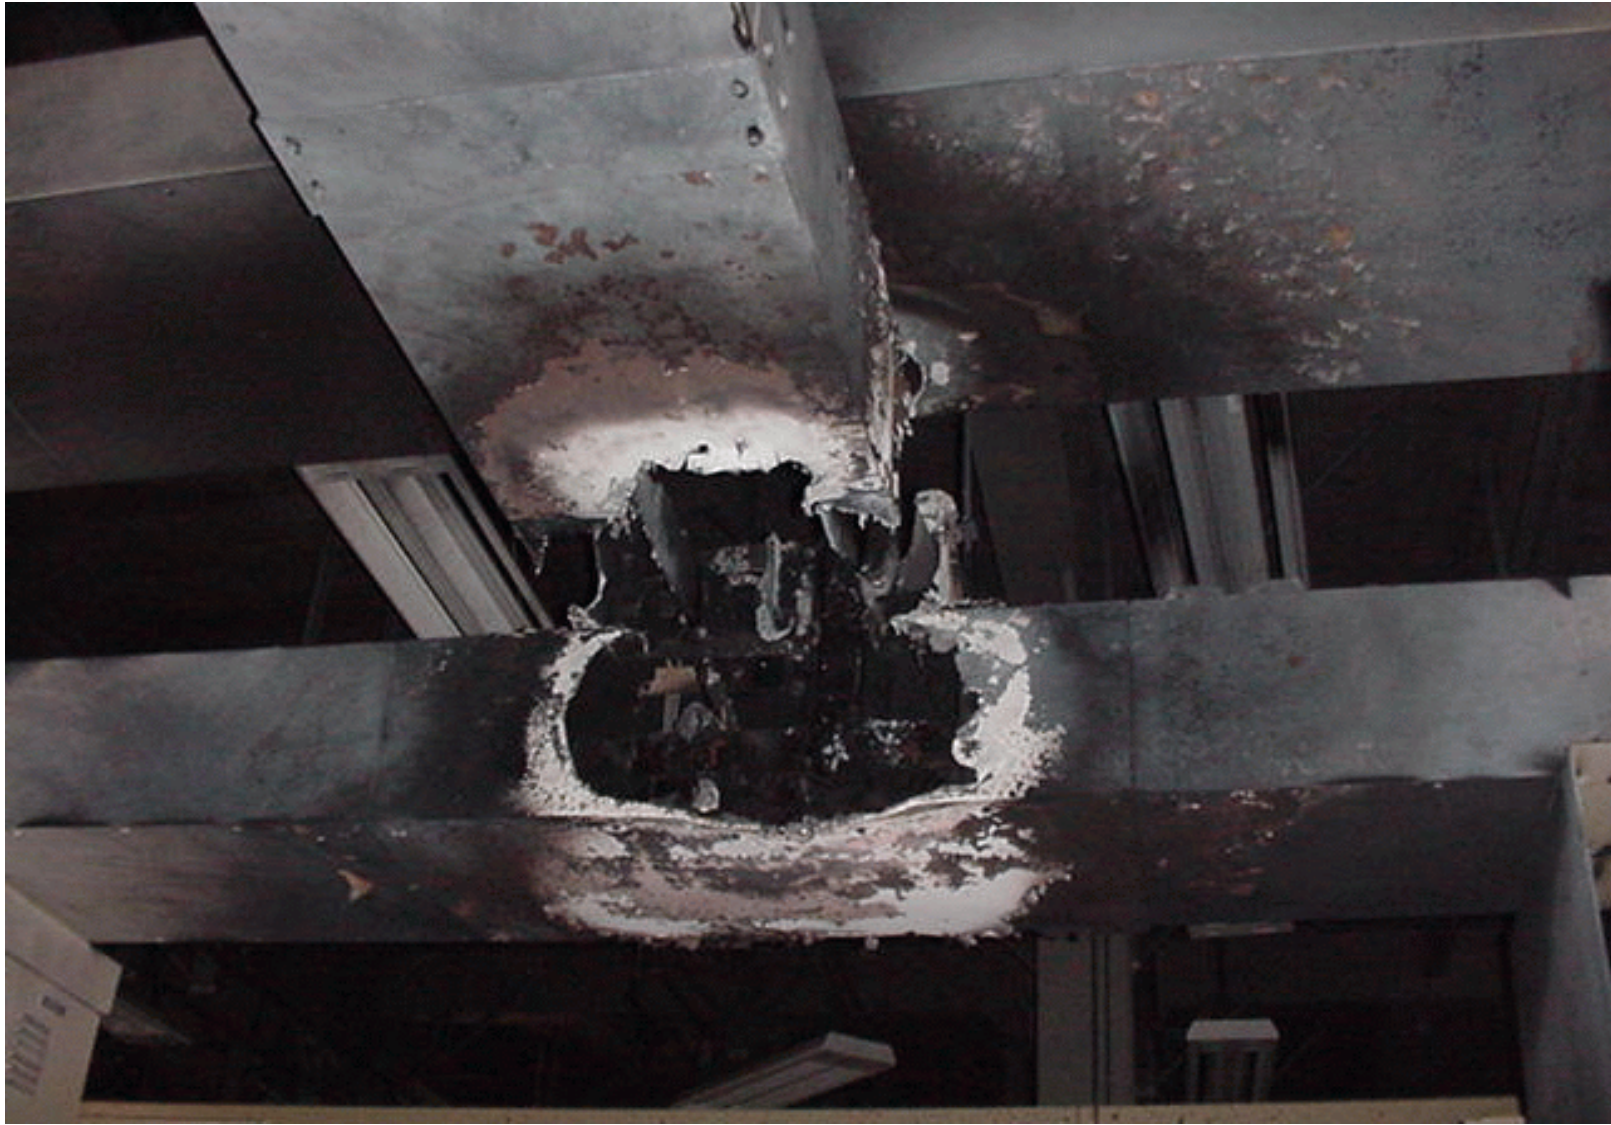
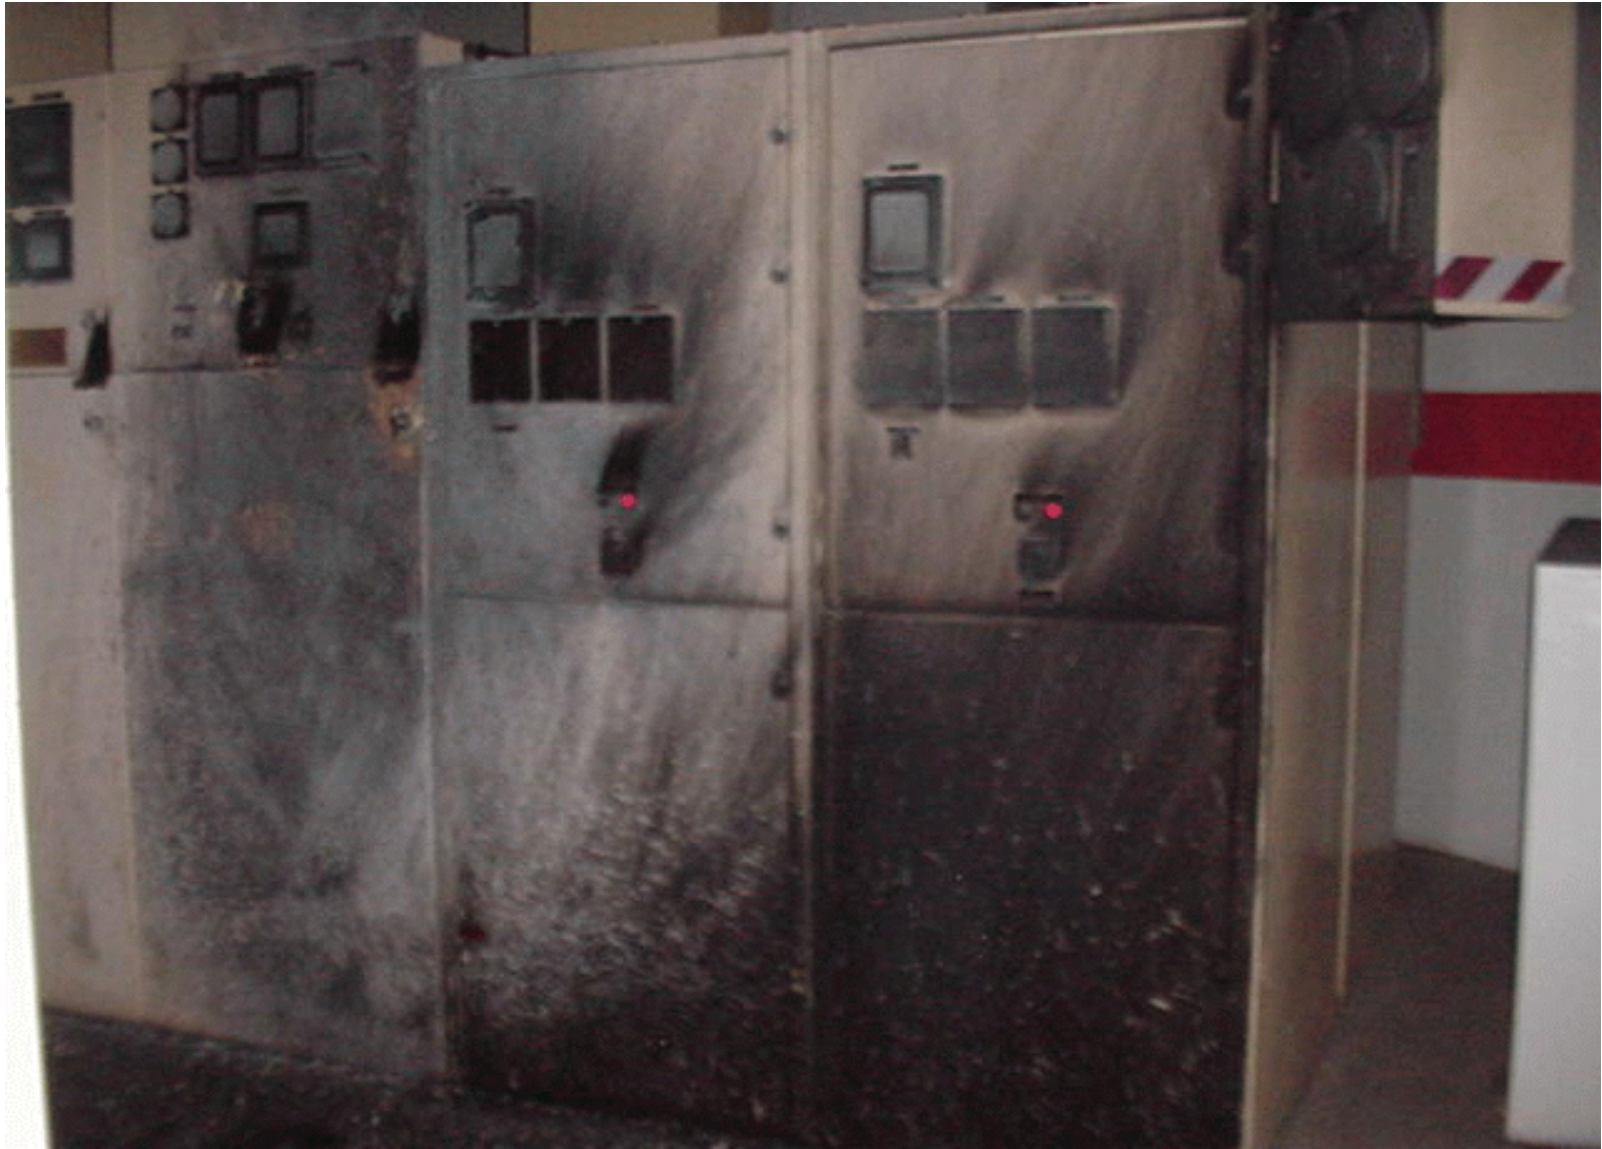
Attachment 4 - Bus Bar and Switchgear Cubicle Damage

After normal entry to the area was allowed, a detailed inspection of the damage was performed. The center 12 kV bus bar was missing for approximately 1 yard, with the two exterior bus bars missing for approximately 6 and 9 inches. One bus bar had a 3 inch diameter hole in it. The bottom and top of the bus duct was melted for several feet, along with sections of the duct work on the perpendicular 12 kV bus sections at the tee connection. In addition, the fire had burned an approximate 1 foot square hole in the bottom of the SUT 1-2 Winding X 4 kV bus duct, which was 4 inches above the 12 kV bus duct. Although the 4 kV bus bars and duct were covered with black soot, the only conductor damage was a small piece of metal missing from the center bus bar and one outer bus bar, which the inspectors considered to be indicative of a single phase-to-phase fault.

- Inconsistent silver plating
- Heavy bus loading
- Splice plate connections that may operate in excess of capacity
- Undetected damage from a 1995 fault of UAT 1-1

The inspectors observed that many of the removed bus bars and splice plates had minimal silver plating. The silver plating was brushed on in lieu of being dipped and had thin spots. The vendor had required only 0.002-inch thickness for the silver plating. The licensee sent one partially destroyed bus splice connection to a laboratory for analysis. The analysis determined that the silver plating on the splice plate had partially separated from the base aluminum, with corrosion products on the aluminum surface. The laboratory stated that they were unable to determine whether the corrosion was present prior to the fault. If the separated silver was present prior to the fault, it would have created higher resistance and, therefore, heat at the connection. The laboratory stated that the most likely source of corrosive compounds was the poly vinyl chloride insulating boot. The inspectors observed that silver plating was flaking off the aluminum bus bars at two other splice joints that were not directly affected by the fault.

The inspectors noted that the as-found torque values for many of the ½ inch splice plate connecting bolts were found to be in the range of 10 to 20 foot-pounds (marked, broken loose, then re-torque to the mark) indicating thermal relaxation from initial installation torque values of approximately 40 foot-pounds.

The licensee inspected all the bus bars that supply 12 kV power between the fault and UAT 1-1. The licensee removed all the aluminum bus bars and splice plates from this section of 12 kV busing and replaced them with copper. The licensee had all the replacement pieces silvered to a minimum of 0.02 inch by dipping to provide a better connection surface and replaced the bus ducts as necessary. Electricians torqued the accessible 4 kV and 12 kV bus bars splice plate connections to 50 ± 5 foot-pounds and high potential tested the replaced bus bars.

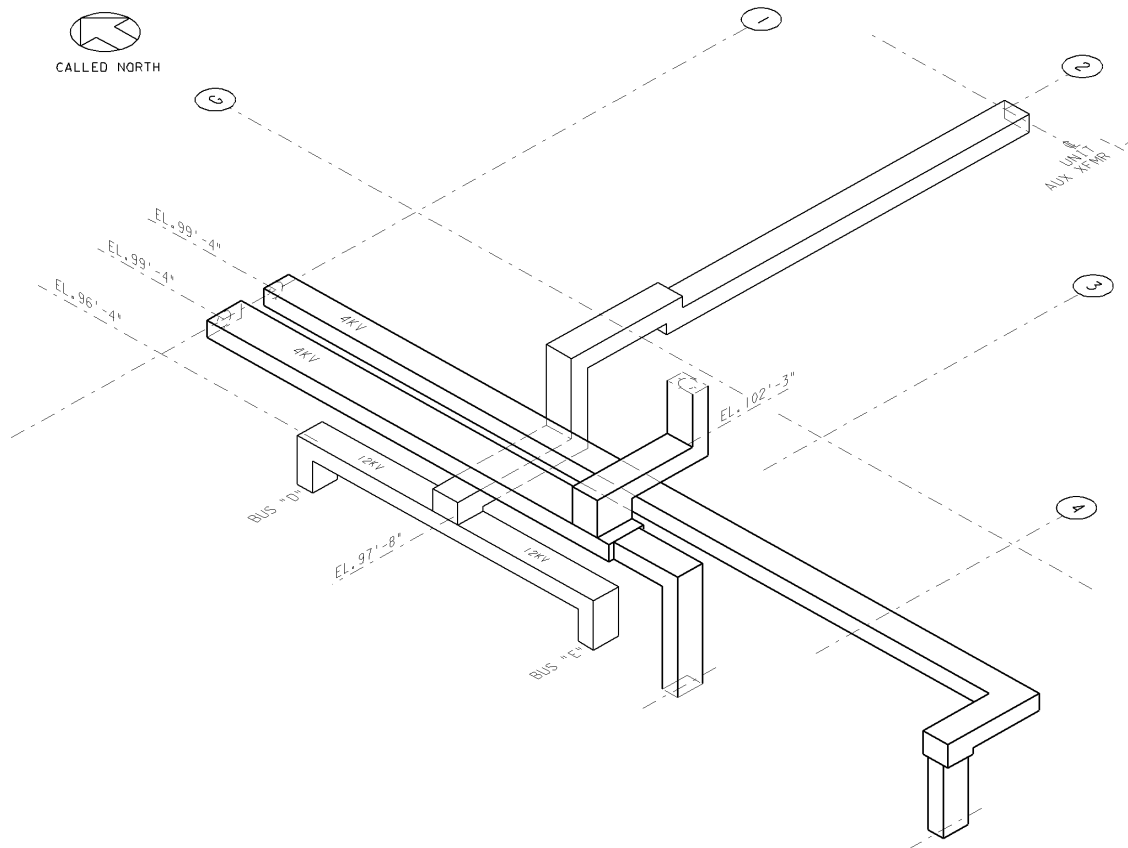
Attachment 8 - Switchgear Room Bus Duct Proximity

The licensee evaluated the extent of nonvital bus duct proximity to each other in each nonvital switchgear room. The licensee determined that for each nonvital 4 kV switchgear the bus ducts for auxiliary power and startup power remained in close proximity for extended stretches. The inspectors noted that a fault on a startup bus duct would be limited and likely result in little damage because of the presence of breakers to interrupt the current flow. However, the inspectors noted that a fault in the 4 kV auxiliary bus duct had no similar breakers to quickly sense and interrupt the fault and would likely affect the adjacent startup bus duct.

The licensee indicated that their approach to prevent a similar exposure of a failure in one nonvital bus duct from affecting an alternate nonvital bus duct would be to ensure preventive maintenance activities were implemented to prevent overheating of the bus duct.
