**Subject: Beaver Valley Power Station, Unit No. 1
Docket No. 50-334, License No. DPR-66
Completion Report for Generic Letter 87-02,
USI A-46 Program**

Beaver Valley Power Station Unit 1 (BV-1) Generic Letter 87-02, USI A-46 Completion Report

JOB NO. 250540 JOB BEAVER VALLEY A-46 OUTLIER RESOLUTION
 CALC. NO. C-021 SUBJECT OUTLIER RESOLUTION FOR DAMPERS

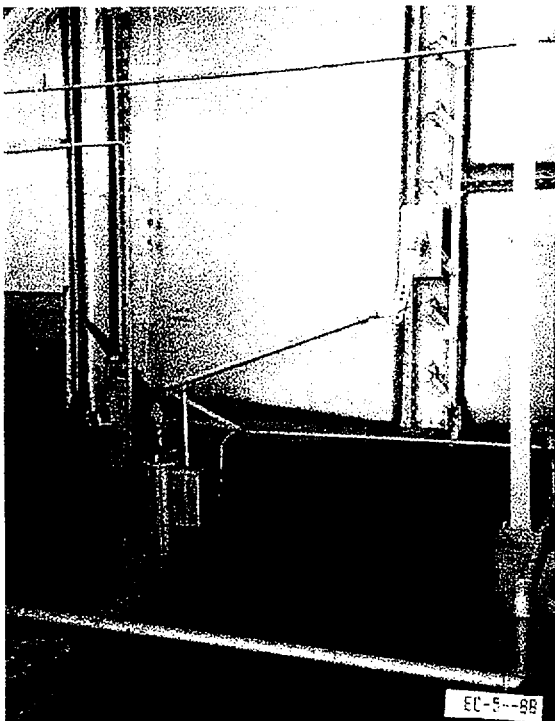
FIGURE A-4: PNEUMATIC DAMPER AT EL CENTRO STEAM PLANT SUBJECTED TO THE 1979 IMPERIAL VALLEY EARTHQUAKE (0.42G).

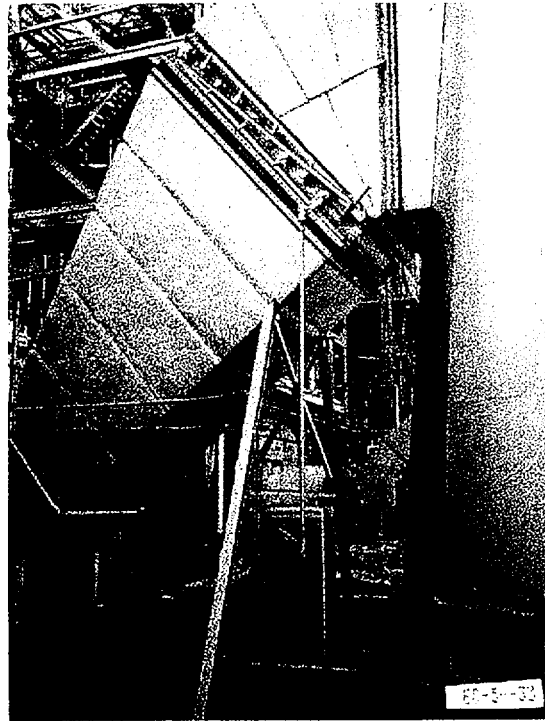
FIGURE A-5: LOUVER STYLE DAMPER ON THE BOILER STRUCTURE AT THE EL CENTRO STEAM PLANT WHICH EXPERIENCED THE 1979 IMPERIAL VALLEY EARTHQUAKE (0.42G).

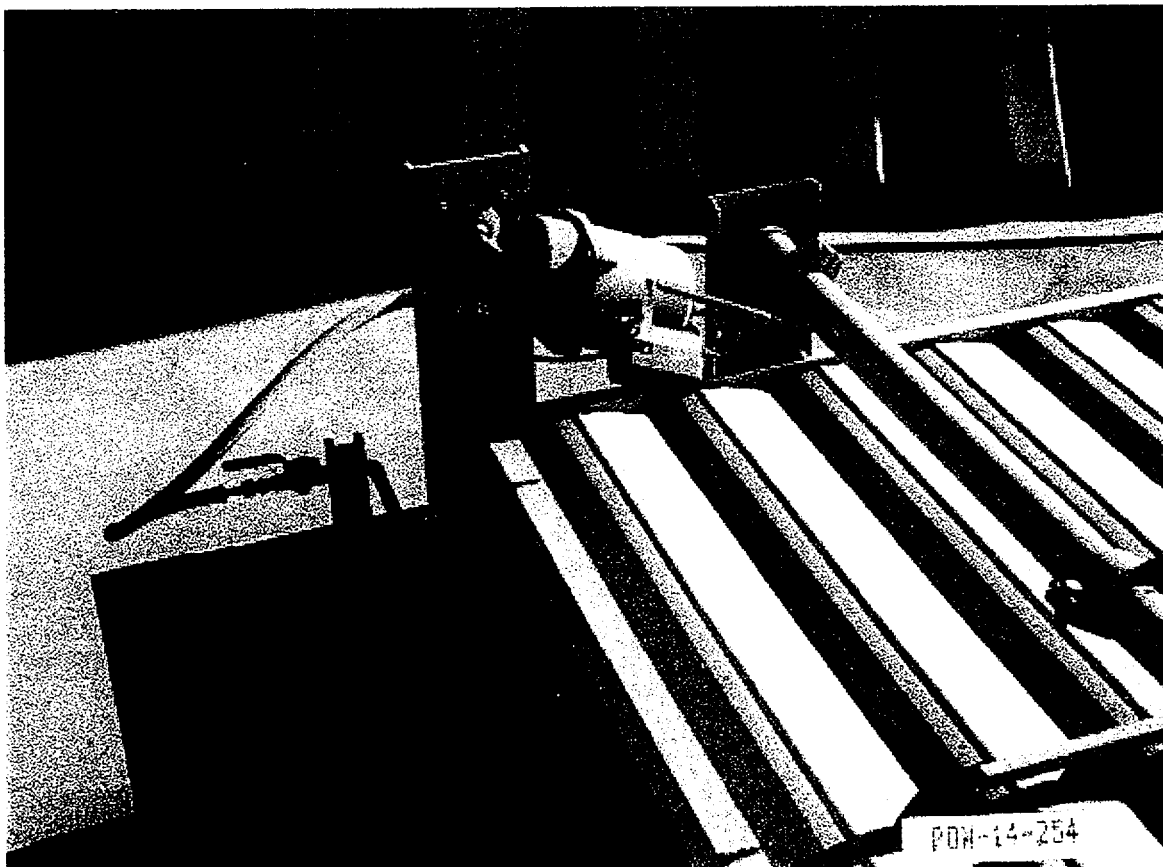
FIGURE A-6: PNEUMATIC ACTUATOR AT THE PUENTE HILLS LANDFILL GAS AND ENERGY RECOVERY PLANT.

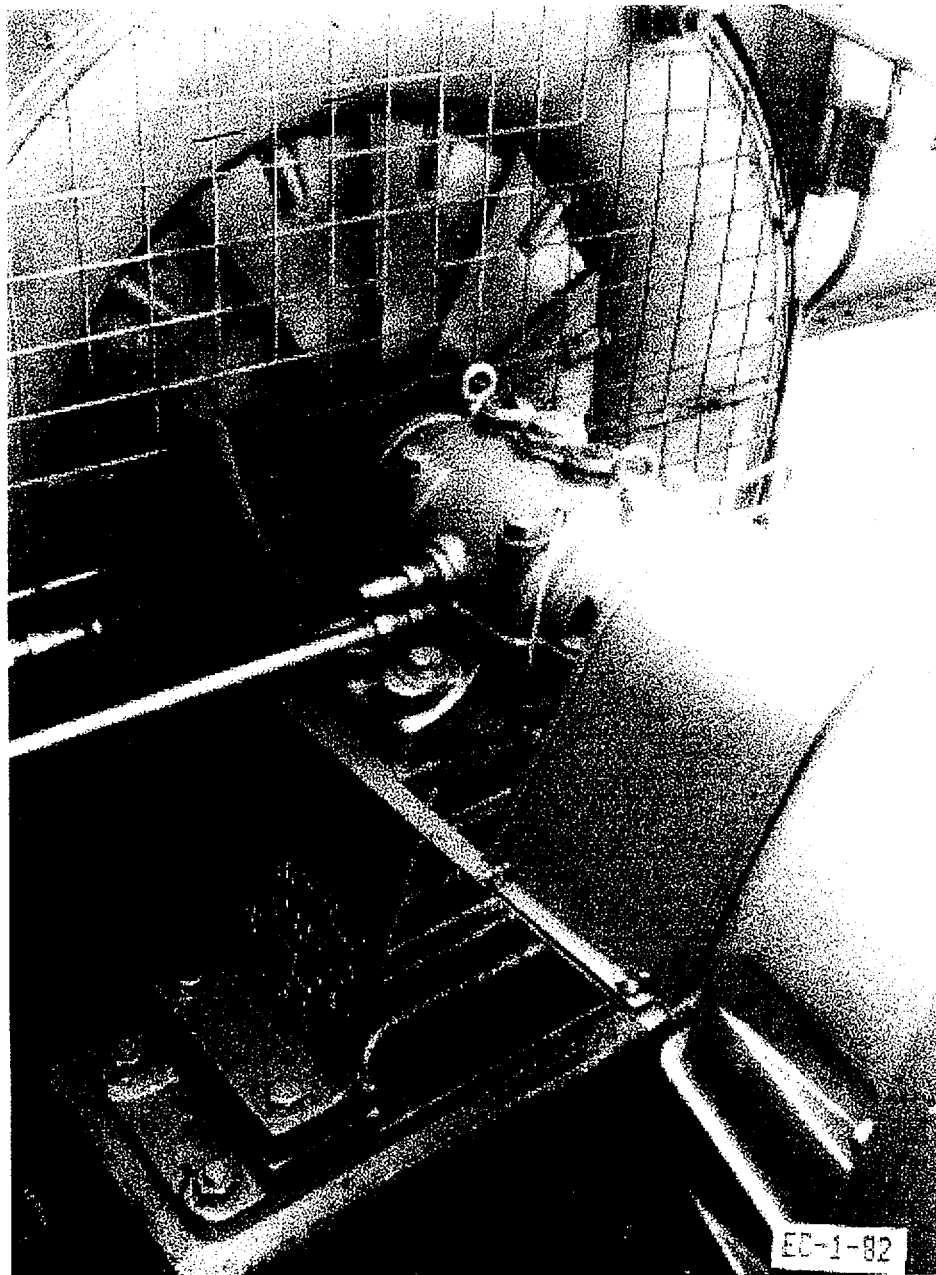
FIGURE A-7: RADIAL TYPE DAMPER AT THE EL CENTRO STEAM PLANT WHICH WAS SUBJECTED TO THE 1979 IMPERIAL VALLEY (0.42G) AND 1987 SUPERSTITION HILLS (0.25G) EARTHQUAKES.

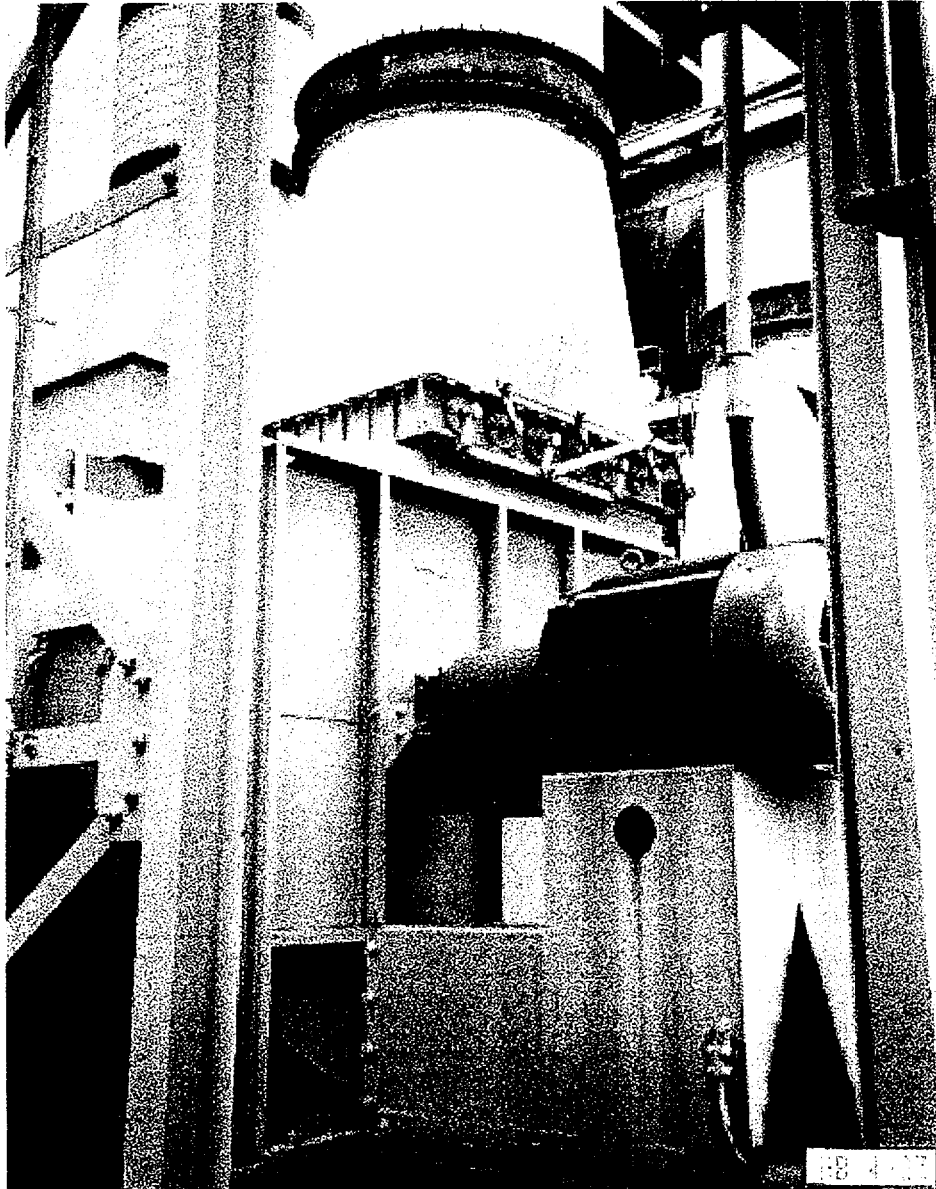
FIGURE A-8: LOUVER TYPE DAMPER AT HUMBOLDT BAY POWER PLANT (0.30G).

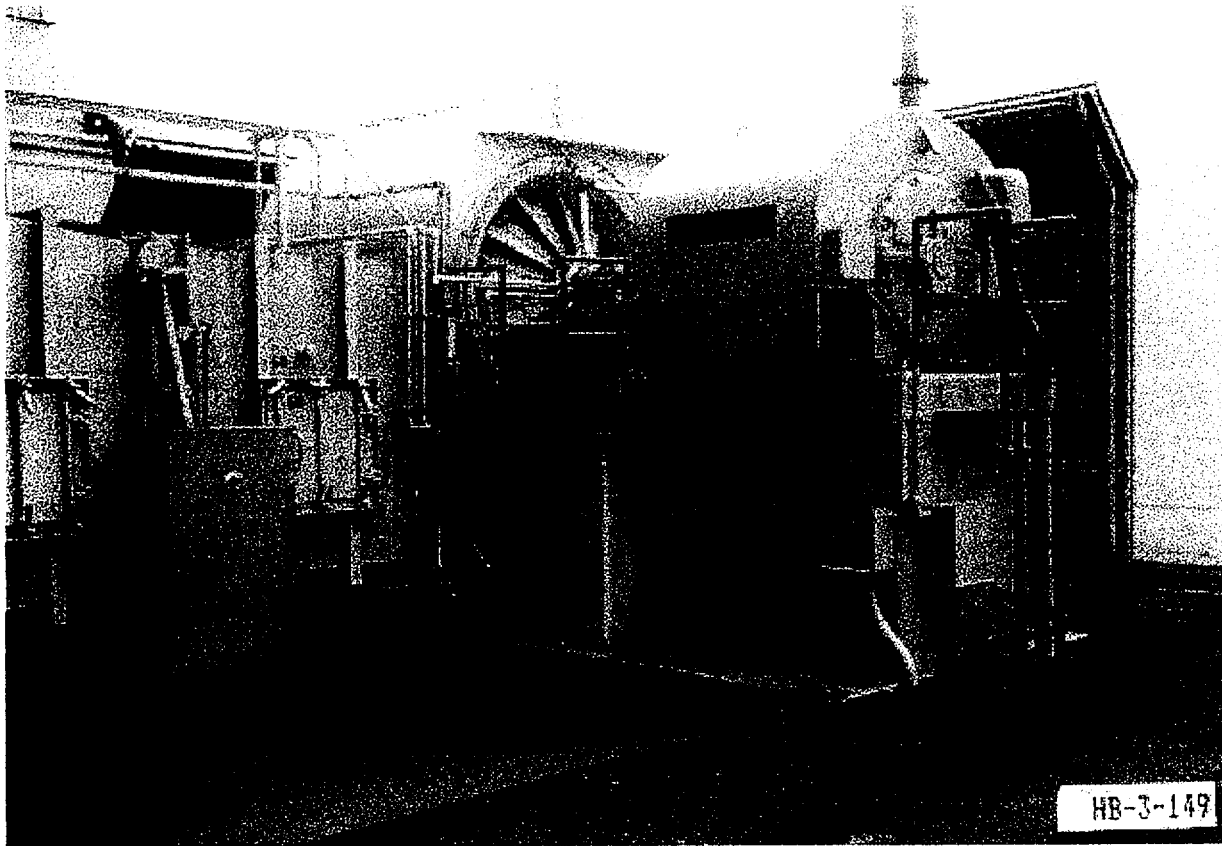
FIGURE A-9: RADIAL AND LOUVER TYPE DAMPERS AT HUMBOLDT BAY POWER PLANT WHICH EXPERIENCED THE 1975 FERNDAL EARTHQUAKE (0.50G).

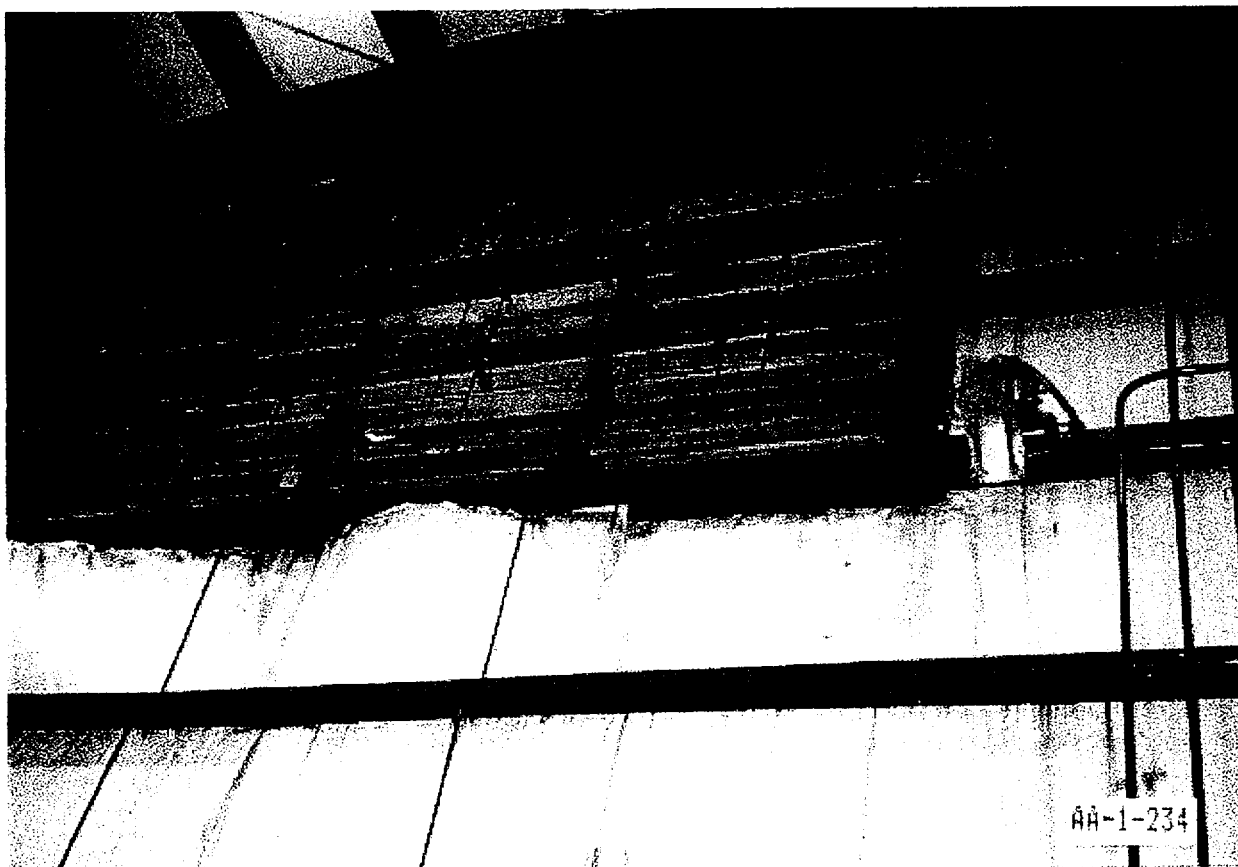
FIGURE A-10: MOTOR-OPERATED DAMPER AT ADAK NAVAL STATION, WHICH EXPERIENCED THE 1986 ADAK ALASKA EARTHQUAKE (0.25G).

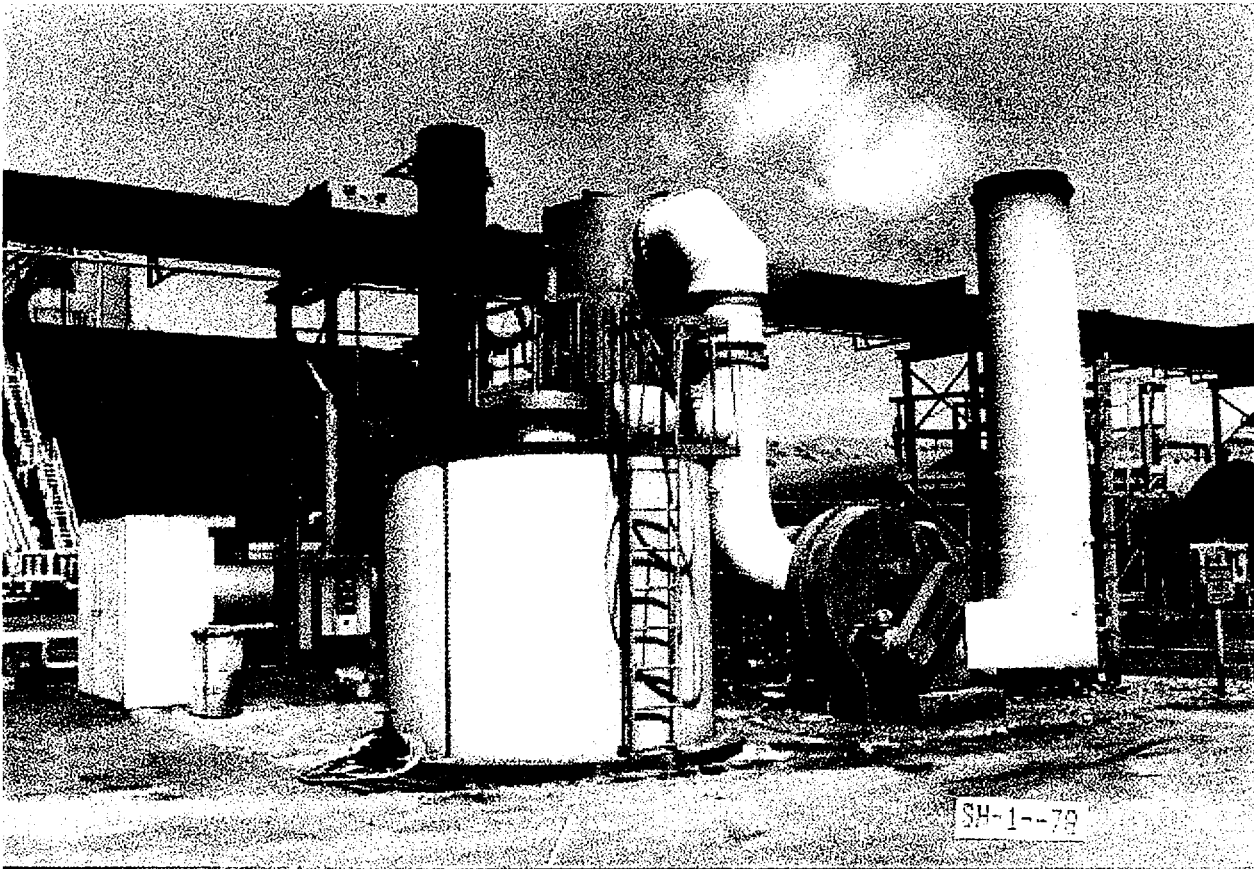
FIGURE A-12: PNEUMATICALLY CONTROLLED DAMPER AT UC SANTA CRUZ APPLIED SCIENCE BUILDING SUBJECTED TO 1989 LOMA PRIETA EARTHQUAKE (0.46G).

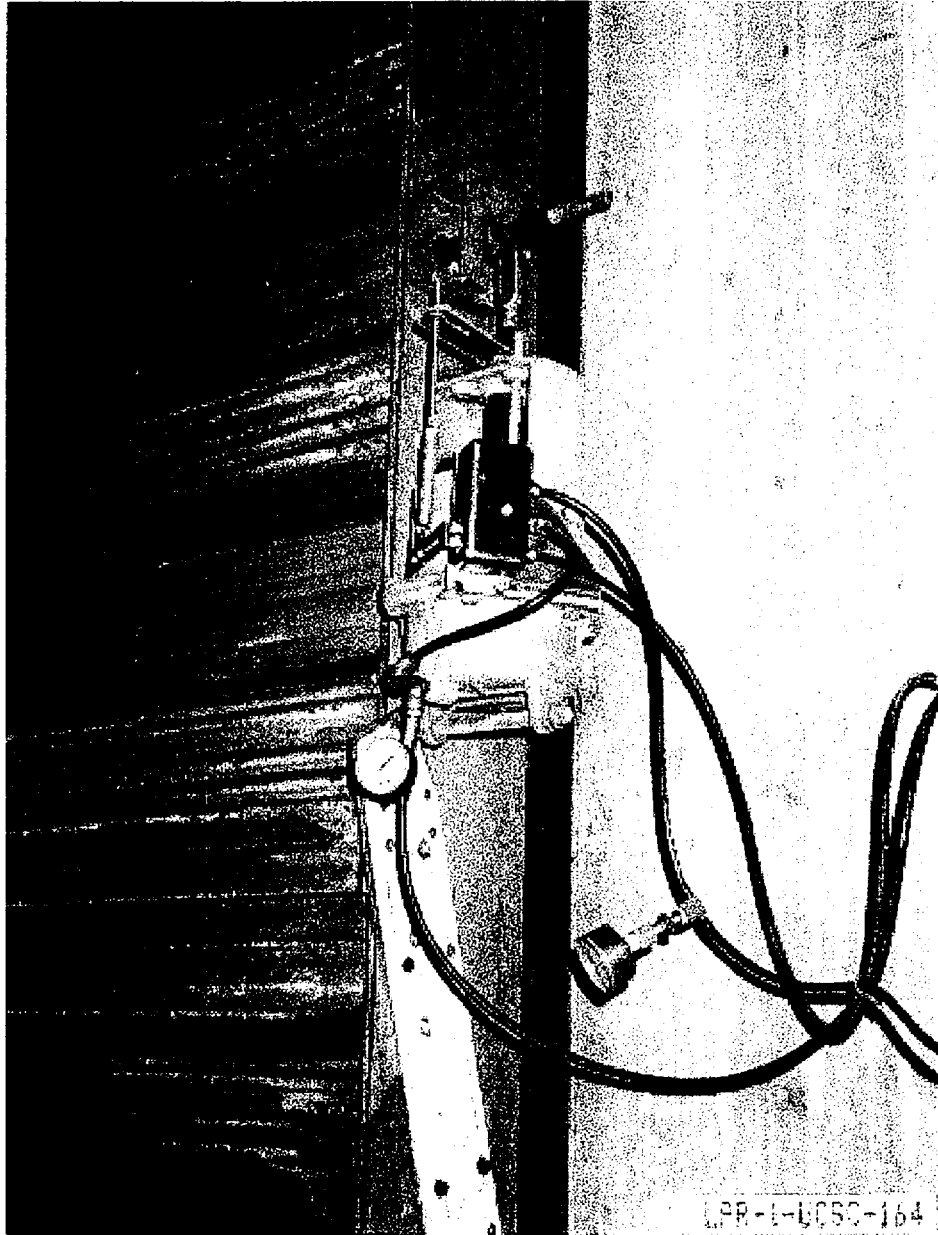
FIGURE A-13: ELECTRIC MOTOR FOR A FIRE DAMPER AT AES PLACERITA COGENERATION PLANT EXPERIENCED THE 1994 NORTHRIDGE EARTHQUAKE (0.60G).

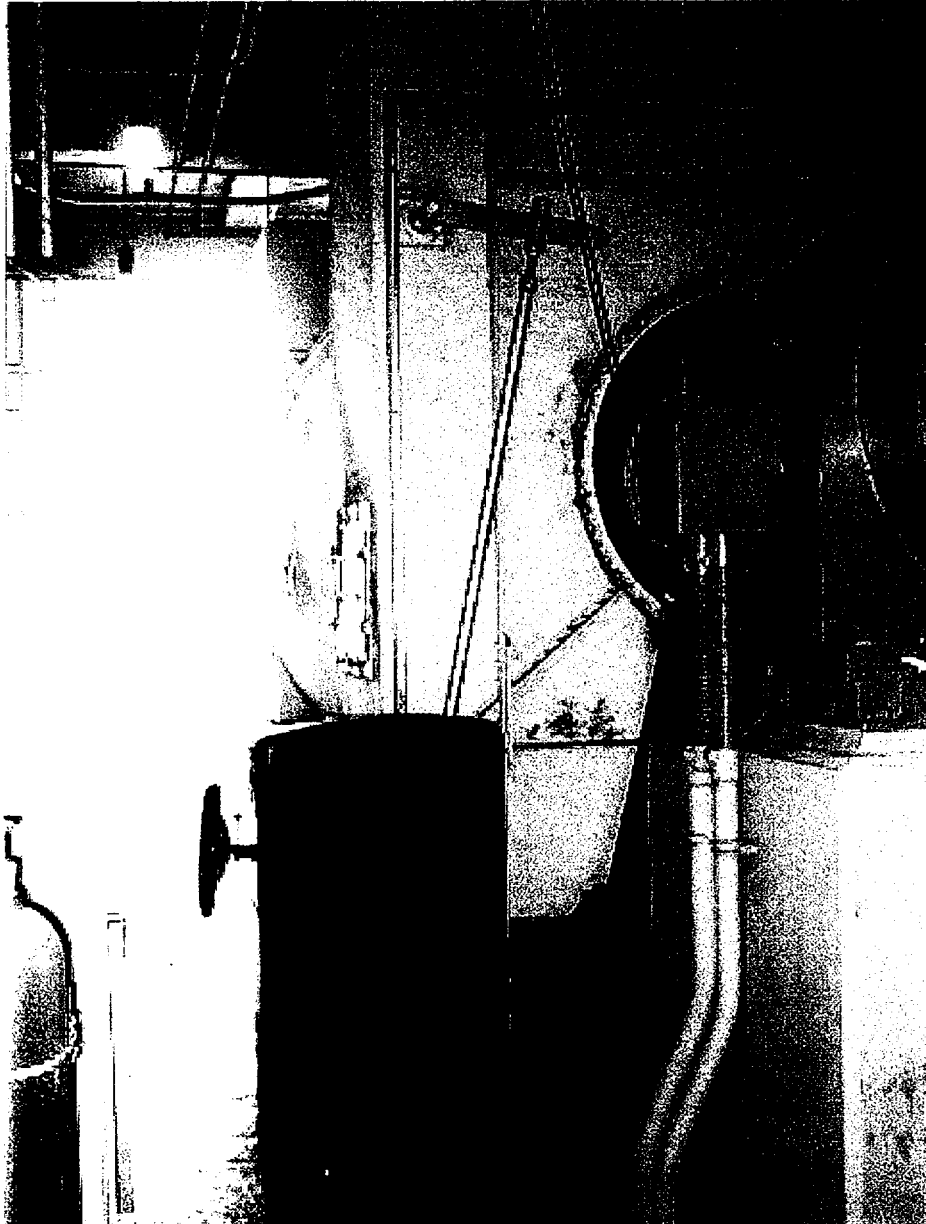
FIGURE A-14: PNEUMATIC DAMPER WITH LONG ACTUATOR AT VALLEY STEAM PLANT WHICH EXPERIENCED THE 1971 SAN FERNANDO (0.40G) AND THE 1994 NORTHRIDGE EARTHQUAKES (0.40G).

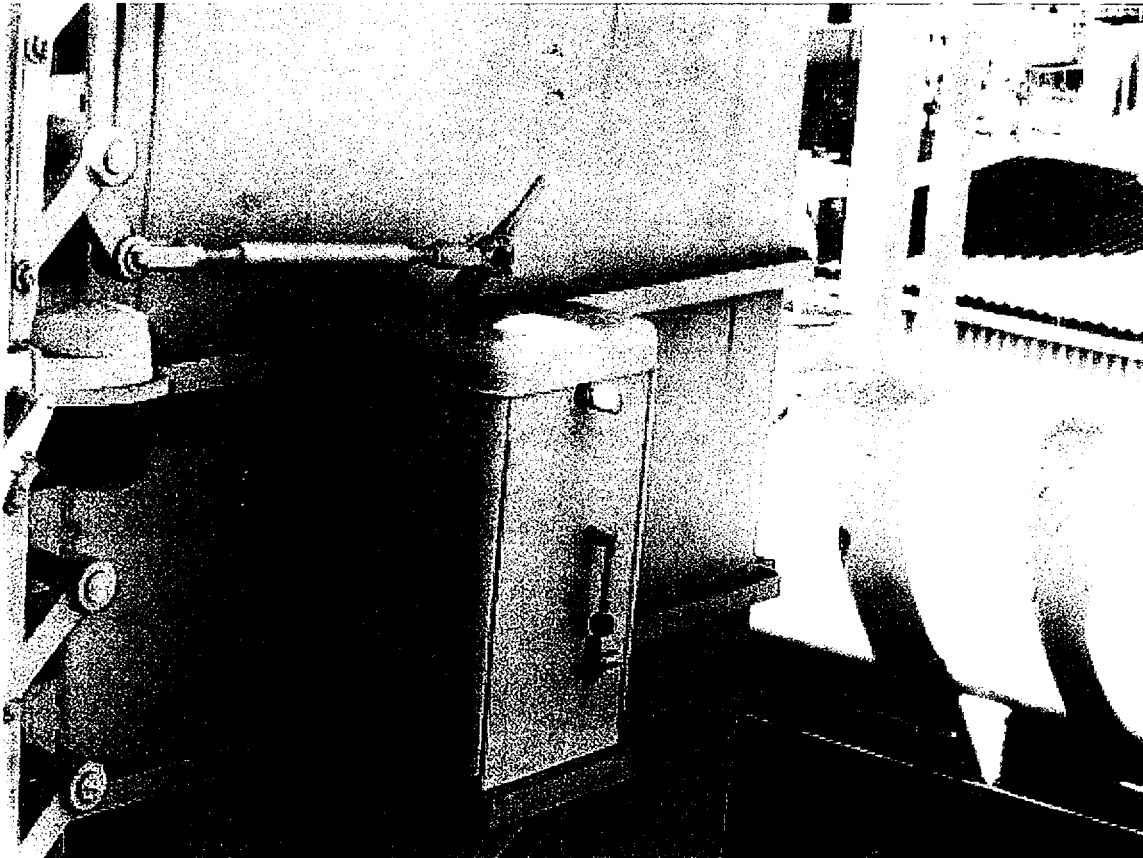
FIGURE A-15: PNEUMATIC LOUVER CONTROL DAMPER AT PASADENA POWER PLANT WHICH EXPERIENCED SEVERAL DATABASE EARTHQUAKES WITH PGA'S OF 0.20G.

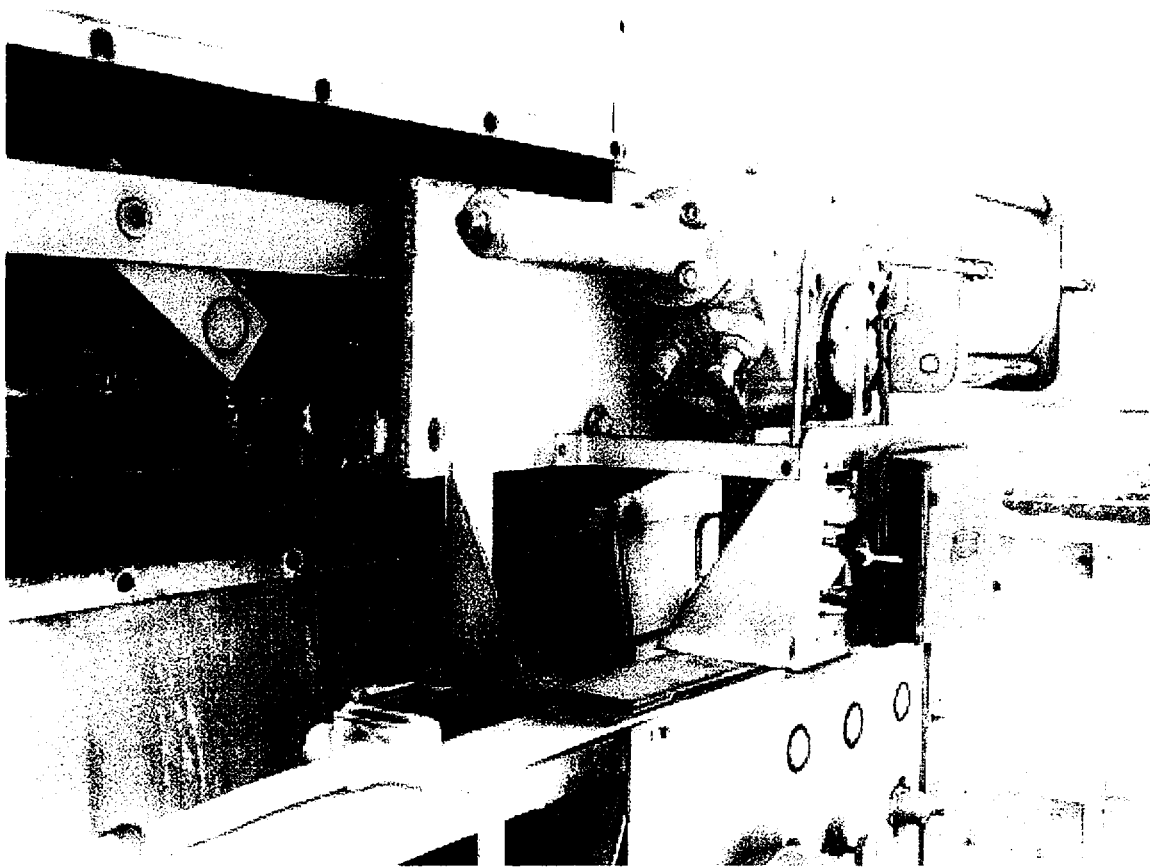
FIGURE A-16: HEAVY PNEUMATIC CONTROLLER, WITH INDEPENDENT SUPPORT, FOR A LARGE DAMPER AT PASADENA POWER PLANT LOCATED VERY HIGH IN THE BOILER STRUCTURE.

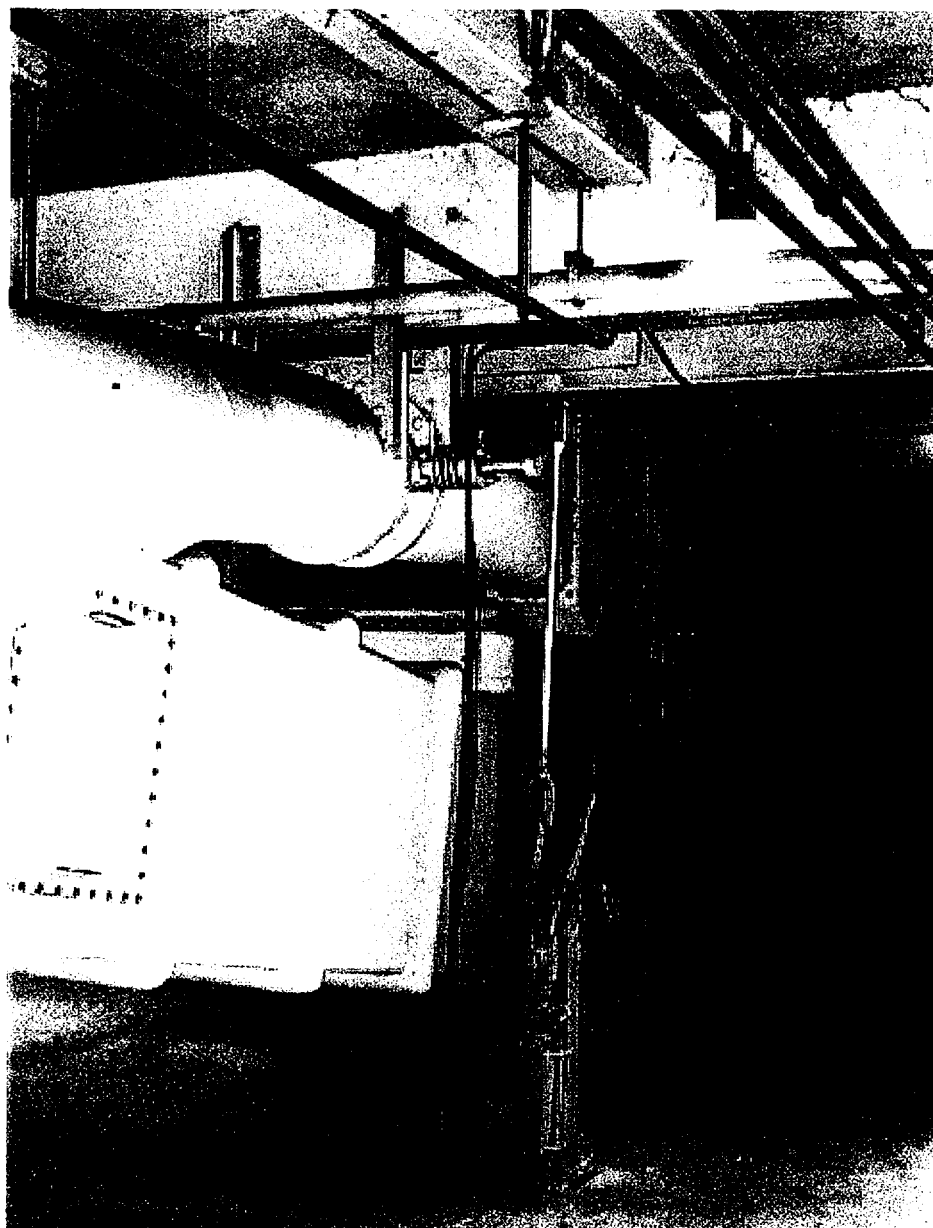
FIGURE A-17: FLOOR-MOUNTED AIR-OPERATED DAMPER WITH REMOTE ACTUATOR AT BURBANK POWER PLANT EXPERIENCED THE 1971 SAN FERNANDO AND THE 1994 NORTHRIDGE EARTHQUAKES (PGA=0.30G).

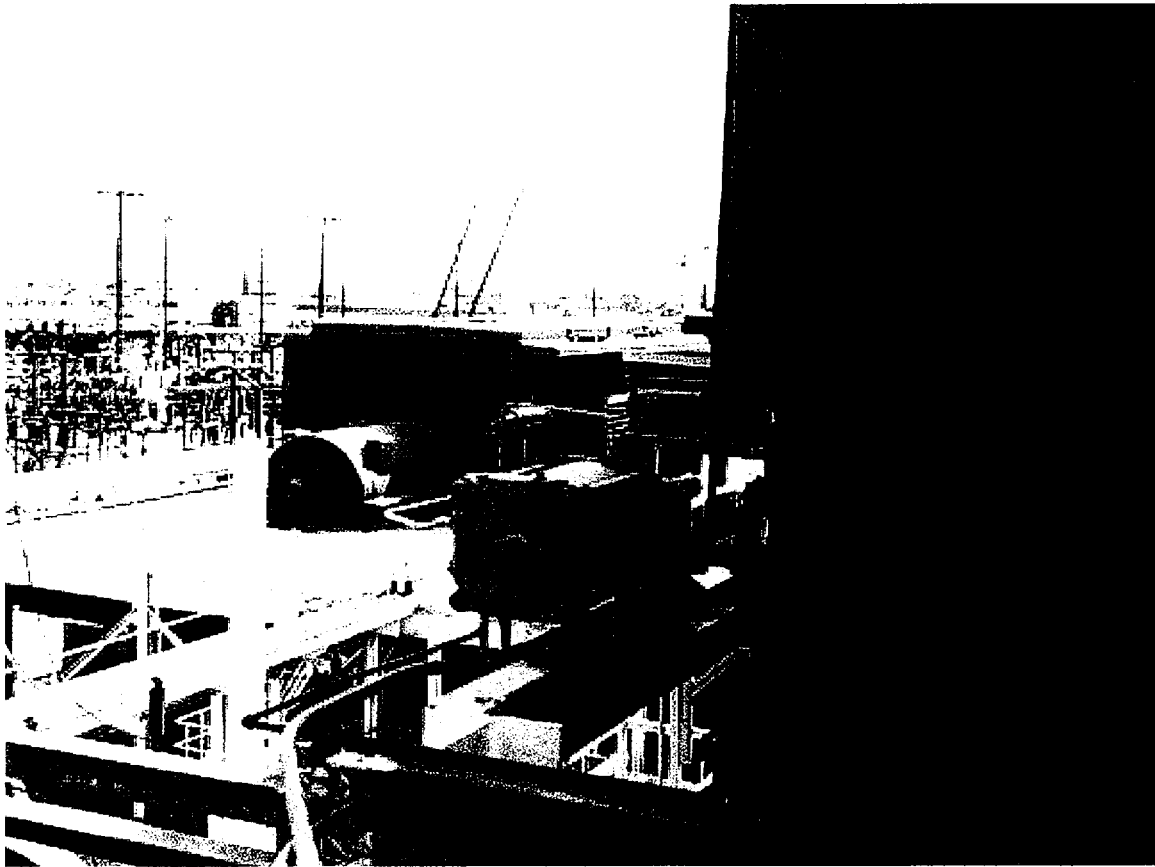
FIGURE A-18: LARGE INDEPENDENTLY SUPPORTED DAMPER CONTROLLER AT THE BURBANK POWER PLANT (PGA=0.30G).

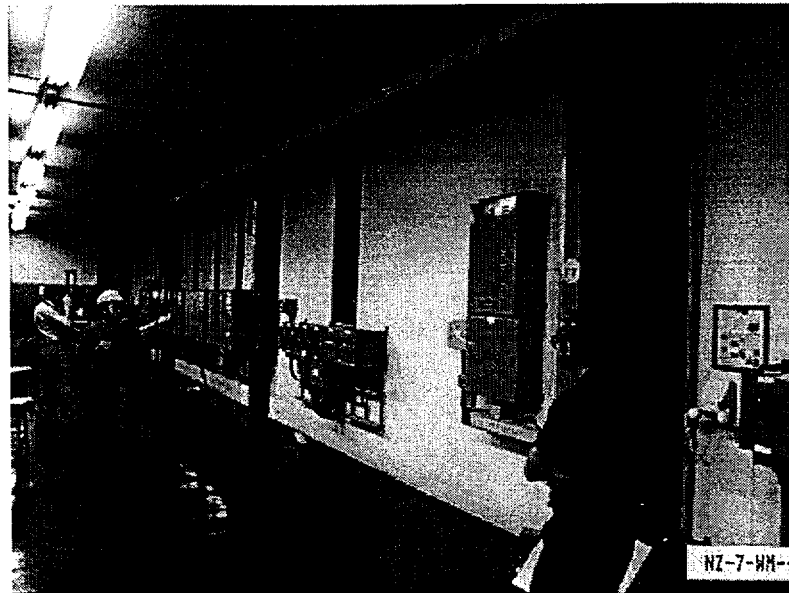
Figure 1: Wall-mounted distribution panelboards exceeding the standard dimensions for depth (dimension normal to the wall) create a question regarding the effect of increased mass moment arm cantilevered from the wall anchorage. Some of the best examples of excessive cantilevered mass in panelboards and similar wall-mounted cabinets are found at sites which withstood the 1987 earthquake in New Zealand. The examples illustrated above are wall-mounted cabinets serving the Whakatane Paper Mill (PGA = 0.3g), where the center of gravity of the cabinets is cantilevered an estimated 18 inches from the bolts anchoring the cabinets to the supporting block wall.

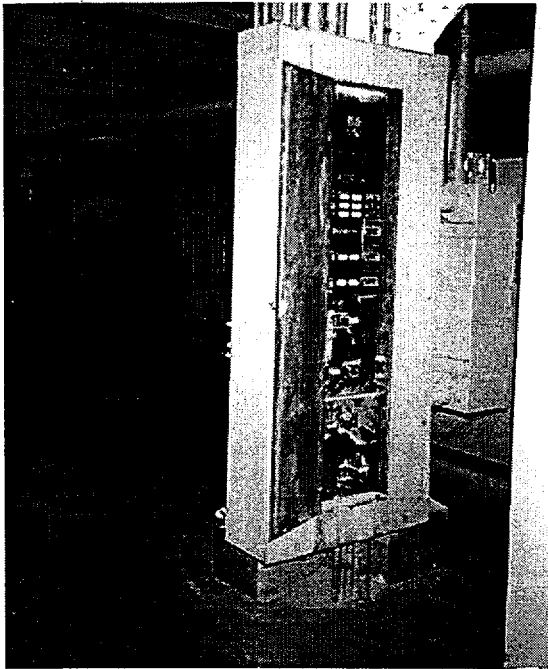
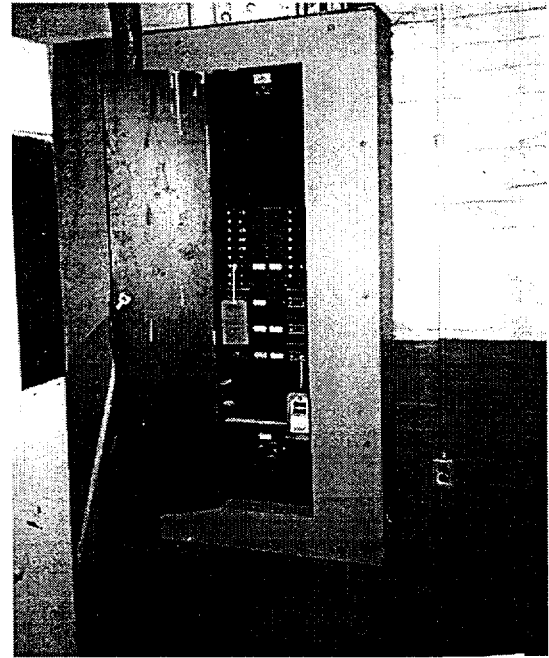
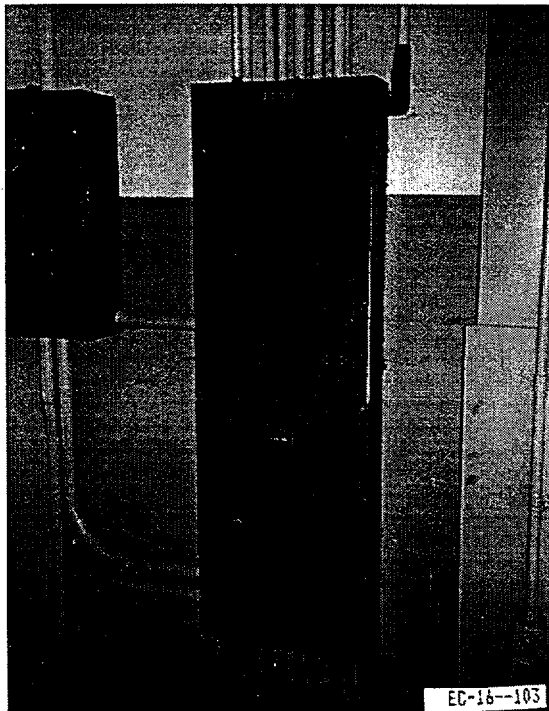
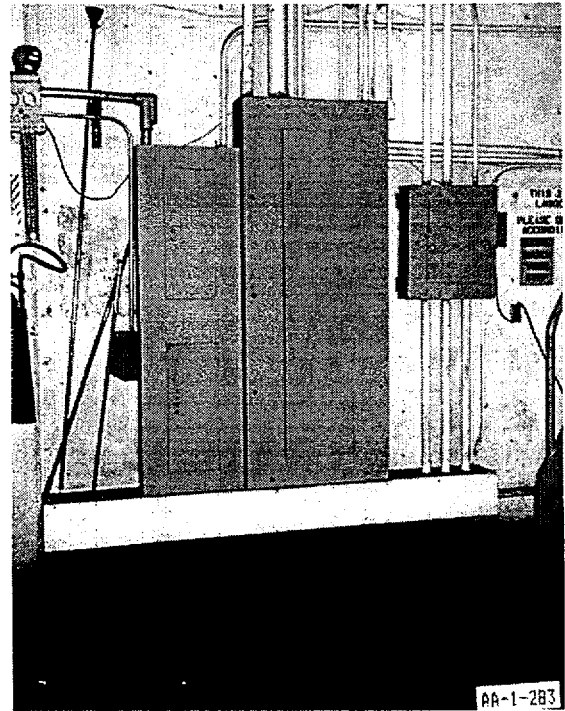
Figure 2: Examples of wall-mounted panelboards ranging from 60 to more than 70 inches in height are found at El Centro Steam Plant (upper and lower left photos, which withstood the earthquakes of 1979 and 1987, with PGA's of 0.42g and 0.25g respectively), and at the Adak Naval Base (lower right photo, which withstood the earthquake of 1986, PGA= 0.25g).

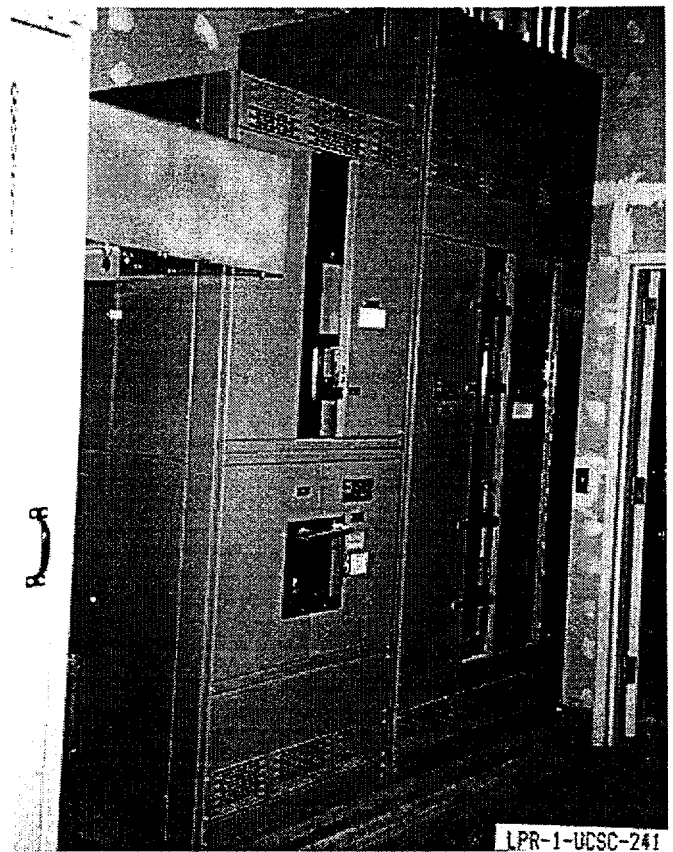
Figure 4: Switchboards exceeding the standard 90 inches in height present a question of excessive mass concentrated at the top of the cabinet, or an excessively high center of gravity. Cabinet height extensions sometimes include cable pullboxes into which overhead conduit connections are made, as in the two examples illustrated in the photos. The switchboards are located in the electrical rooms of the UC Santa Cruz Central Campus, which withstood the 1989 Loma Prieta earthquake ($PGA = 0.4g$).

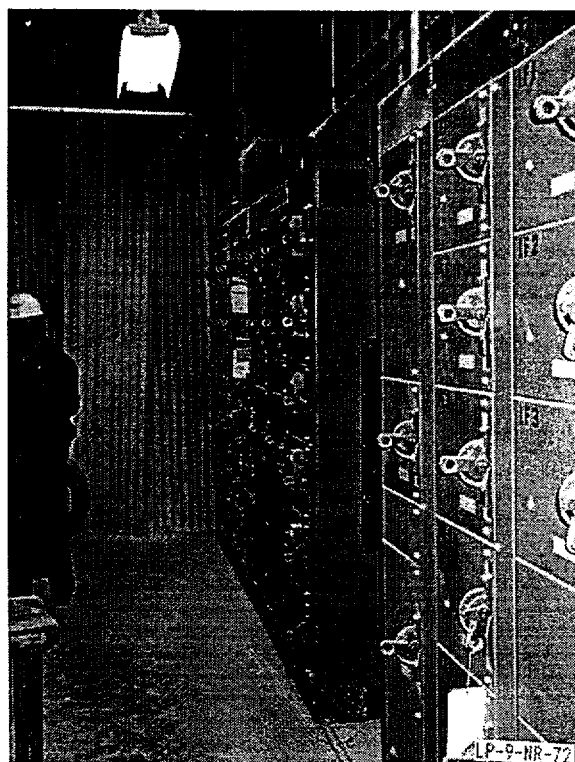
Figure 6: Examples of excessive mass concentrated above the standard cabinet height of 90 inches are best illustrated by the heavy distribution transformers mounted atop motor control centers (with characteristics similar to those of a switchboard) at the National Refractory, which withstood the 1989 Loma Prieta earthquake, $PGA = 0.30g$. The two transformers, which comprise concentrated masses of about 100 pounds each, did not overstress the floor anchorage of the MCCs or otherwise damage the cabinets or the switching components housed within.
