Re: Turkey Point Units 3 & 4
Docket Nos. 50-250 & 50-251
Reportable Event: 2000-002-00
Date of Event: July 21, 2000
Entry into Technical Specification LCO 3.0.3 While Performing Load
Center Undervoltage Relay Surveillance

NRC FORM 366 (6-1998)		U.S. NUCLEAR REGULATORY COMMISSION			APPROVED BY OMB NO. 3150-0104		EXPIRES 06/30/2001				
LICENSEE EVENT REPORT (LER) (See reverse for required number of digits/characters for each block)					Estimated burden per response to comply with this mandatory information collection request: 50 hrs. Reported lessons learned are incorporated into the licensing process and fed back to industry. Forward comments regarding burden estimate to the Records Management Branch (T-6 F33), U.S. Nuclear Regulatory Commission, Washington, DC 20555-0001, and to the Paperwork Reduction Project (3150-0104), Office of Management and Budget, Washington, DC 20503. If an information collection does not display a currently valid OMB control number, the NRC may not conduct or sponsor, and a person is not required to respond to, the information collection.						
FACILITY NAME (1) Turkey Point Unit 3					DOCKET NUMBER (2) 05000250		PAGE (3) Page 1 of 6

TITLE (4) Entry int

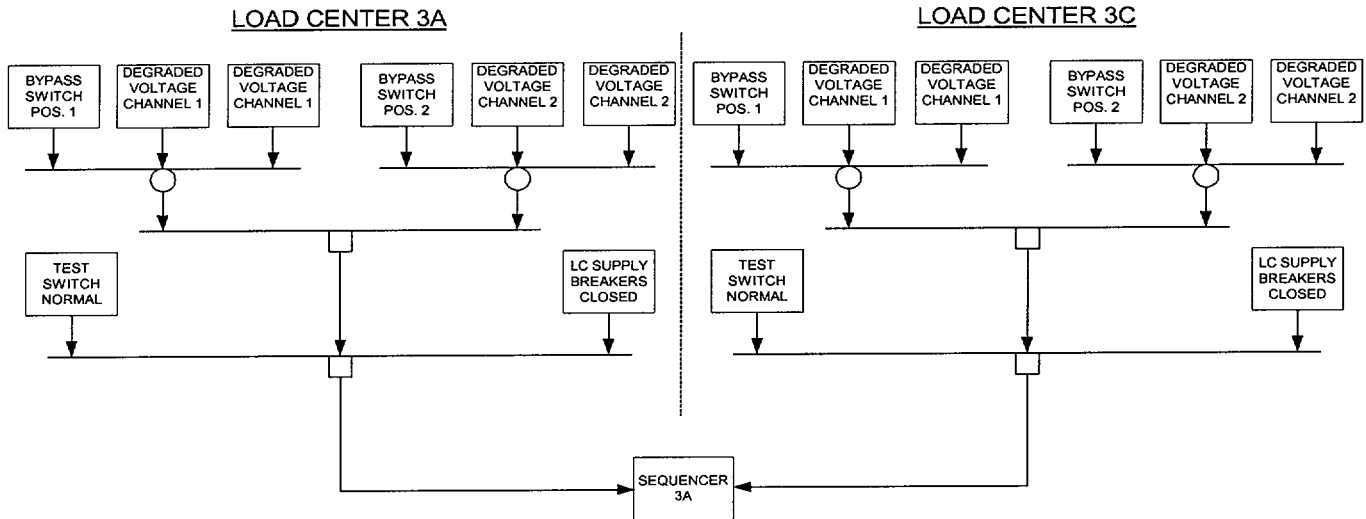
Degraded Voltage - Non-SI Situation

The non-SI scheme has four voltage sensing relays on each load center. Channel 1 utilizes one 327I and one 327T relay; channel 2 does the same. The relays are interconnected in a "one out of two taken twice" channel trip logic such that the logic trips (initiates bus stripping) if degraded voltage is detected by either channel 1 relay (327I or 327T) concurrently with either channel 2 relay (327I or 327T). The 327I relay protects the system from degraded voltage over a long duration while the 327T relay protects the system during a large voltage transient for a short duration.

A five position test switch (with positions labeled 12, 11, Normal, 21 and 22) enables the operator to test either relay on either channel. Placing the test switch in any position other than Normal will block the trip signal from its associated load center.

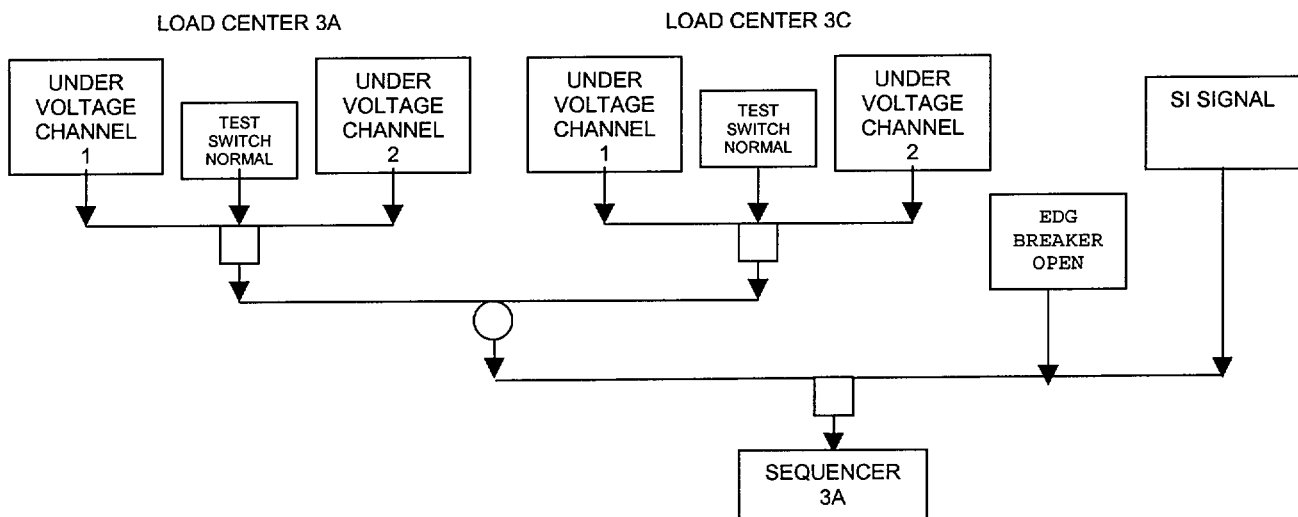
Degraded Voltage Protection; Coincident with SI

The scheme for SI has two voltage sensing relays (327H's) on each load center. If both relays on the load center sense an undervoltage condition (along with an SI signal and the associated EDG's output breaker being open), they will initiate bus stripping on the associated 4.16 kV bus.

A three position, spring return to Normal, test switch enables the operator to test either relay. Placing the test switch in any position other than Normal will bypass the trip circuit of both channels and block the trip signal from its associated load center.
