**UNITED STATES
NUCLEAR REGULATORY COMMISSION
REGION IV
611 RYAN PLAZA DRIVE, SUITE 400
ARLINGTON, TEXAS 76011-8064**

SUBJECT: REGION IV REFUELING OUTAGE RISK - AN OPERATIONAL PERSPECTIVE

Refueling Outage Risk -
An Operational Perspective

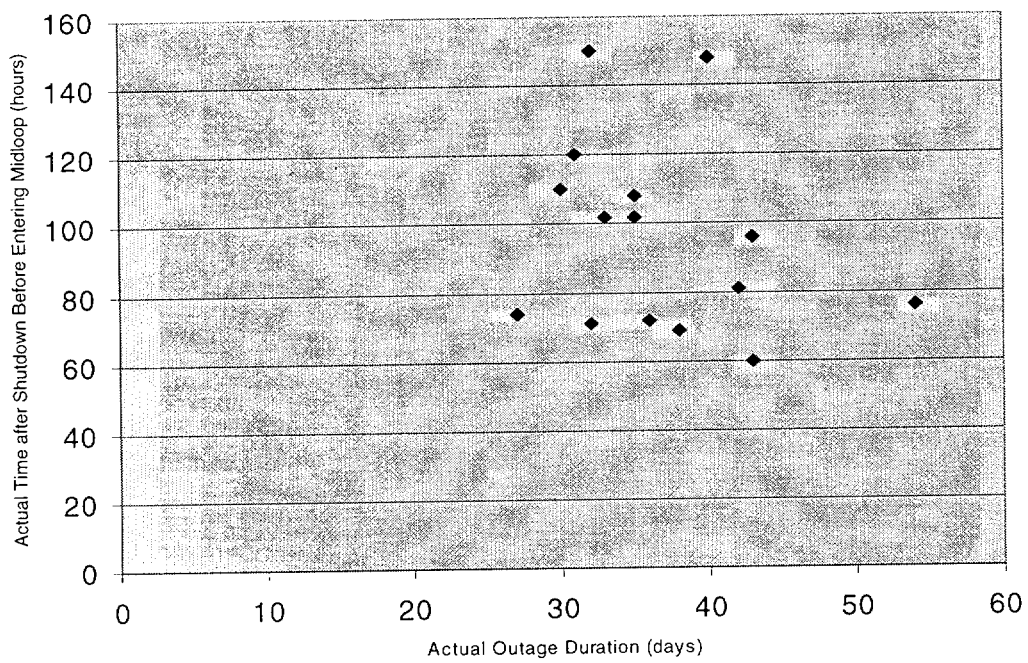
Figure 1 - Outage Duration vs. Time Before Entering Midloop

Given that the primary reason for entering the early, hot midloop was to shorten the overall outage duration, it is interesting to note that the data show a slightly negative correlation ($\rho = -0.26$) between the actual outage duration and the delay before entering midloop. In other words, those plants which employed an early entry into the midloop configuration were observed to have outages of slightly longer duration relative to those plants that delayed the entry into the midloop configuration. For example, the plant that waited the longest before entering midloop (150 hours) realized a total outage duration of 32 days (slightly below the average) whereas one of the facilities that had the most aggressive midloop schedule (68 hours) had a duration of 38 days (slightly above average). The reasons for this relationship are not clear; however, these data suggest that further reviews of the relationship between scheduling of the midloop configuration with respect to the overall outage duration may be warranted. A graphical representation of this relationship is shown in Figure 1.

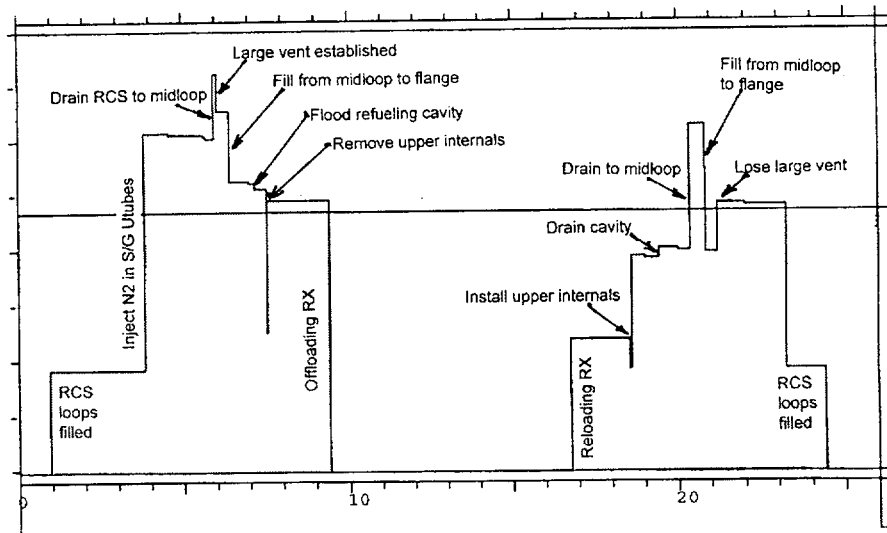
FIGURE 2 - Typical PWR Outage Risk Profile

Figure 2 shows a graphical representation of the risk profile associated with a typical PWR refueling outage. Initially, the risk is relatively low due to the high reactor coolant inventory and the availability of all electric power sources and decay heat removal systems. The risk then experiences a prompt jump when the steam generator tubes are voided, thereby eliminating the availability of secondary heat removal as a decay heat removal mechanism. The risk can be seen to reach its peak as reactor coolant inventory is reduced during the midloop configuration. Risk is gradually reduced as inventory is restored following the midloop and decay heat levels abate. Once the core is offloaded, the risk of in-vessel core damage is eliminated during the interval when the reactor fuel is in the spent fuel pool and the risk of spent fuel pool boiling represents the primary radiological risk of the outage. Following the reload of the fuel, the risk then rises in an inverse relationship with respect to inventory levels and reaches a somewhat lower (due to reduced decay heat levels) late peak during the "back-end" midloop to restore the steam generators.

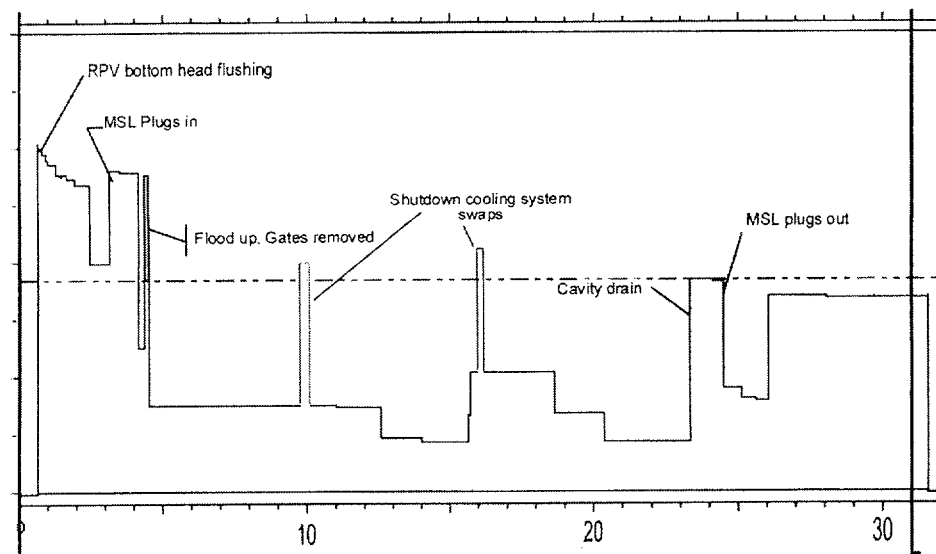
FIGURE 3 - Typical BWR Outage Risk Profile

The risk profile of a typical BWR outage is somewhat different from that seen in the PWR case. In general, the refueling activities associated with a BWR are more time-intensive and full core offloads are not generally performed. Thus, the risk of in-vessel core damage remains throughout the outage. The risk profile associated with the BWR outage shows an inverse relationship with respect to inventory levels and decreases gradually throughout the outage due to dissipating decay heat levels. Several "spikes" in the typical profile can be seen during swaps of the shutdown cooling system and cavity draining evolutions. These spikes are primarily the result of human errors during these processes. A representative profile of a BWR outage is shown in Figure 3.
