UNITED STATES  
NUCLEAR REGULATORY COMMISSION

SUBJECT: NRC SPECIAL INSPECTION REPORT - INDIAN POINT UNIT 2  
STEAM GENERATOR TUBE FAILURE - REPORT NO. 05000247/2000-010

IR 05000247-00-010, March 7 thru July 20, 2000; Consolidated Edison of New York, Inc.; Indian Point Unit 2; Special Team; steam generator tube failure, visual, eddy current inspection, technique qualification, corrective actions.

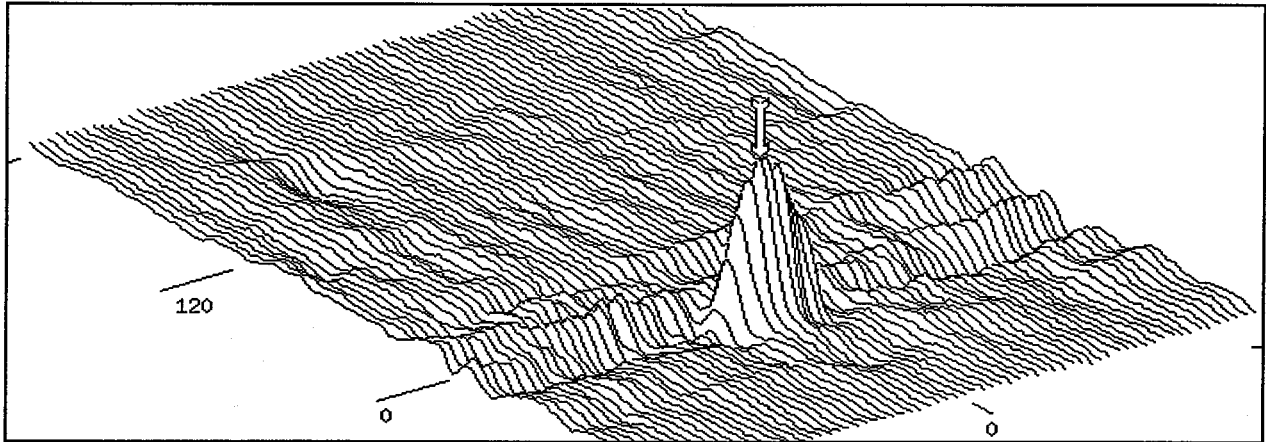
**Figure 5** - Crack in tube 2-67 of steam generator 24, found in 1997.

The c-scan plot of the 1997 data from R2C67 is shown in Figure 5. The crack sits beside a noise ridge, in a valley, and is in an easily detectable portion of the tube. The large amplitude of the voltage signal, in relation to the standard calibration notch, would indicate that this is a "mature" crack. No year 2000 data is available since the tube was plugged in 1997.

While the flaw was identified and the tube plugged, neither Con Edison nor its ECT contractor identified the discovery of the low-row U-bend apex indication as a significant condition adverse to quality. There was no specific review as to the significance of this flaw or the possible extent of the condition. Identification of this flaw was significant, because it was the first observation of this type of degradation at the apex of a low-row U-bend SG tube at Indian Point 2. Further, apex cracks, if not detected and removed from service, have a greater likelihood of causing a tube rupture than other U-bend cracks, based on past industry events including the Surry 1 tube rupture in 1976 and the Doel (Belgium) tube rupture in 1979. This issue was not entered into the corrective action program.

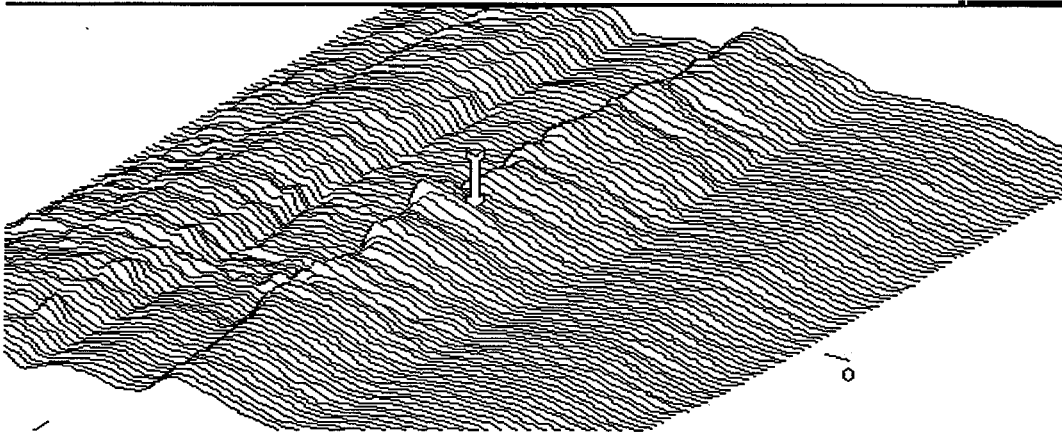
Figure 6 R2C5C-scan with 1997 phase setting.

1. R2C5 in SG 24 - Figure 6 is a c-scan plot of the vertical component of the ECT voltage signal. The defect signal, indicated by the arrow, sits on a noise ridge that runs the length of the tube. This noise ridge is about 1-volt in amplitude. This ridge makes both the detection and sizing of this defect difficult, because of the very low signal-to-noise ratio. Figures 7 and 8 are the lissajous plots for the flaw area and the noise ridge, respectively. No year 2000 data is available since the tube failed.
