**Pacific Gas and
Electric Company**

PG&E Letter DCL-00-115

Docket No. 50-275, OL-DPR-80
Diablo Canyon Unit 1
Licensee Event Report 1-2000-004-01
Unit 1 Unusual Event Due to a 12 kV Bus Fault

TITLE (4)
Unit 1 Unusual Event Due to a 12 kV Bus Fault

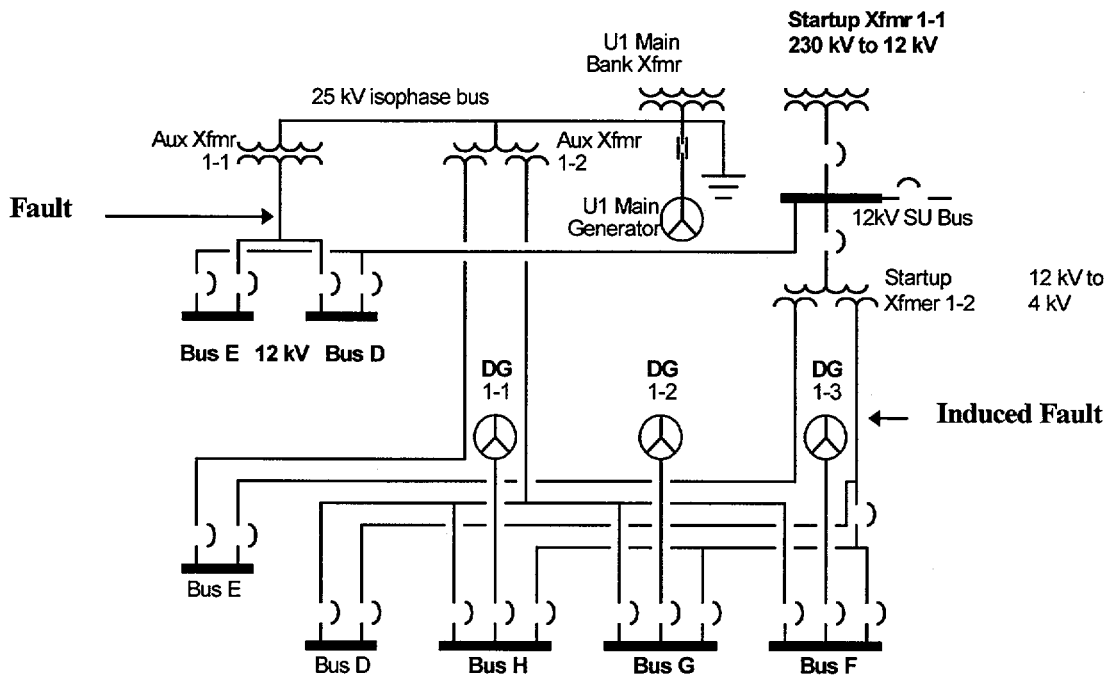
During normal operation, the Unit 1 main generator [EL] supplies 25 kV electrical power to the main transformers [XFMR] (25 kV to 500 kV) that are connected to the PG&E transmission system. The 25 kV system also supplies power to plant loads [EA] fed from Auxiliary Transformer 1-1 (25 kV to 12 kV) and Auxiliary Transformer 1-2 (25 kV to 4 kV). Figure 1 depicts a simplified single line diagram of the Unit 1 power supplies to the 4 kV and 12 kV buses.

On May 15, 2000, at 0025 PDT, a phase-to-phase fault occurred on the 12 kV nonsegregated phase bus between Auxiliary Transformer 1-1 and 12 kV bus D and bus E. The fault was immediately sensed by phase differential protective relays which initiated a unit trip. The unit trip caused a turbine trip and automatic reactor trip as designed. Power automatically transferred from Auxiliary to Startup power. Figure 1 shows the location of the fault.
