L-2000-242
10 CFR § 50.73

Re: Turkey Point Unit 4
Docket No. 50-251
Reportable Event: 2000-004-00
Date of Event: October 21, 2000
Loss of Offsite Power and Safety Injection Actuation While in Mode 3

Loss of Offsite Power and Actuation of Safety Injection While in Mode 3

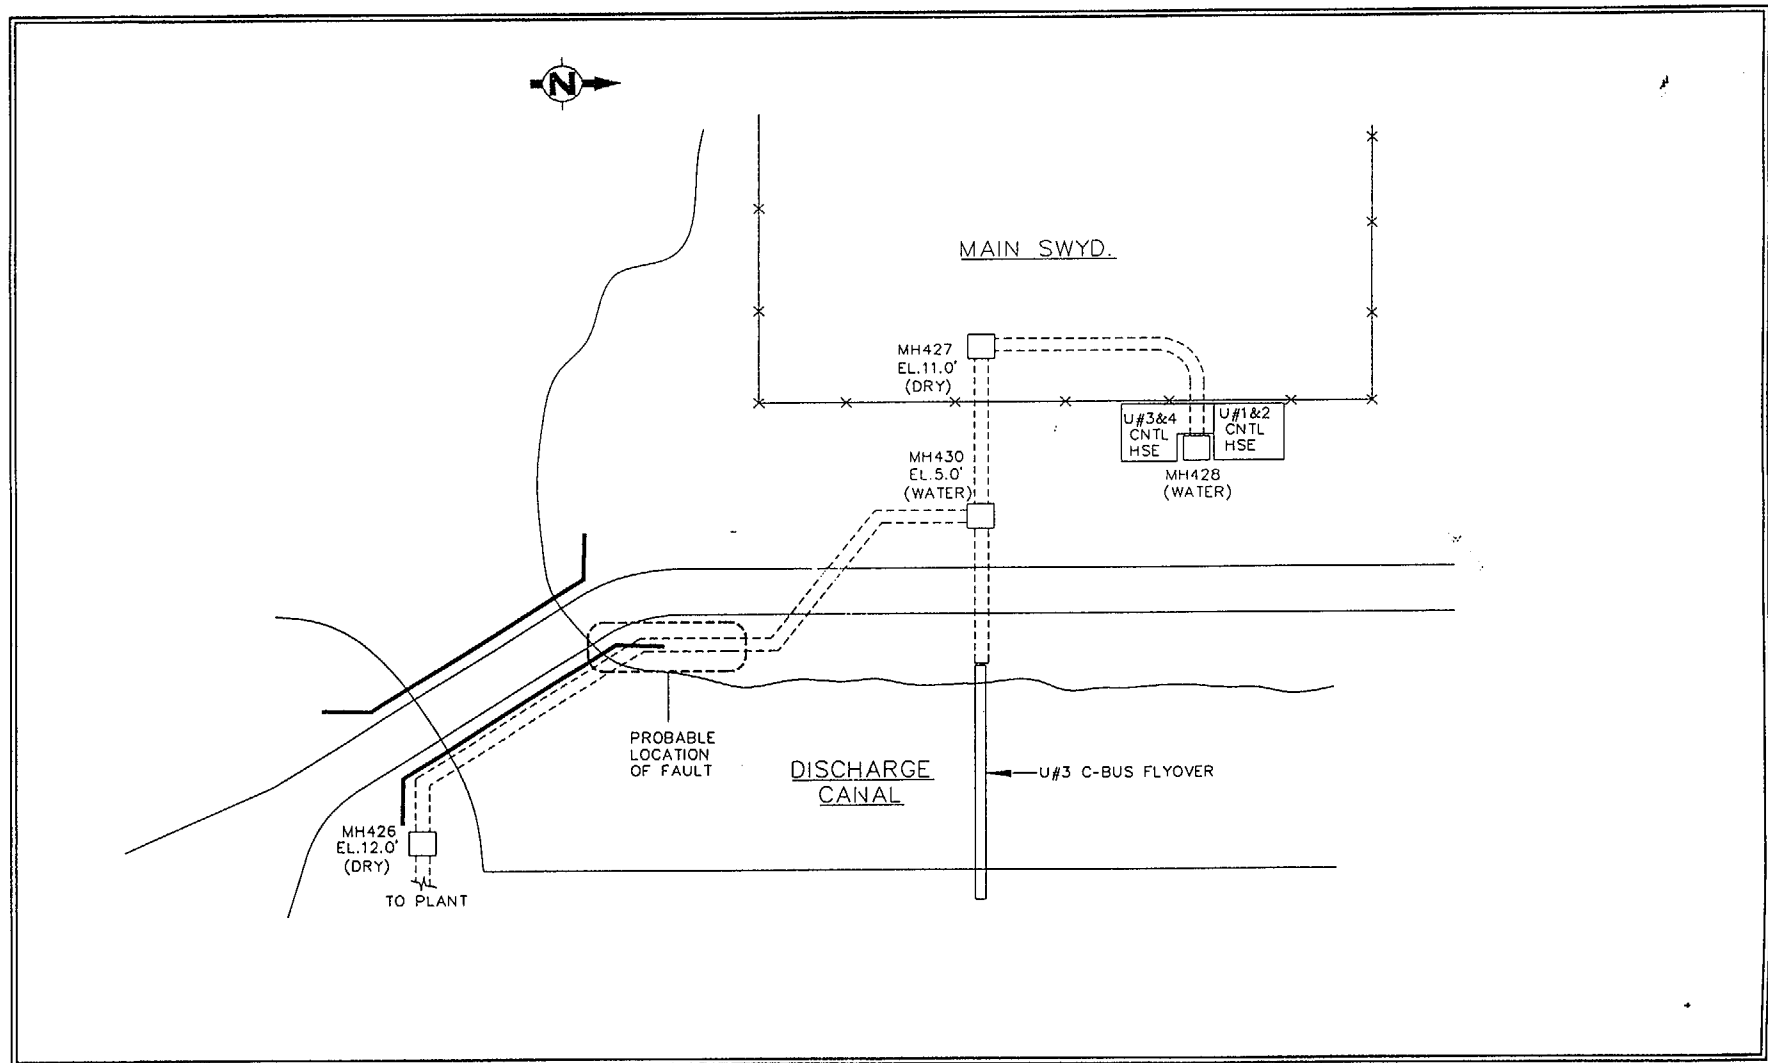
PTN UNIT 4 STARTUP TRANSFORMER PROTECTION CIRCUIT ROUTING

In order to identify the location of the faulted portion of the cable, a Time Domain Reflectometry (TDR) analysis was performed. The fault location was determined to be in underground conduit 4L198 between manholes 426 and 430 (see attached sketch), which are located on opposite sides of a bridge over the condenser discharge canal. In addition to the two cables associated with lockout relay 86/k, six other cables are routed through 4L198. All cables within this conduit were identified and evaluated for potential adverse effect on the Unit 4 startup transformer. It was determined that the failure of any of the other cables in 4L198 would not adversely affect operation of the Unit 4 startup transformer. Engineering identified nine other cables whose potential failure could separate the unit from offsite power while on the startup transformer, and determined that these cables are either not routed in any common raceways with the faulted cable (except for a short section at the switchyard control house) or are protected from physical damage associated with the faulted cable.

The shorting of the two conductors in cable F01/C1709-4C11/4 is the root cause of this event. Based on TDR analysis, the fault location was determined to be in the underground conduit (4L198) between two manholes, (426 and 430), which are located on opposite sides of the bridge over the condenser discharge canal. The specific location of the fault in the cable could not be identified. It is conceivable that some relatively minor damage might have occurred at the time of cable installation while pulling the cable. The area of the faults was in one of the lowest elevation raceways outside the plant protected areas. There was ground water in the raceway as a result of a faulted manhole sump pump.

5. Sump pumps and water level alarm lights were installed/repared in switchyard manholes 427, 428, and 430. These manholes were also added to the plant's severe weather preparation procedure.
