NPL 2001-0003

January 2, 2001

DOCKET NUMBER 50-266
LICENSEE EVENT REPORT 266/2000-011-00
LOSS OF 120 VAC VITAL INSTRUMENT BUS DURING INVERTER MAINTENANCE
POINT BEACH NUCLEAR PLANT UNIT 1

Loss of 120 VAC Vital Instrument Bus During Inverter Maintenance

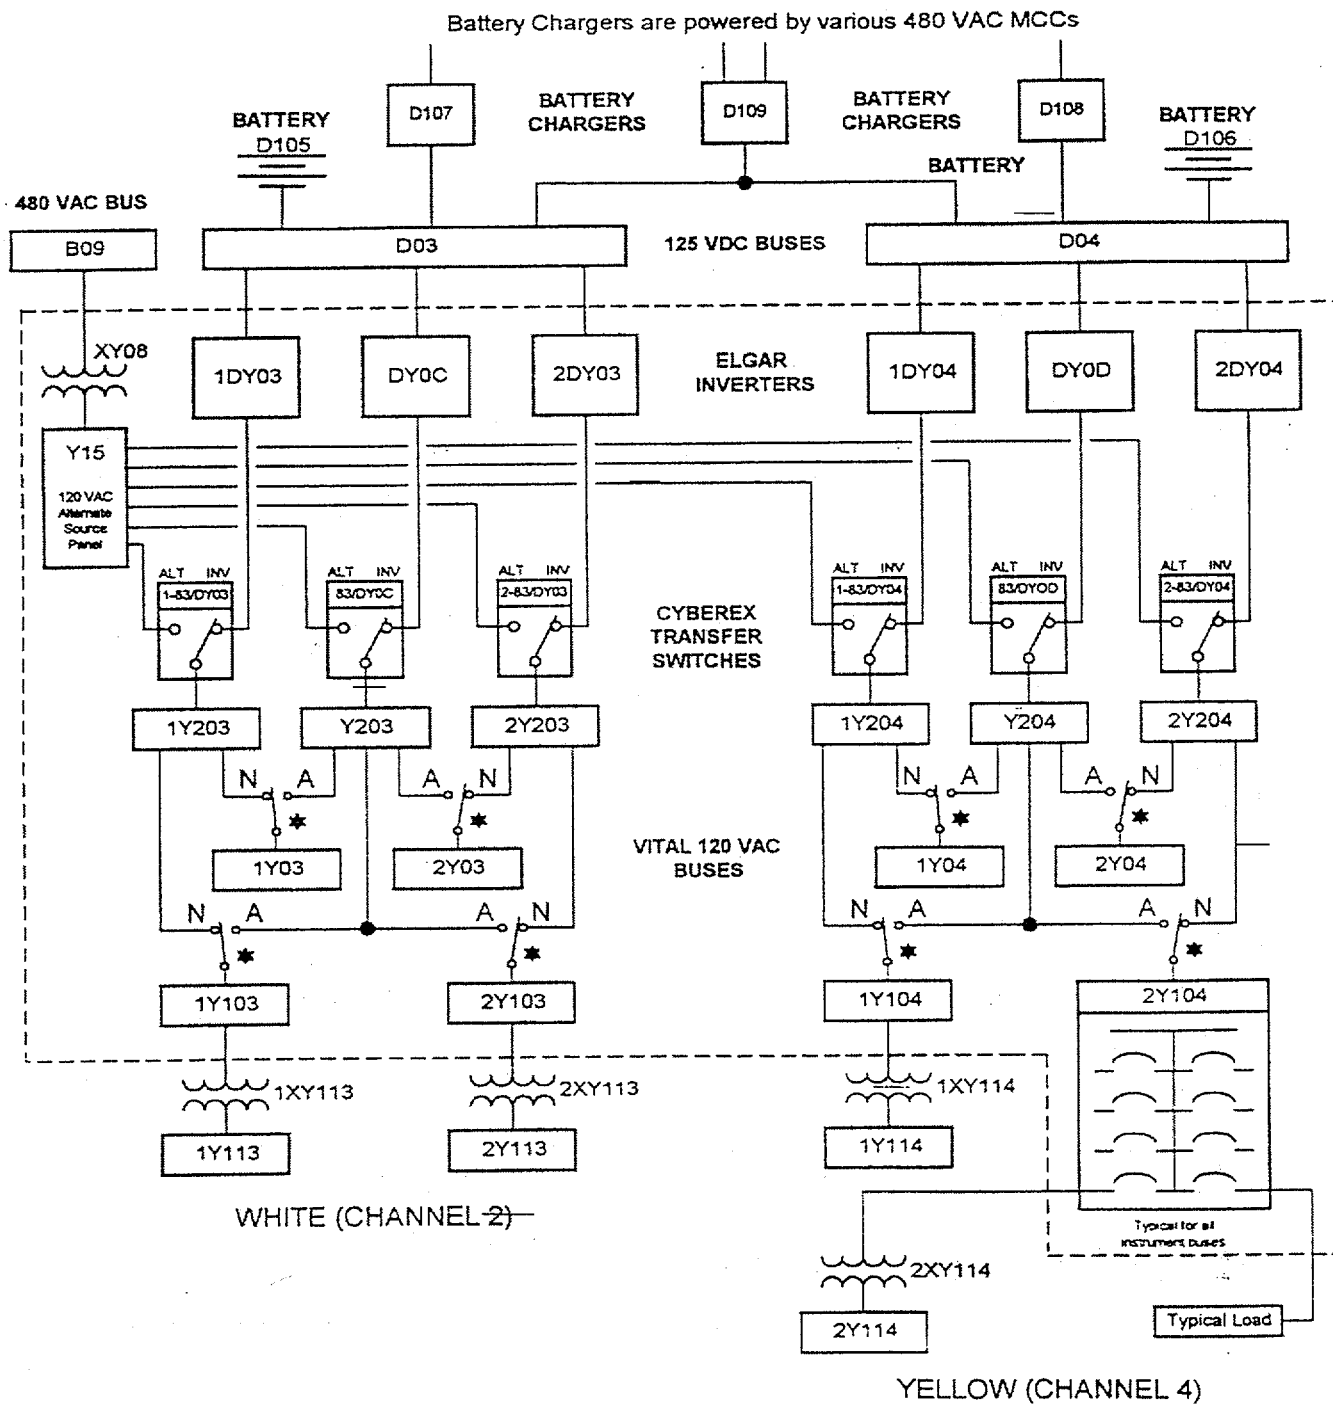
Figure 1-4: White and Yellow Instrument Bus Configuration

Each channel is powered by three inverters (see attached figure). One inverter is dedicated to the Unit 1 bus group and a second inverter is dedicated to the Unit 2 bus group. The third inverter is an alternate, and can swing between the Unit 1 and Unit 2 buses. Shifting between normal and alternate inverters is accomplished using manual make-before-break transfer switches. Use of the alternate inverter allows either dedicated inverter to be removed from service for maintenance. The function of the inverters is to convert 125 volt DC from the station batteries to 120 volt AC. The inverters are; therefore, powered from the 125 volt DC system.

Although normally powered from an inverter supply, each instrument channel can be powered from a backup power source. The backup power source is from non-safety-related Y-15 or Y-16 buses which are supplied from 480V bus B-09 via regulating transformer XY-08. The output of each inverter is connected to a static transfer switch that will automatically transfer the associated instrument buses to the backup power source in the event of an inverter failure, with little or no power interruption. Signals causing the transfer of the static switches include high voltage (white and yellow channels only), low voltage, current overload, and inverter failure signal (anticipatory to loss of voltage). The backup source is designed to maintain power to affected buses only until they can be manually transferred back to an operable safety
