VIRGINIA ELECTRIC AND POWER COMPANY
NORTH ANNA POWER STATION UNIT 2
ASME SECTION XI INSERVICE INSPECTION PROGRAM
RELIEF REQUEST NDE-47

**Second Ten Year Interval
Relief Request NDE-47**

**Virginia Electric and Power Company
(Dominion)
North Anna Power Station Unit 2**

RELIEF REQUEST NDE-47

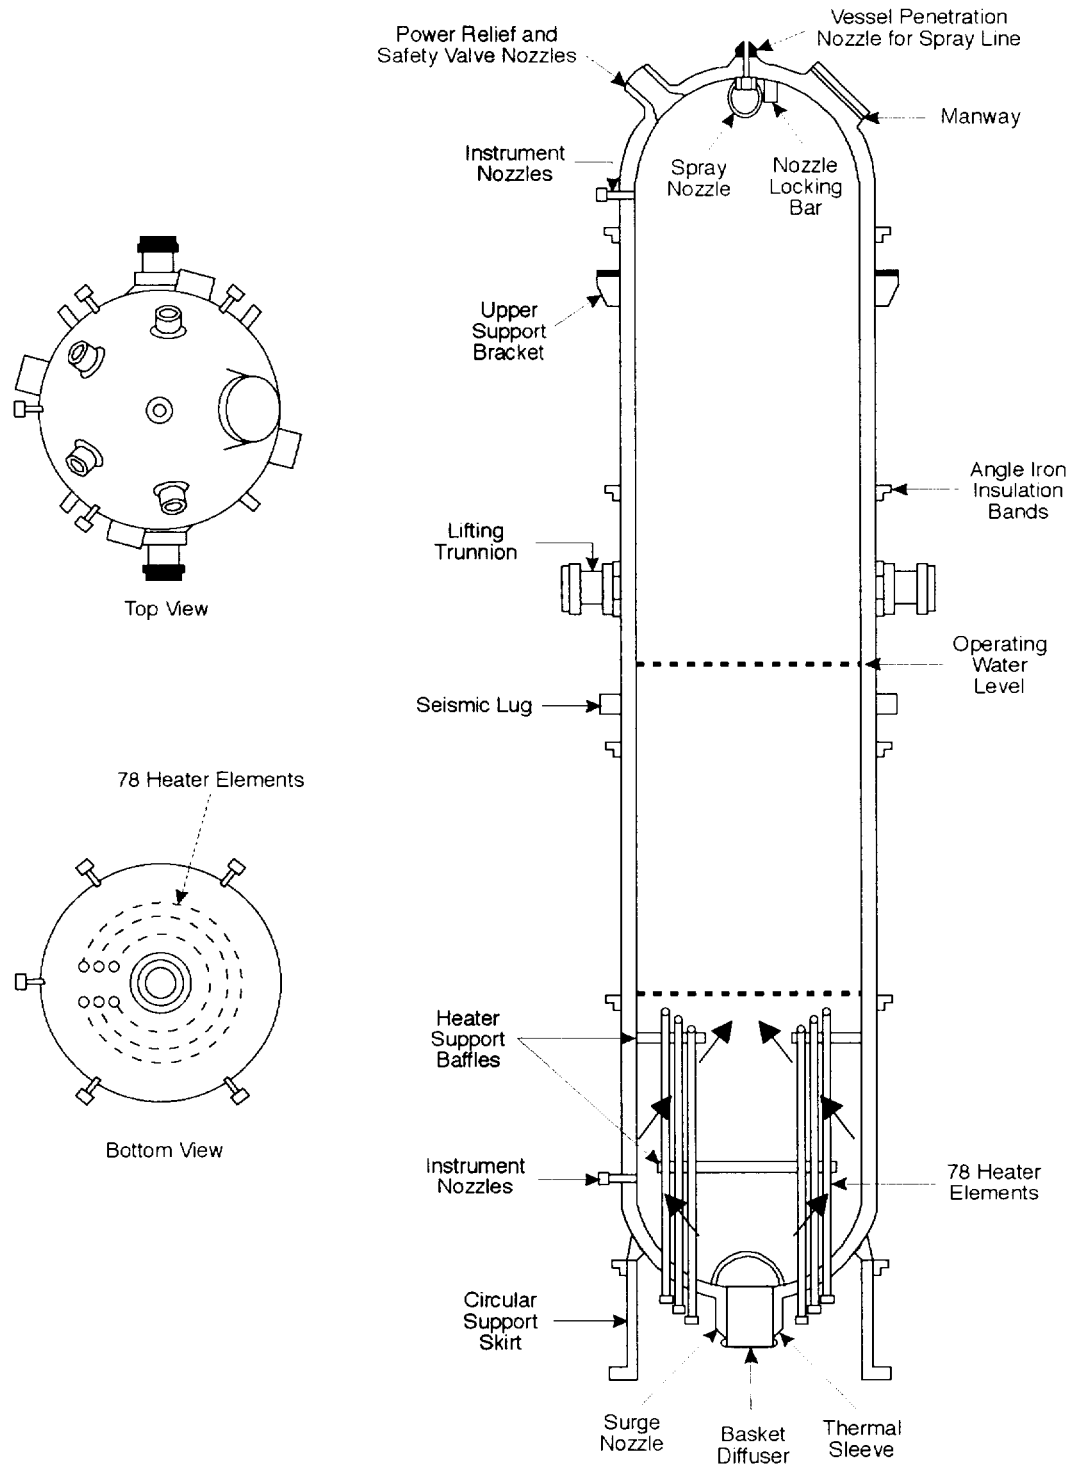
RELIEF REQUEST NDE-47
FIGURE NDE-47-1

Pressurizer (2-RC-E-2) nozzle-to-vessel weld 9 and nozzle inner radius section 9NIR (Figures NDE-47-1 and 2). These welds are shown on drawing 12050-WMKS-RC-E-2.

Access to the North Anna Unit 2 pressurizer surge line nozzle is obstructed by multi-layered, stainless steel mirror insulation and the cables for the pressurizer heaters. Removal of the insulation and cables would be difficult as well as labor and time intensive. It is also likely that cable or heater pin damage would occur during removal. In addition it is possible that the impingement shield would have to be removed to gain access to the examination area.

A visual (VT-2) examination of the pressurizer surge line nozzle-to-vessel weld will be performed during the normally scheduled system leakage test each refueling and will provide continued assurance of component integrity. In addition:
