Byron Station, Unit 1  
Facility Operating License NPF-37  
NRC Docket No. STN 50-454

Subject: Byron Station Unit 1 Cycle 10 Steam Generator Eddy Current  
Examination, 90-Day Summary Report

**STEAM GENERATOR EDDY CURRENT INSPECTION REPORT**

**CYCLE 10 REFUELING OUTAGE (B1R10)**

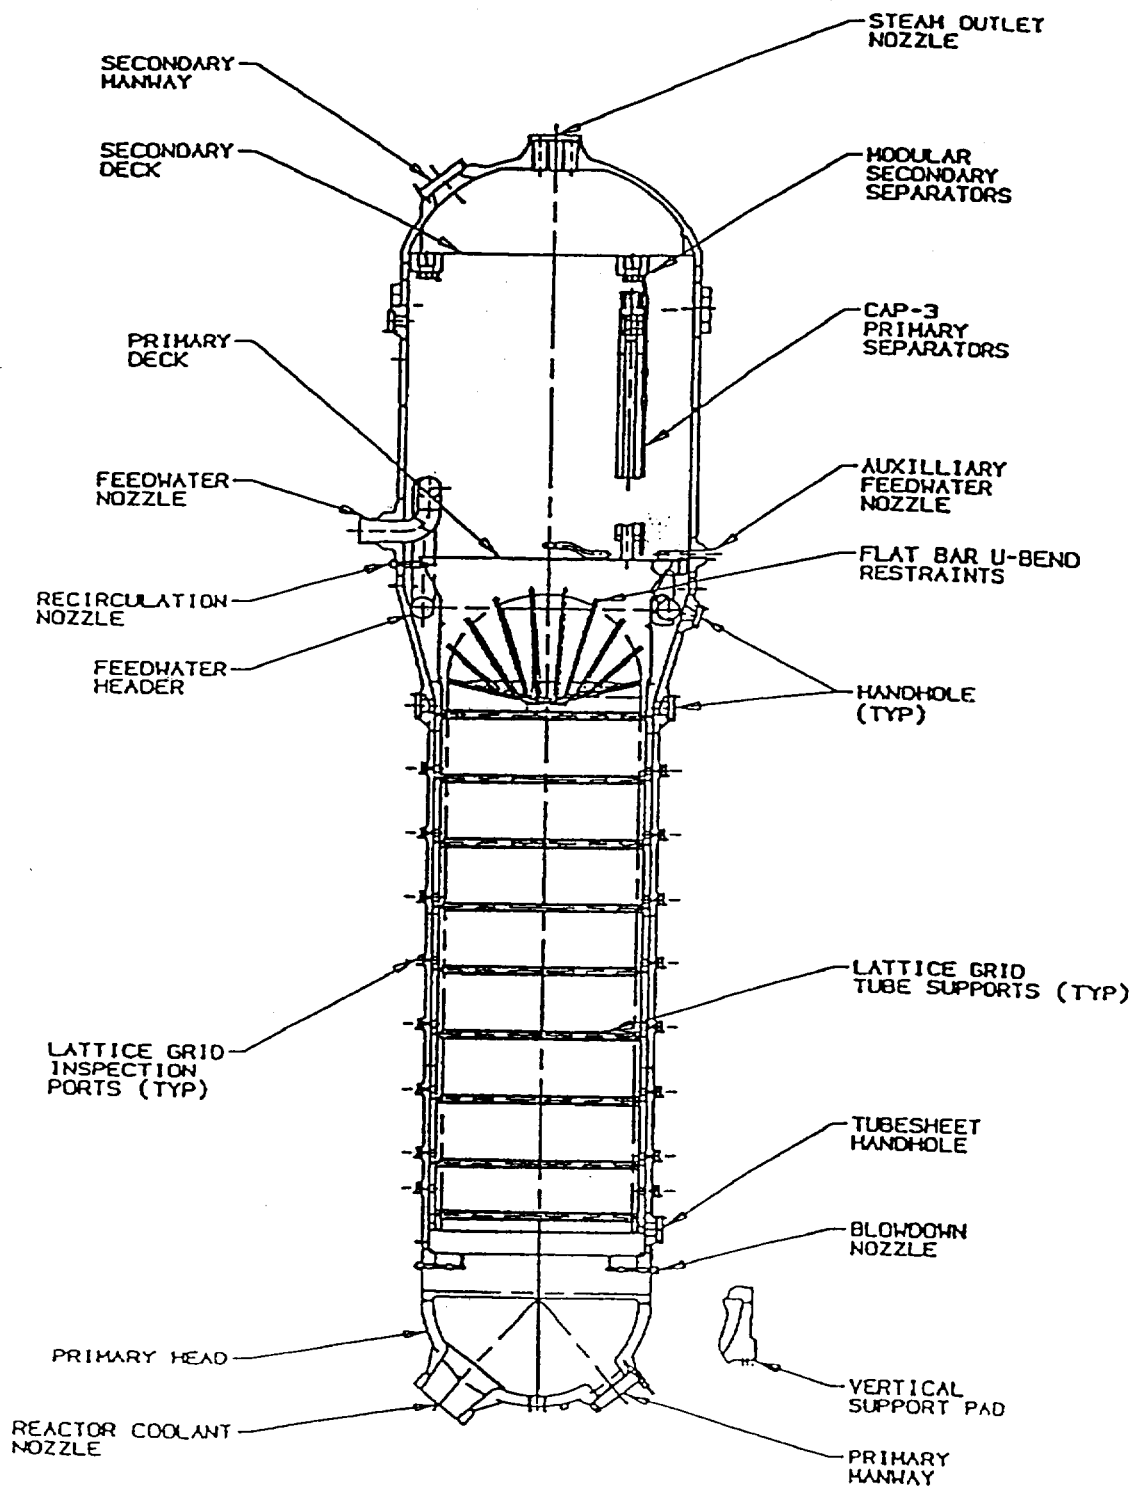
FIGURE A.1

Byron Station Unit 1 operates with four Babcock & Wilcox Replacement Steam Generators (SGs) in the four loop pressurized water reactor system. The SGs each contain 6633 thermally treated Inconel-690 U-tubes that have a nominal diameter of 0.6875 inches and a nominal thickness of 0.040 inches. The tubes are supported by stainless steel lattice grid structures and fan bars. The tubes are hydraulically expanded into the full depth of the tubesheet. Main Feedwater enters the SGs above the tube bundle through a feeding and J-tubes. The SG configuration is shown in Figures A.1 and A.2. The replacement SGs were installed at the end of Cycle 8.
