Re: Indian Point Unit No. 2
Docket No. 50-247
NL-01-005

Subject: Reply to a Notice of Violation – NRC Inspection Report 05000247/2000-010

ATTACHMENT B TO NL 01-005
REPLY TO A NOTICE OF VIOLATION
INSPECTION REPORT NO. 05000247/2000-010

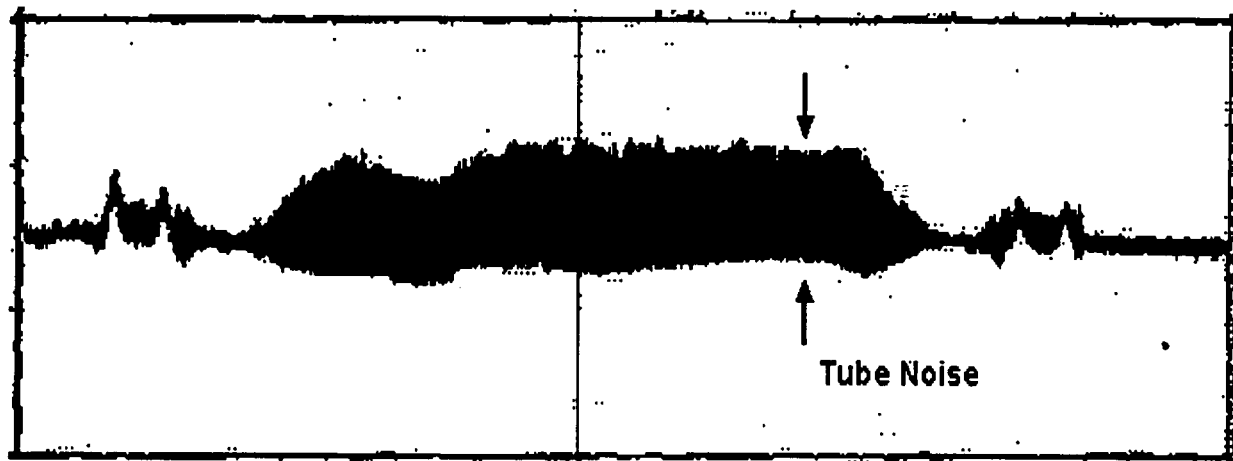
Exhibit 2
Strip chart data showing visual representation of
tube noise extremes in SG 24 row 2 U-bends
- Highest noise level (R2C74) -

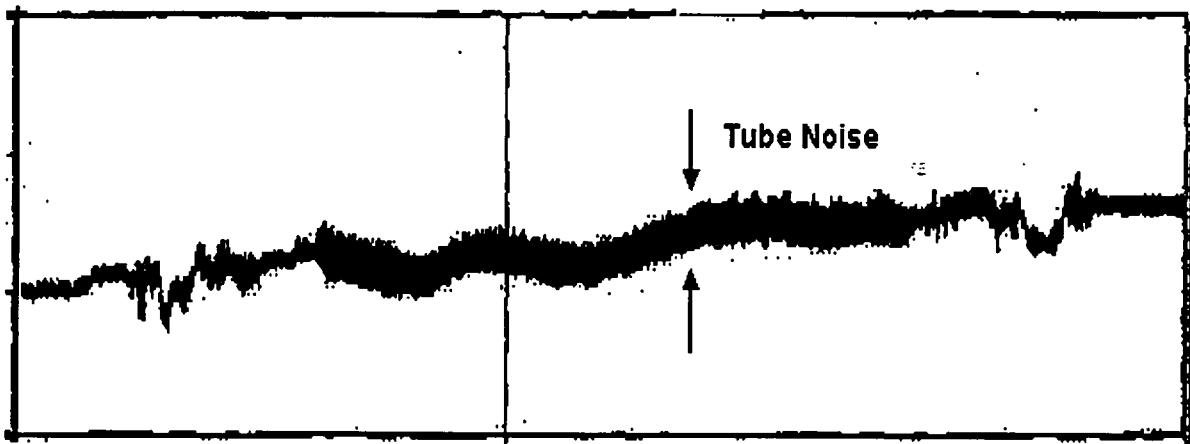
Exhibit 3
Strip chart data showing visual representation of
tube noise extremes in SG 24 row 2 U-bends
- Lowest noise level (R2C31) -

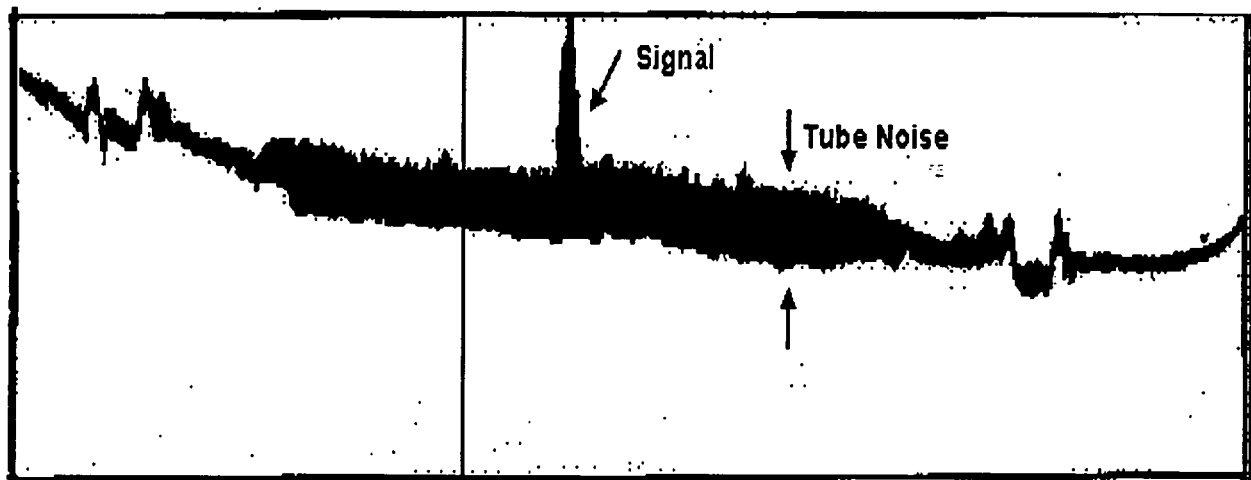
Exhibit 4
300 kHz vertical channel strip chart data showing noise levels in
SG 24 plugged tube (R2C67)
- Low noise level with high (S/N) indication -

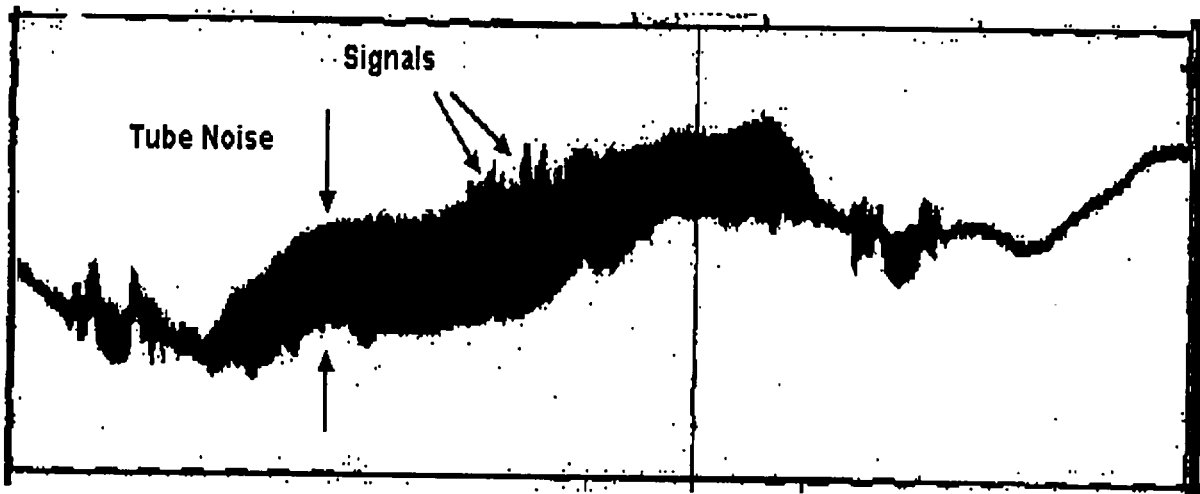
Exhibit 5
300 kHz vertical channel strip chart data showing noise levels in
SG 24 tube with unreported indications (R2C5)
- High noise level with low (S/N) indication -

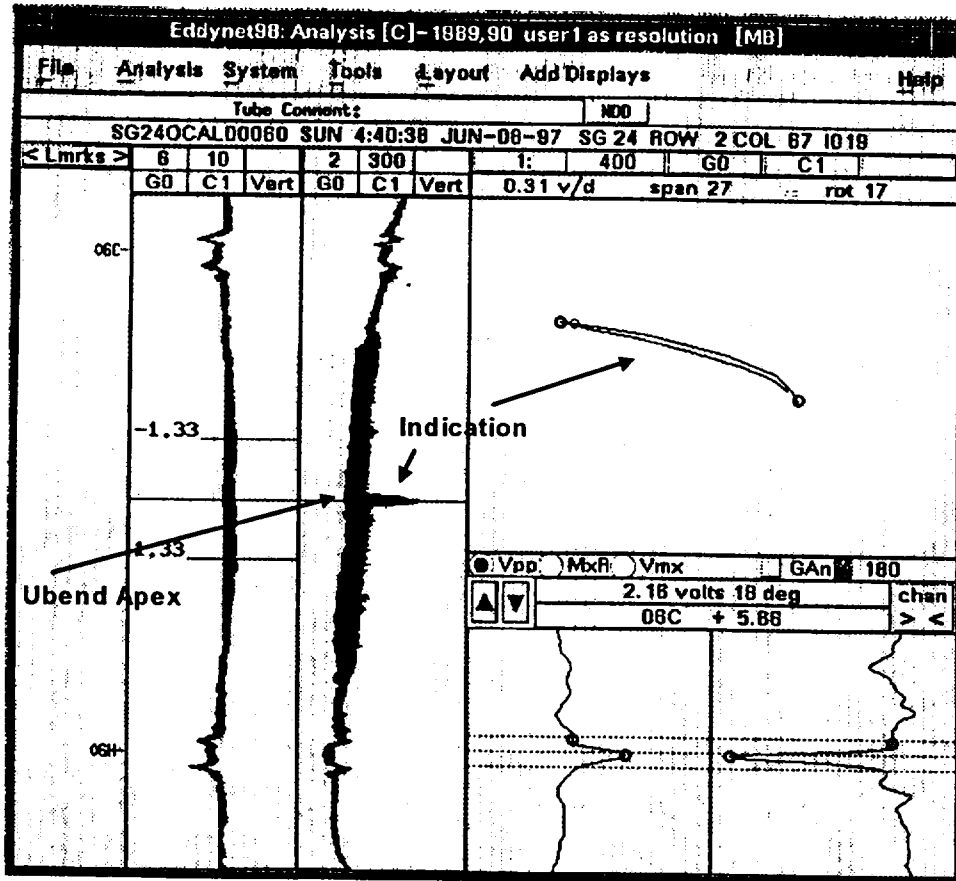
Exhibit 6
R2C67 plus point data for indication reported during 1997
- Lissajous display -

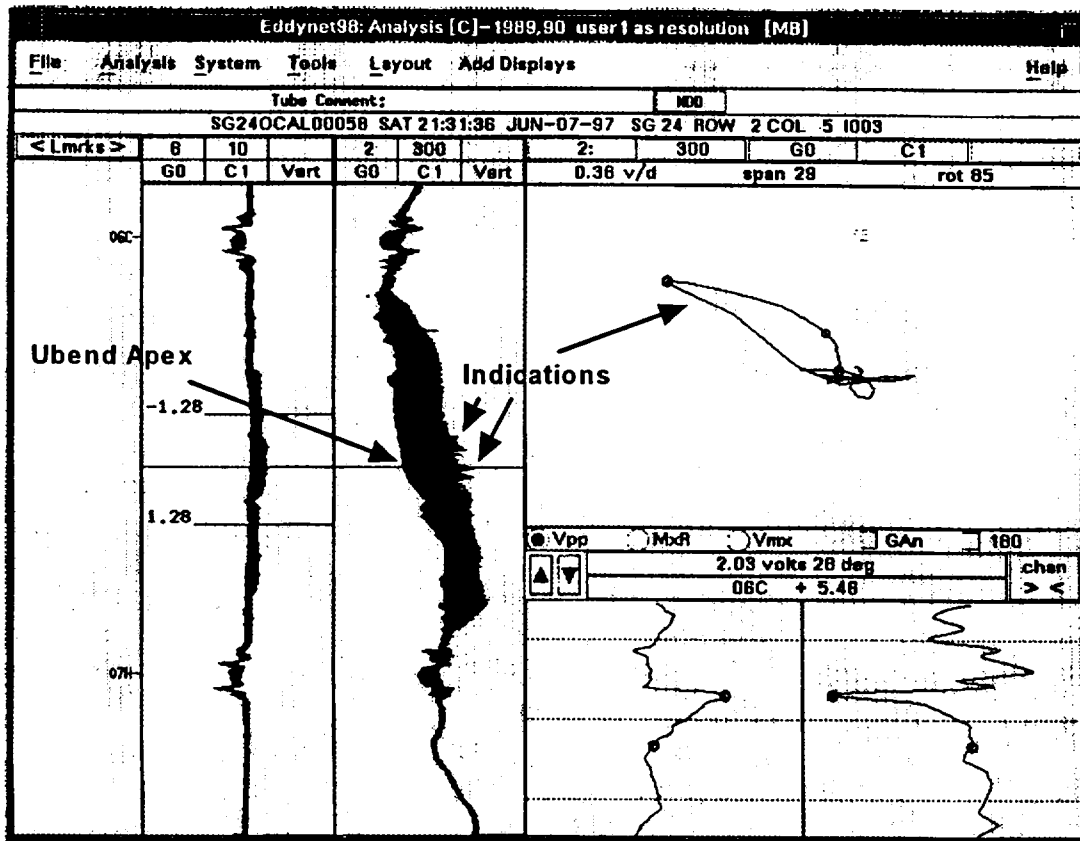
Exhibit 7
R2C5 plus point data for indication not reported during 1997
- Lissajous display -

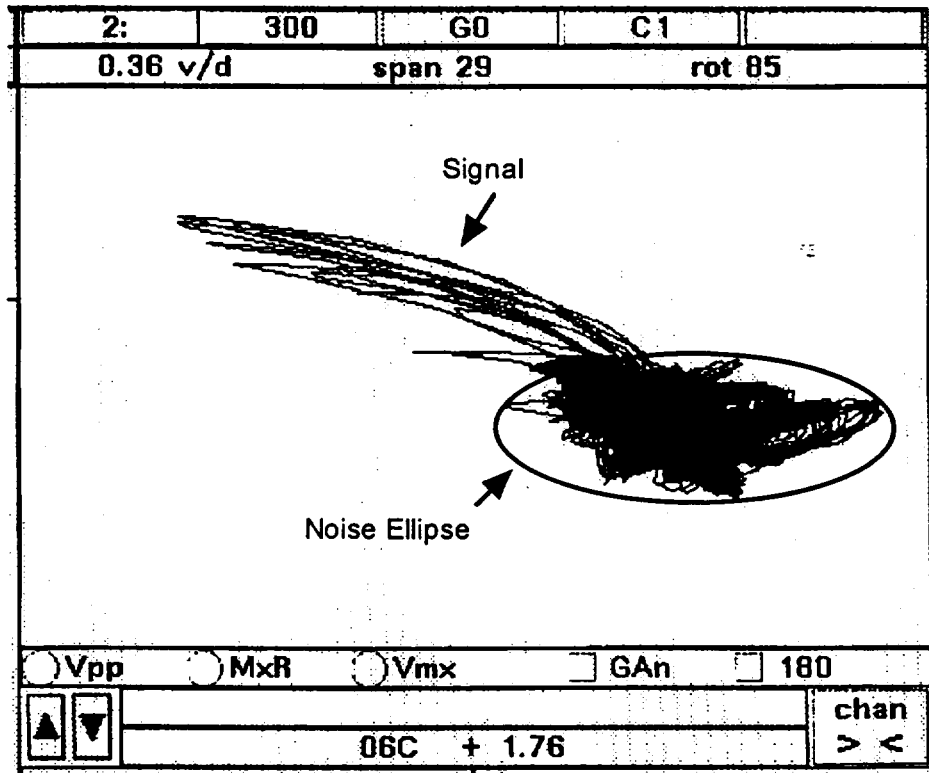
Exhibit 8

Lissajous display showing dynamic integrated noise levels in
SG 24 plugged tube R2C67 as the plus-point probe is pulled through the U-bend
- Low noise level with high (S/N) indication -

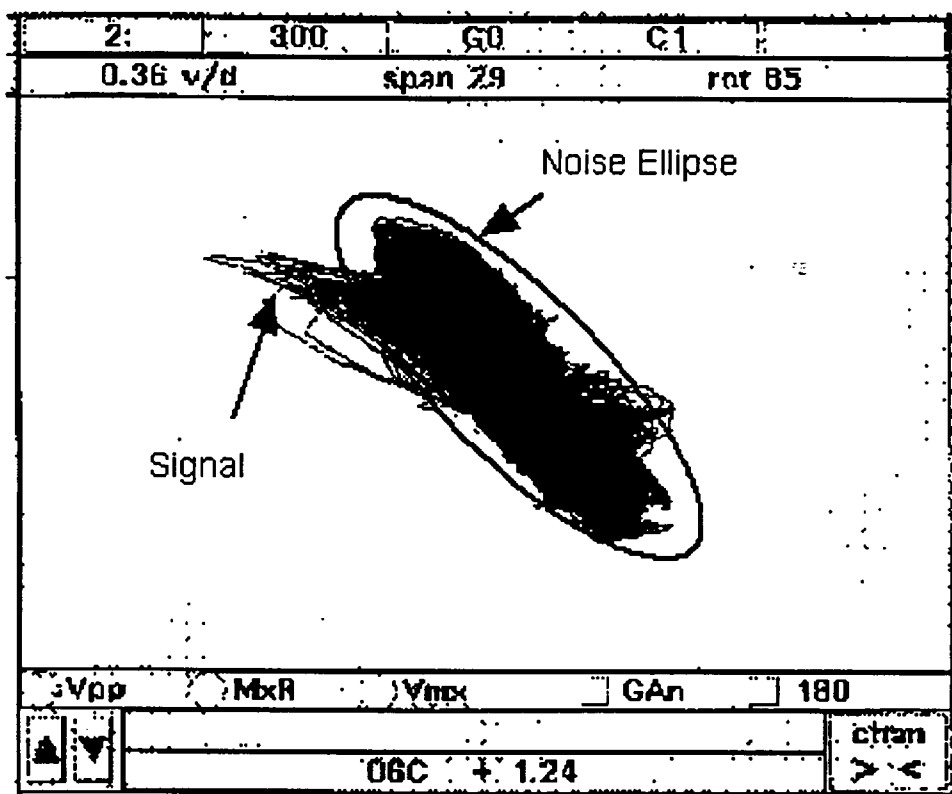
Exhibit 9

Lissajous display showing dynamic integrated noise levels in
SG 24 tube R2C5 as the plus point probe is pulled through the U-bend.
- Higher noise level with low (S/N) indication -

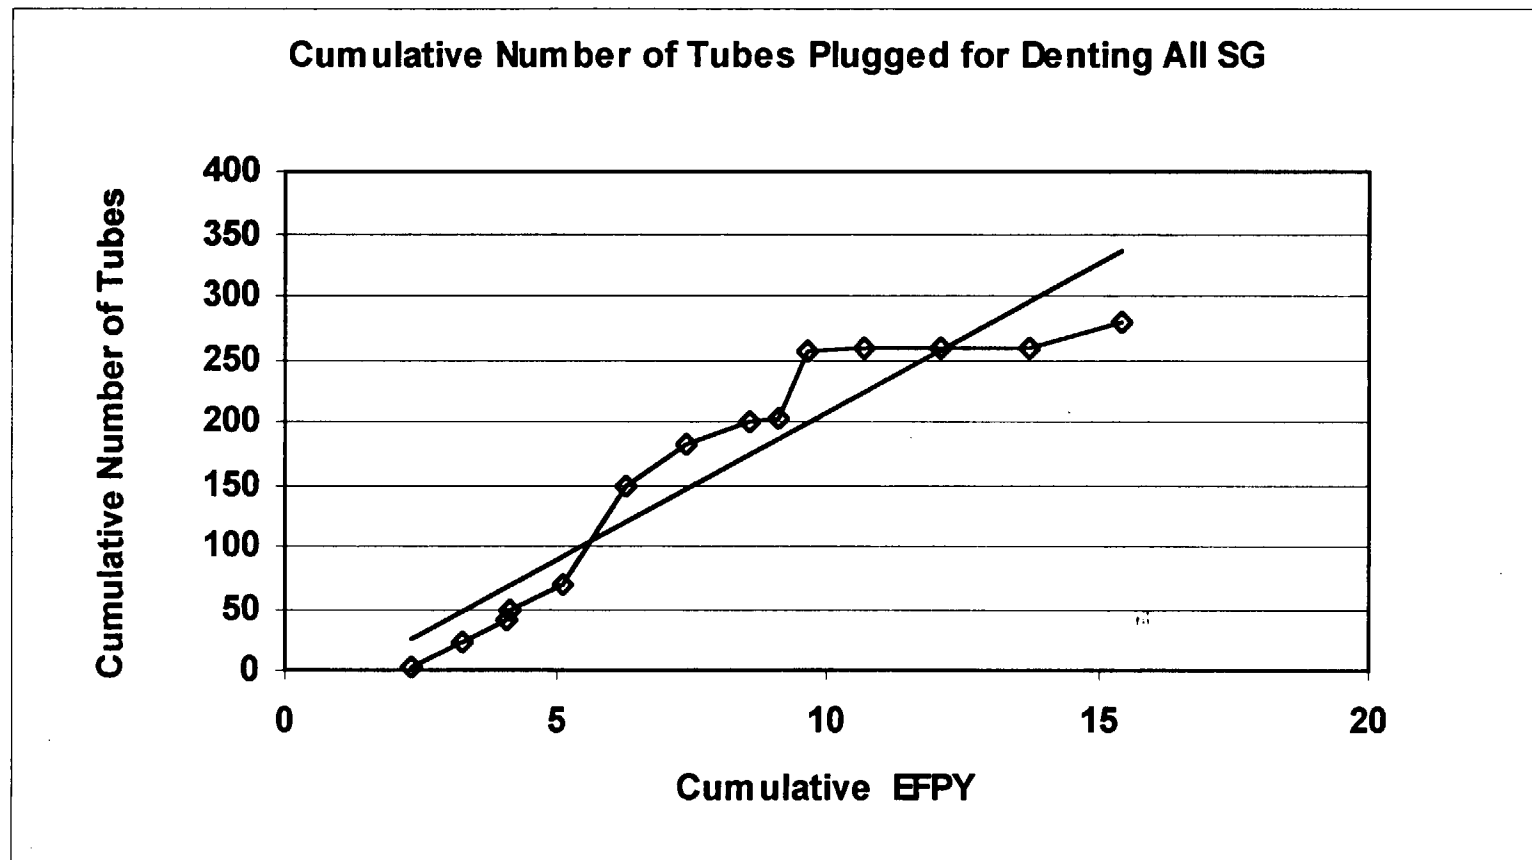
Exhibit 9. Plot of Cumulative Number of Tubes Plugged as Function of EFPY Showing Linear Regression

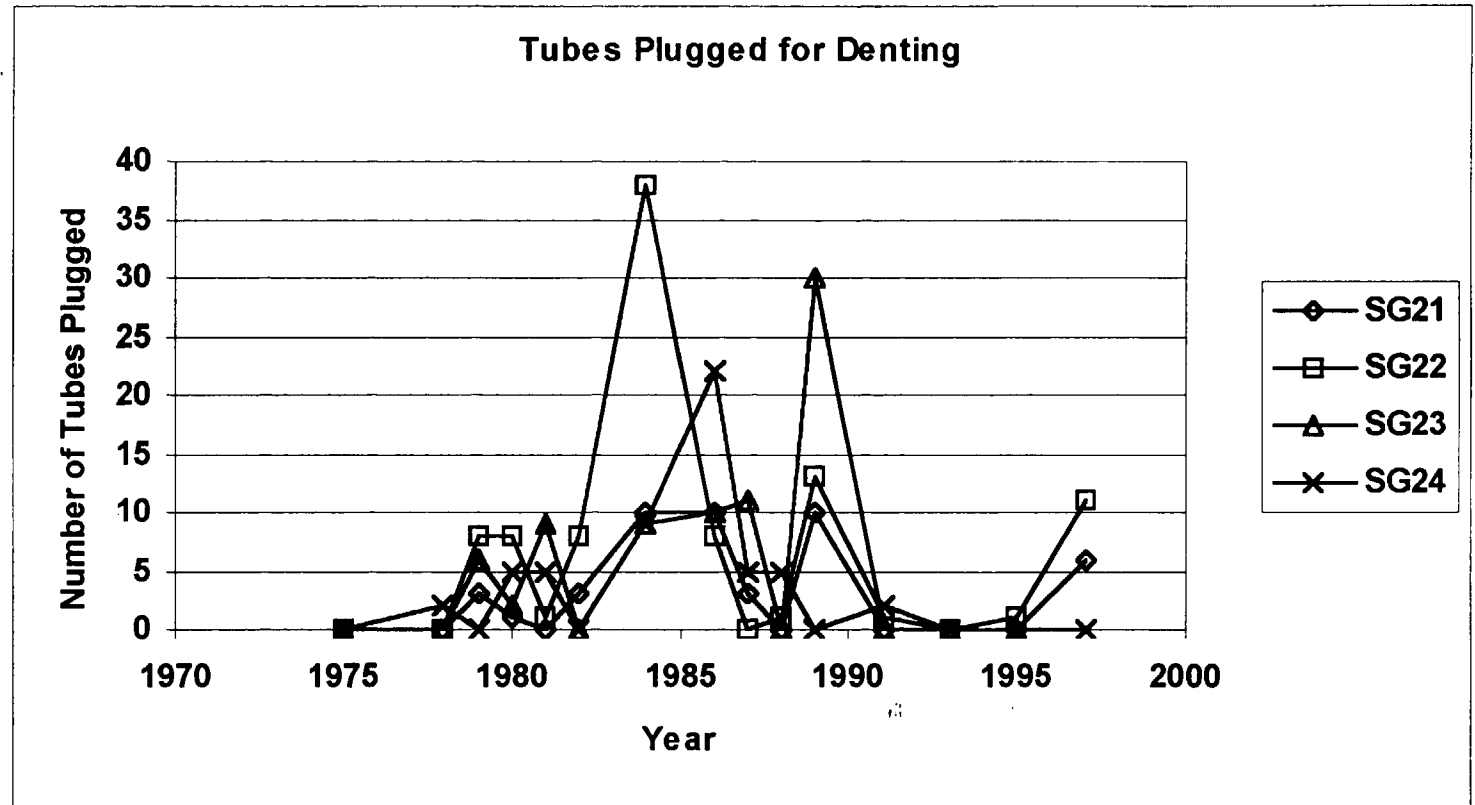
Exhibit 10. Plot of Outage Specific Repairs Showing Variation in Number of Repairs
