MAP OF NORTH WALL TRENCH T-2
Private Fuel Storage Facility
Skull Valley, Utah

Project No.
4790

Plate
3

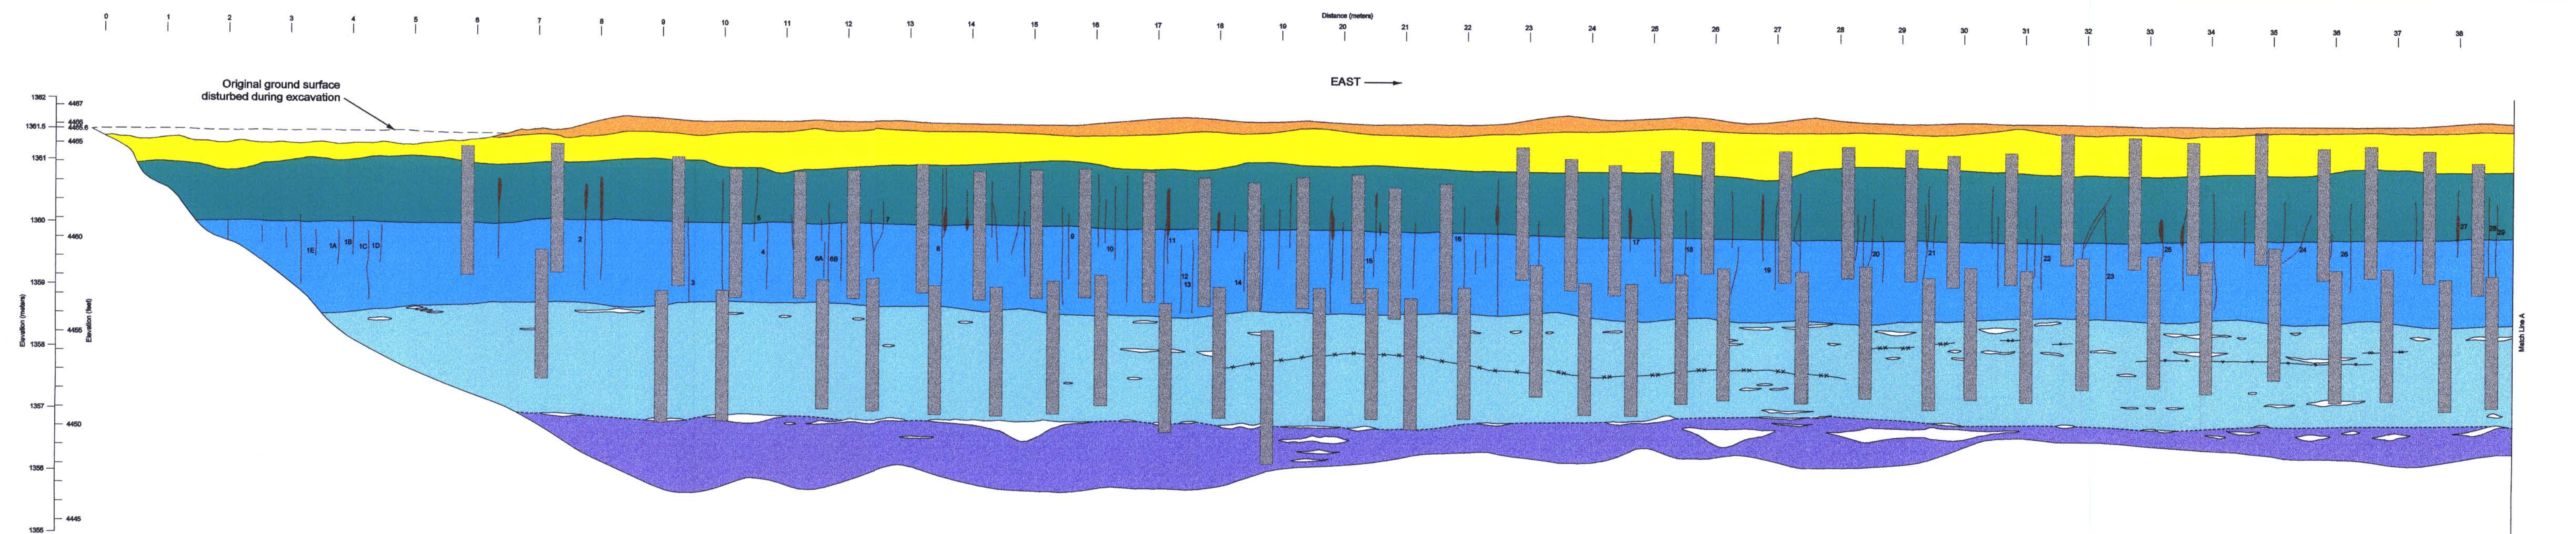
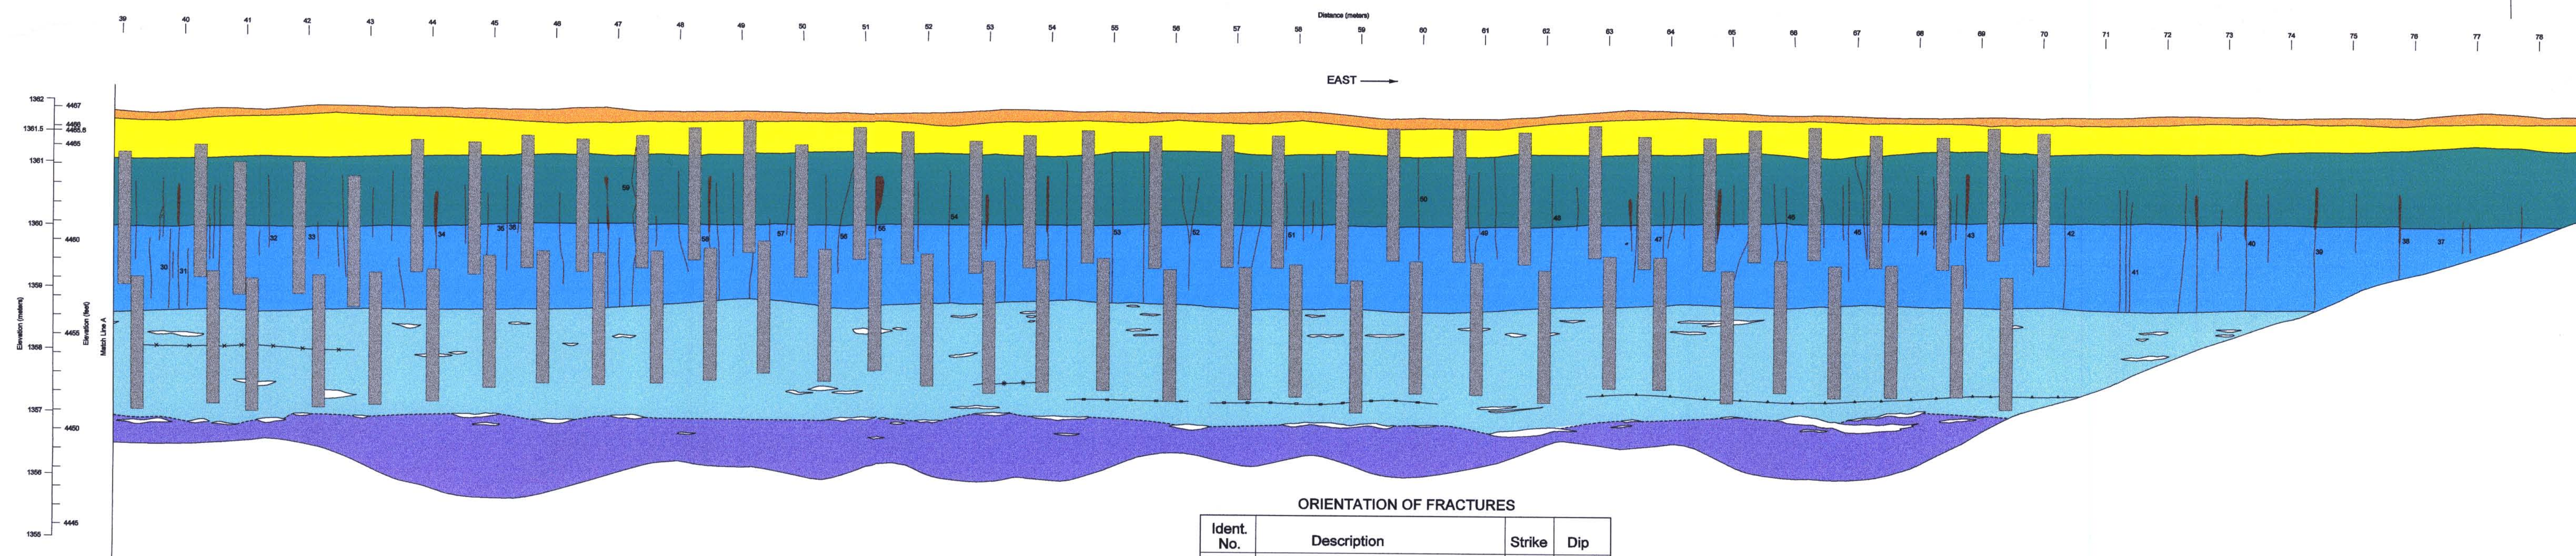
Ident. No.	Description	Strike	Dip
1A	Fracture	15°	88°E
1B	Fracture	328°	85°W
1C	Fracture	52°	88°W
1D	Fracture	8°	90°
1E	Fracture	50°	90°
2	Infilled fractures	352°	84°E
3	Fracture	50°	86°E
4	Fracture	350°	90°
5	Fracture: 2 cm displacement, E-side up *	32°	90°
6A	Fracture: 2 cm displacement, E-side up *	70°	80°E
6B	Fracture: 2 cm displacement, E-side up *	332°	90°
7	Fracture: 2.5 cm displacement, E-side down *	10°	90°
8	Fracture	315°	90°
9	Fracture	48°	87°W
10	Fracture	314°	88°W
11	Infilled Fracture	60°	90°
12	Fracture	55°	90°
13	Fracture	57°	88°W
14	Fracture	34°	85°W
15	Fracture	50°	90°
16	Fracture	24°	88°W
17	Infilled Fracture	25°	85°W
18	Fracture	30°	88°W
19	Fracture	0°	88°W
20	Fracture	340°	87°W
21	Fracture	320°	90°
22	Fractures	285°	90°
23	Fracture	76°	89°NW
24	Fracture	10°	90°
25	Fracture	315°	90°
26	Fracture	340°	90°
27	Fracture: 2.5 cm displacement, E-side up *	10°	90°
28	Fracture	345°	88°E
29	Fracture	330°	90°
30	Fracture	355°	90°

31	Infilled fracture	345°	90°
32	Fractures	20°	90°
33	Fracture	350°	88°E
34	Fracture: 1 cm displacement, E-side up *	0°	88°E
35	Fracture: 2 cm displacement, E-side up *	352°	90°
36	Fracture: 1 cm displacement, E-side up *	30°	88°E
37	Fracture	345°	88°E
38	Fracture: 2 cm displacement, E-side down *	35°	90°
39	Fracture	355°	90°
40	Fracture: 1 cm displacement, E-side down *	20°	90°
41	Fracture	340°	90°
42	Fractures	40°	85°W
43	Fracture	345°	88°E
44	Fracture	40°	90°
45	Fractures	345°	88°E
46	Fracture: 2 cm displacement, E-side down *	10°	90°
47	Fracture	350°	90°
48	Fractures	345°	87°E
49	Fracture	330°	82°W
50	Fracture	320°	86°W
51	Infilled fractures	5°	84°W
52	Fracture	38°	88°W
53	Fracture	310°	90°
54	Fracture	345°	90°
55	Fracture	60°	90°
56	Fracture	15°	85°
57	Fractures	350°	87°W
58	Fracture	5°	90°
59	Fracture	5°	90°

* Displacements observed only in Bonneville deep-water facies; thin clay layers and bedding in lower Stansbury regressive facies and Post-Stansbury transgressive facies show evidence of no discrete faulting at depth.
