February 23, 2001

Reference: Oregon State University TRIGA Reactor (OSTR)
Docket No. 50-243, License No. R-106

Subject: Replacement of dashpot covers on OSTR control rod barrels

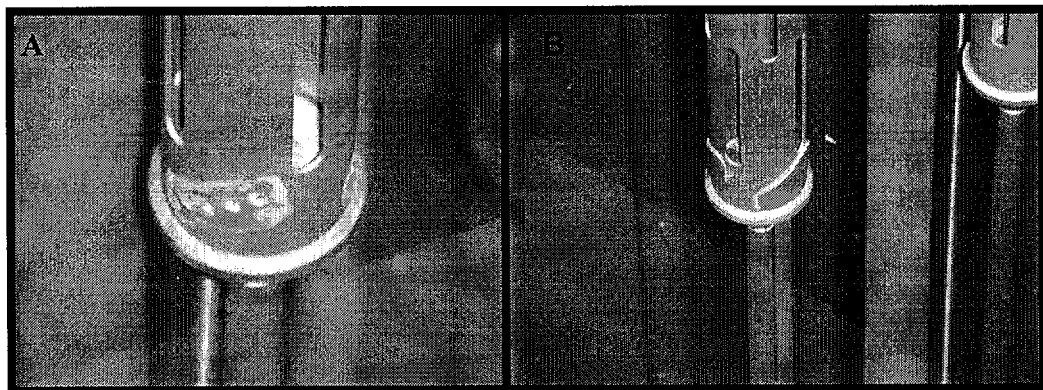
Upon completion of the biennial control rod inspection on November 13, 2000, one of our operators noticed a small piece of metal at rest on the top grid plate. It was quickly identified as one of two dashpot covers that were no longer on the shim control rod barrel. In Figure 1-A, the shim FFCR barrel is shown as it was found on that day. Evidence of an adhesive can clearly be seen surrounding the dashpots. In Figure 1-B, the safety FFCR barrel is shown with the dashpot covers still intact. Per our own procedures, reactor operations were suspended pending resolution of the situation.

Figure 1 - (A) Evidence of epoxy and missing dashpot cover on the shim barrel; (B) Intact dashpot covers on the safety barrel.

The shim and safety FFCR barrels have three sets of dashpots. Each set consists of four holes of increasing diameter placed in a diagonal pattern on the bottom of each barrel. The safety FFCR barrel was found with both dashpot covers intact. The shim FFCR barrel was found with no covers but evidence of adhesive suggests that two of the three had previously been covered. The OSTR has two other control rods. However, they are both different than the shim and safety. The regulating FFCR barrel has only one set of dashpots and they are not covered. The

On November 15, the metal piece found on the top grid plate was retrieved and inspected. It was clear that the adhesive used was an epoxy of some kind. However, this left one of the dashpot covers unaccounted for. Using an underwater camera, all accessible areas surrounding the core were videotaped in an effort to find the missing cover. These areas included the top grid plate, any vacant lattice positions, and underneath the core itself. On November 16, our USNRC Program Manager was informed of the situation.

On the morning of November 17, a Reactor Operations Committee meeting was held. A 10 CFR 50.59 Safety Evaluation was performed which approved welding aluminum covers over the previously covered dashpots. Welding the covers would return the barrels to their original condition, allow the use of the 10 CFR 50.59 process, and preclude the possibility of this problem from reoccurring. Later that afternoon, a series of fuel movements were performed to investigate the possibility that the missing dashpot cover had inadvertently worked its way onto the bottom grid plate. As a fuel element was raised above the top grid plate, a video camera was lowered to look at the bottom grid plate. The missing dashpot cover was not found. After the video search of the bottom grid plate was completed, the shim and safety barrels were removed. The two dashpot covers that were intact on the safety barrel came off with relative ease.

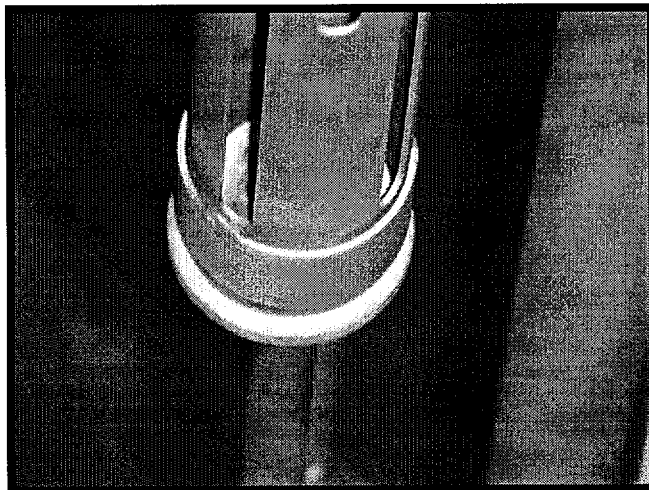
Figure 2 – Repaired dashpot cover on the shim barrel.

On November 20, both barrels were repaired and reinstalled. A picture of the repaired Safety FFCR barrel is shown in Figure 2. The rod up travel time, rod down travel time, and rod scram time for all four rods were measured and verified to be within the normal range of values observed in the past. On November 21, suspension of reactor operations was lifted, and normal operations resumed.

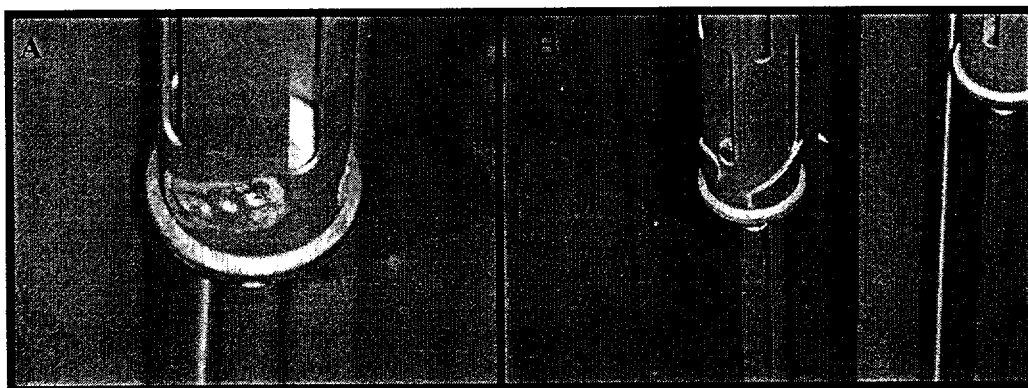
Upon completion of the biennial control rod inspection on November 13, 2000, one of our operators noticed a small piece of metal at rest on the top grid plate. It was quickly identified as one of two dashpot covers that were no longer on the shim control rod barrel. In Figure 1-A, the shim FFCR barrel is shown as it was found on that day. Evidence of an adhesive can clearly be seen surrounding the dashpots. In Figure 1-B, the safety FFCR barrel is shown with the dashpot covers still intact. Per our own procedures, reactor operations were suspended pending resolution of the situation.

Figure 1 - (A) Evidence of epoxy and missing dashpot cover on the shim barrel; (B) Intact dashpot covers on the safety barrel.

The shim and safety FFCR barrels have three sets of dashpots. Each set consists of four holes of increasing diameter placed in a diagonal pattern on the bottom of each barrel. The safety FFCR barrel was found with both dashpot covers intact. The shim FFCR barrel was found with no covers but evidence of adhesive suggests that two of the three had previously been covered. The OSTR has two other control rods. However, they are both different than the shim and safety. The regulating FFCR barrel has only one set of dashpots and they are not covered. The

On November 15, the metal piece found on the top grid plate was retrieved and inspected. It was clear that the adhesive used was an epoxy of some kind. However, this left one of the dashpot covers unaccounted for. Using an underwater camera, all accessible areas surrounding the core were videotaped in an effort to find the missing cover. These areas included the top grid plate, any vacant lattice positions, and underneath the core itself. On November 16, our USNRC Program Manager was informed of the situation.

On the morning of November 17, a Reactor Operations Committee meeting was held. A 10 CFR 50.59 Safety Evaluation was performed which approved welding aluminum covers over the previously covered dashpots. Welding the covers would return the barrels to their original condition, allow the use of the 10 CFR 50.59 process, and preclude the possibility of this problem from reoccurring. Later that afternoon, a series of fuel movements were performed to investigate the possibility that the missing dashpot cover had inadvertently worked its way onto the bottom grid plate. As a fuel element was raised above the top grid plate, a video camera was lowered to look at the bottom grid plate. The missing dashpot cover was not found. After the video search of the bottom grid plate was completed, the shim and safety barrels were removed. The two dashpot covers that were intact on the safety barrel came off with relative ease.

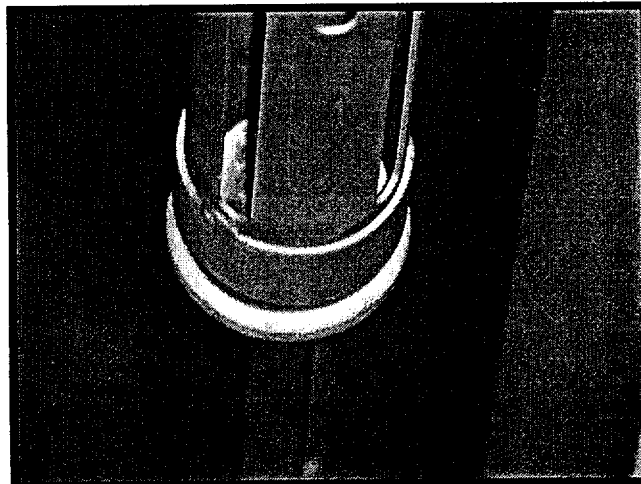
Figure 2 – Repaired dashpot cover on the shim barrel.

On November 20, both barrels were repaired and reinstalled. A picture of the repaired Safety FFCR barrel is shown in Figure 2. The rod up travel time, rod down travel time, and rod scram time for all four rods were measured and verified to be within the normal range of values observed in the past. On November 21, suspension of reactor operations was lifted, and normal operations resumed.
