Project No. 686
WCAP-15338

Subject: Westinghouse Owners Group
**Transmittal of WCAP-15338, "A Review of Cracking Associated
with Weld Deposited Cladding in Operating PWR Plants (MUHP-
6110)"**

A Review of Cracking Associated with Weld Deposited Cladding in Operating PWR Plants

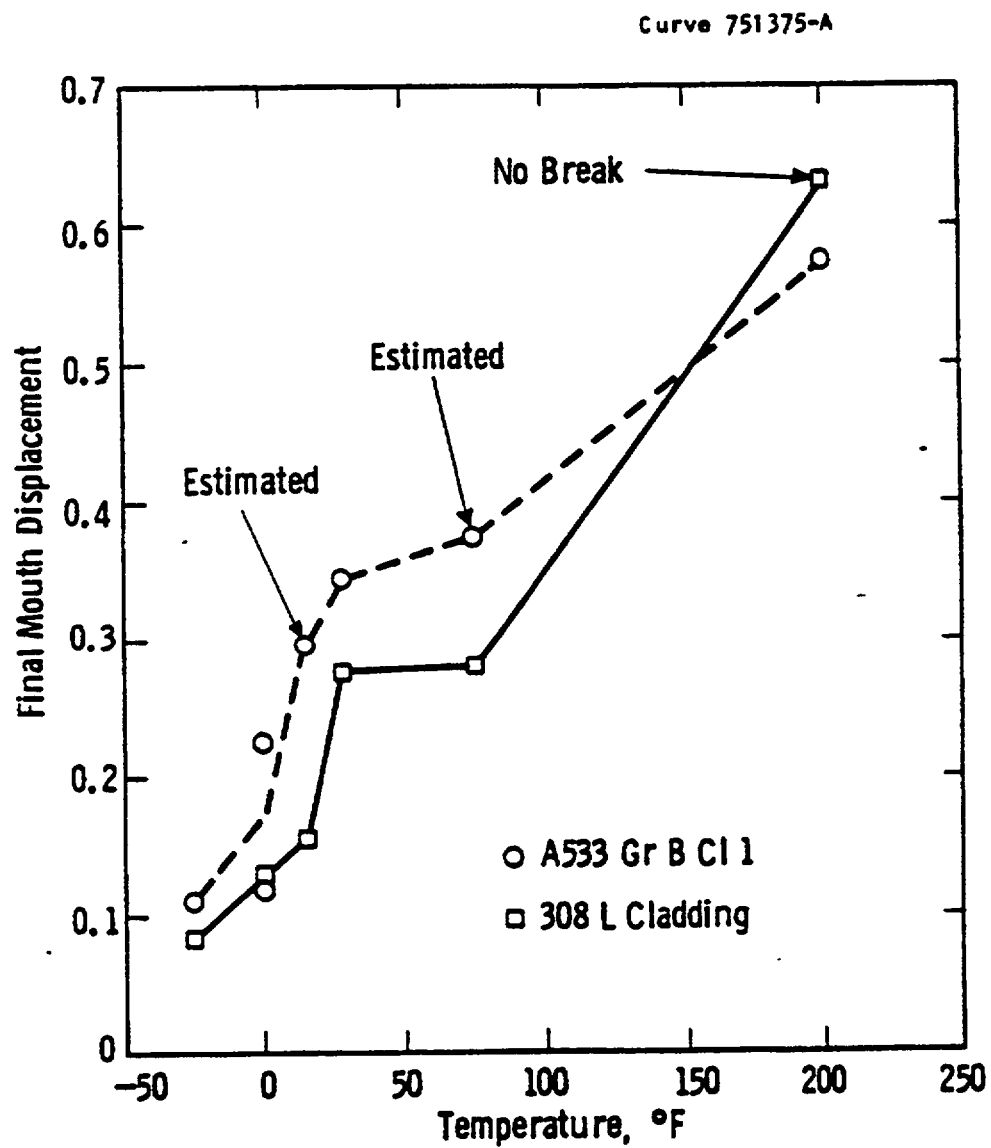
Figure 4-3. Final Mouth Displacement Versus Temperature for A533 Gr B Cl 1 and 308 L Clad Bend Bar Specimens

Load-deflection records for both the unclad and clad bend bar specimens were smooth up to the point of unstable fracture, regardless of temperature. The final mouth opening can be viewed as a measure of the fracture resistance of each specimen, and these results are presented in Figure 4-3 as a function of test temperature for both the clad and unclad (base metal) specimens.

The effect of the cladding is seen here as a small but distinct shift in the apparent fracture resistance in the lower range of temperatures. In the temperature range of -30 to 75°F (-34 to 24°C) the apparent shift is approximately 20°F (11°C), but at higher temperatures this effect completely vanishes.

This means that the effect of the cladding on fracture behavior vanishes at temperatures above the transition temperature of the base metal. This conclusion is further proven by the two bend bar results at 200°F (93°C), where the clad specimen failed to experience unstable fracture at a mouth displacement greater than that sustained by a failed unclad specimen (Figure 4-3).

The clad residual stress measurements provide an explanation for the fracture behavior observed in the bend bar tests. There is a clearly observable effect of the cladding in the transition region of fracture behavior as shown in Figure 4-3. In this region, the cladding residual stresses have a small but measurable impact on the critical crack mouth opening values, which are a measure of the fracture resistance of the component.

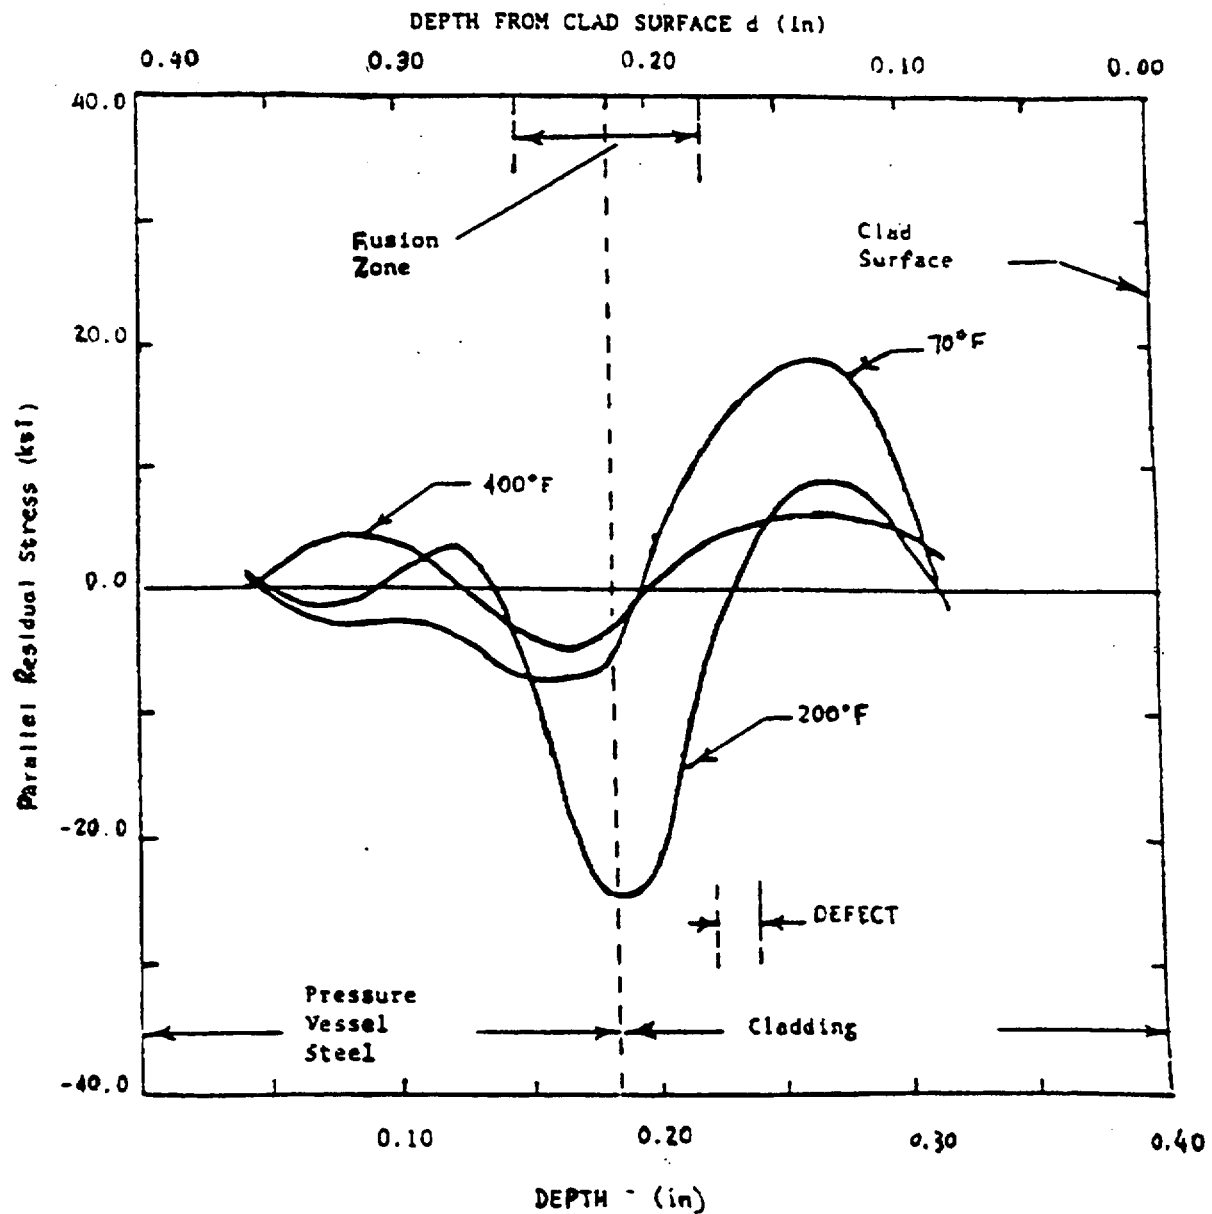
Figure 4-7. Average Residual Stresses Parallel to Direction of Welding

The curves of the residual stresses at 70°F (24°C) shown in Figures 4-7 and 4-8 are similar in shape to that obtained previously at 70°F (24°C) for another nozzle drop-out except that the peak compressive and tensile residual stresses are 15.0 ksi, compared to 20 ksi as shown in the figures. These lower stresses may have been caused by the use of different welding procedures. Underclad defects were noted in the cladding characterized in the earlier test series during layer-removal at the depth shown in Figures 4-7 and 4-8. These defects, which covered as much as 5% of the 1.00 x 1.00 inch cross section of some specimens, may have reduced the stresses measured during the layer-removal phase of the testing. The parting-out stress for all specimens averaged 12.7 ksi higher for the present tests than the previous ones, also indicating a difference in welding procedures.

The clad residual stresses result from the difference in thermal expansion coefficient between the stainless steel cladding and the low alloy steel. When the cladding was originally applied, the condition was stress-free. As the weld cooled, the residual stresses developed. The lower the temperature, the higher the clad residual stresses, and in the lower transition region of toughness, these residual stresses can effect failure.
