Clinton Power Station

Subject: Clinton Power Station
Licensee Event Report No. 2000-002-01

Out-of-Phase Synchronization Results in Damage to Division 3 Emergency Diesel Generator and Inadequate Design of Static VAR Compensator Freeze Circuit Results in Overvoltage of Class 1E Divisional Bus

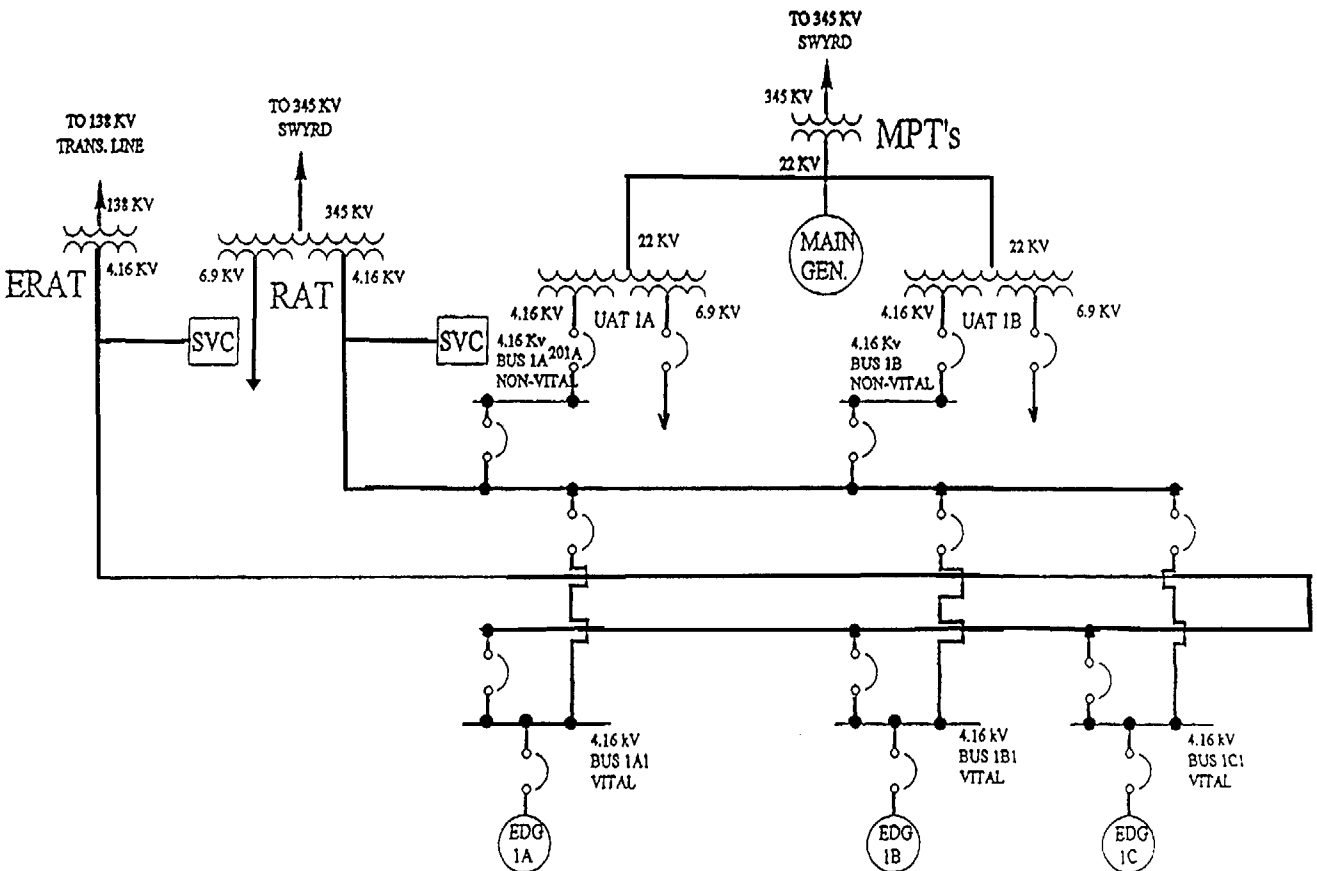
Figure 1

The Clinton Power Station (CPS) Class 1E 4160 VAC electric power system consists of three electrically and physically independent distribution divisions, i.e., the 1A1, 1B1 and 1C1 electrical buses. Each of the three distribution divisions can be supplied with electric power from either of two offsite sources via two physically independent circuits or an EDG that serves as a standby power source, independent of the offsite source. The two physically independent offsite source circuits are the 345 kilovolt (kV) circuit through the Reserve Auxiliary Transformer (RAT) and the 138 kV circuit through the Emergency Reserve Auxiliary Transformer (ERAT). A Static VAR Compensator (SVC) is installed on each of the secondary sides of the RAT and ERAT to assist in maintaining acceptable voltages to the 4160 VAC distribution divisions during normal plant operating conditions and / or accident conditions. Each SVC is rated at +28.5/-14.0 MVAR and includes a thyristor-controlled reactor bank rated at 21.5 MVAR, a thyristor switched capacitor bank rated at 21.0 MVAR, and a capacitive harmonic filter bank rated at 7.5 MVAR. (Figure 1 on page 10 contains a simplified diagram of the 4160 VAC electrical power system.)
