Duke Energy

Subject: Oconee Nuclear Station, Unit 1
Docket No. 50-269
Licensee Event Report 269/2000-006, Revision 1
Problem Investigation Process No.: O-00-04134

TITLE (4)
Reactor Coolant System Pressure Boundary Leakage Due To Cracks Found in Several Small Bore Reactor Vessel Head Penetrations

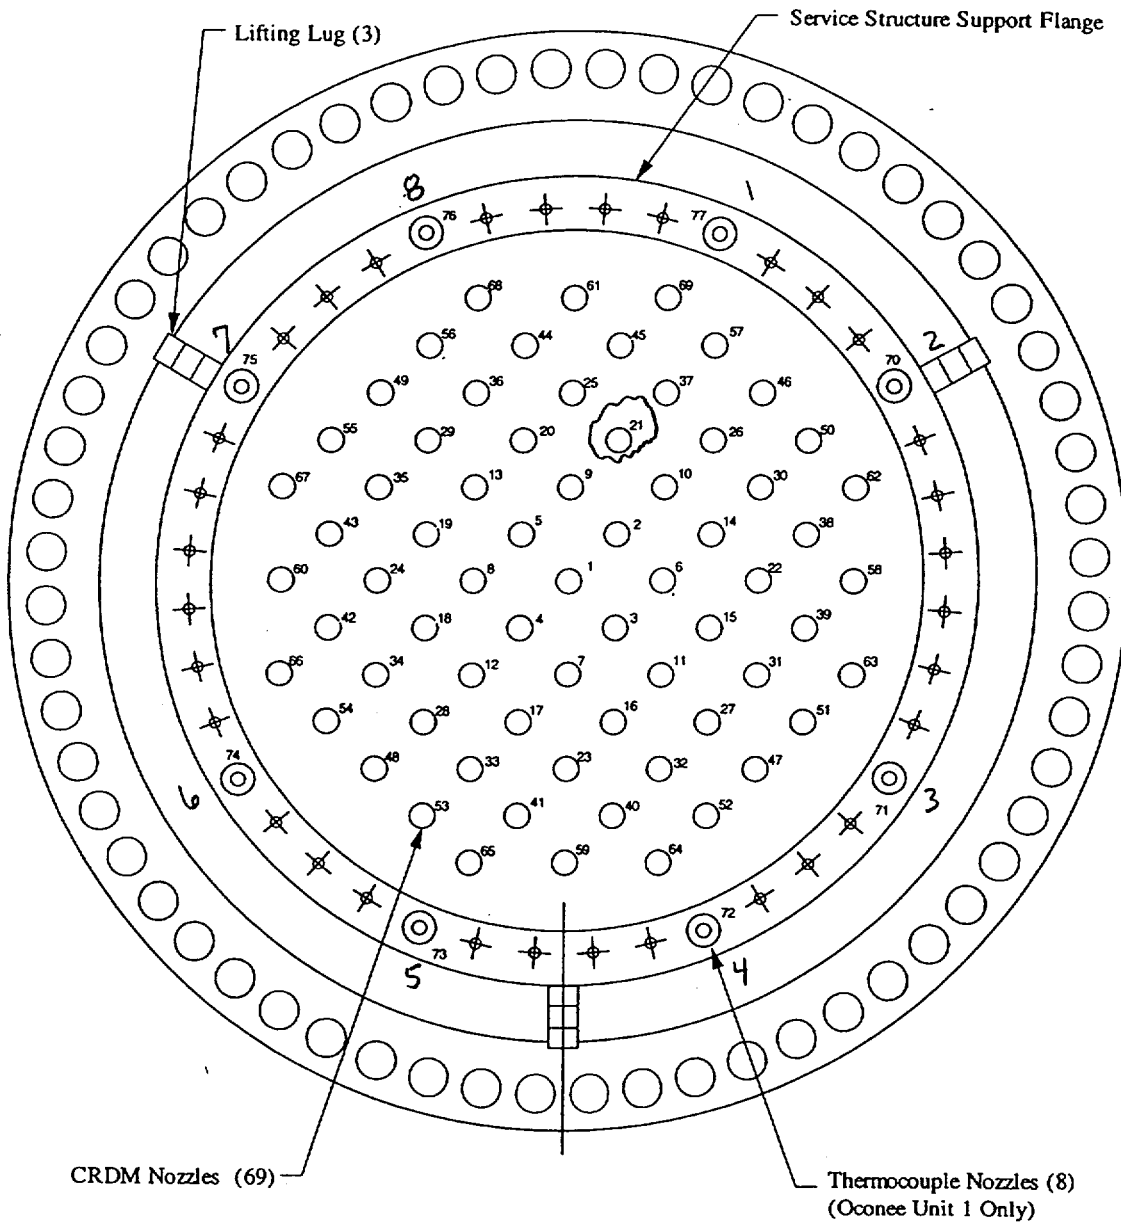
Figure 1

Boric acid deposits appeared to be located at the base of 5 (of the 8) unused thermocouple (T/C) nozzles and 1 (of 69) Control Rod Drive Mechanism (CRDM) nozzle at points where they penetrate the RPV head surface. A more detailed video inspection, performed on December 1, 2000, confirmed the presence of the boric acid crystals around the base of T/C nozzles #1, #2, #3, #4 and #5. The maximum volume of boric acid observed was around the base of CRDM #21 and was estimated to be approximately 0.5 cubic inches. The amounts around the T/Cs were much less.

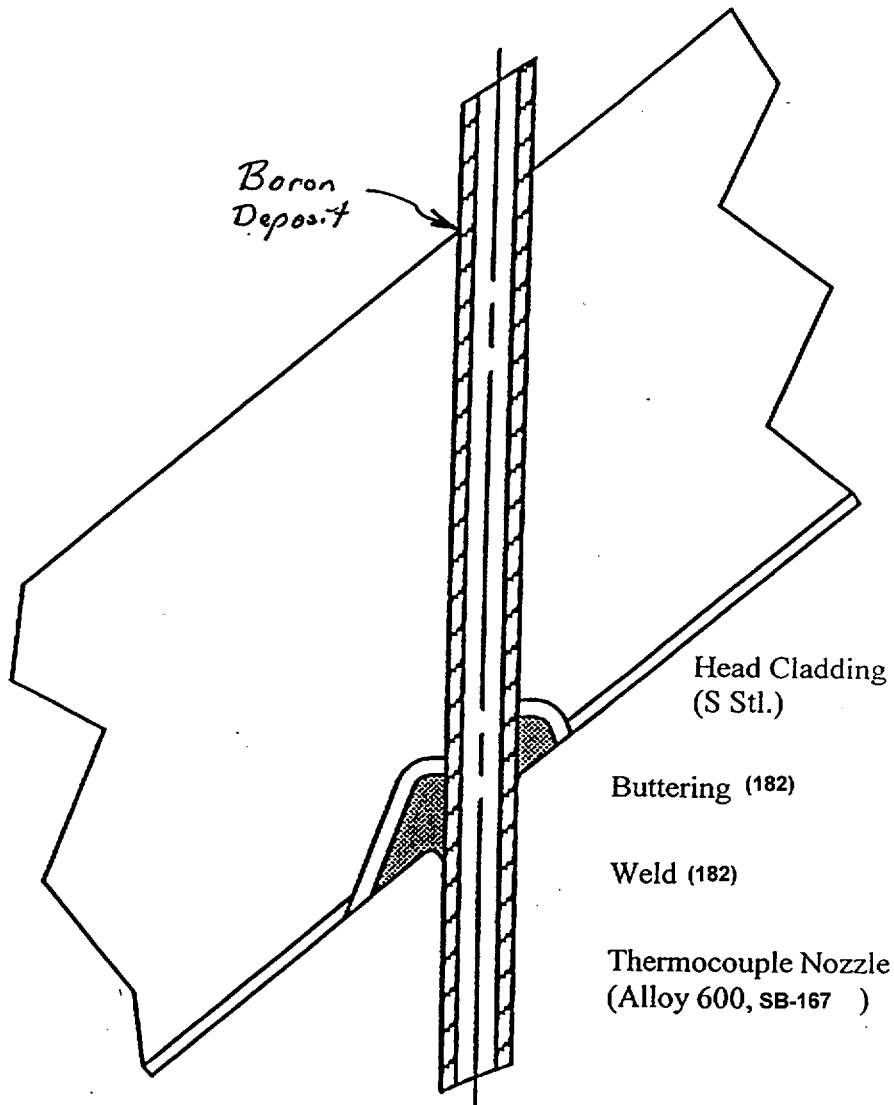
Figure 2

A typical T/C head penetration (See Figure 2) consists of a 1.03-inch outside diameter (OD) by 0.218-inch nominal wall alloy 600 pipe that is inserted vertically into the RPV head and connected to the inside diameter (ID) surface by a J-groove partial penetration weld. All 8 thermocouple penetrations have an overall length of approximately 62-inches. Approximately 8 inches of each penetration extends past the ID surface of the J-groove weld located on the inside surface of the RPV head. Each thermocouple penetration has a flange welded to the top of the pipe that extends the penetration length by approximately 2-inches.

On December 6, 2000, ultrasonic Test (UT) examinations from the inside surface of the T/C nozzles allowed the weld size to be determined and the axial crack-like indications (as determined by the prior EC examination) to be located relative to the welds. This work showed that most welds: (a) were significantly larger than specified on the design drawings, (b) lacked weld symmetry, (c) contained small areas of possible slag inclusions at the interface between the nozzles and welds, and (d) were undercut at the toes of the fillets where the weld joins the nozzle outside diameters.

Liquid penetrant (LP) examinations of the J-groove welds (after boring out the nozzles), showed that some cracks had penetrated through the nozzle walls and that the orientation of these cracks was predominantly axial at the plane where the cracks penetrated into the welds. Four T/C nozzles (#4, #6, #7 and #8), had crack depths less than 0.163 inches into the 182-weld metal. Two other T/C nozzles (#1 and #3), had crack depths less than 0.288 inches into the weld. The remaining two nozzles (#2 and #5), had some cracks penetrating completely through the J-groove weld, the Inconel buttering and up to the vessel head low alloy steel. After all crack indications had been removed, the total exposed low alloy material was about 1.75 square inches for T/C #2 and 2.5 square inches for T/C #5.

- All eight thermocouple nozzles were removed by boring them out from the underside of the vessel head and cutting a 4-inch long, 1.375-inch diameter counter bore in the lower head region. The counter bore diameter was larger than the nominal 1.035-inch diameter of the original hole in the vessel head.

- For nozzle locations #1, #3, #4, #6, #7 and #8, all remaining indications in the partial penetration welds were removed, and 4-inch long alloy 690 plugs were welded to the existing J-groove weld metal from the underside of the head. The plugs fit the counter bore diameter and are thus larger than the original hole in the vessel head so that the plugs cannot be ejected if the repair welds fail.

- For nozzles #2 and #5, the cracks extended up to the low alloy, steel base metal of the reactor vessel head. It was undesirable to perform an under-the-head temper bead weld repair at this location. These nozzles were repaired using a 9-inch long alloy 690 plug installed from the underside of the vessel head and welded to the top surface of the vessel head using a temper bead technique. The bottom portions of these plugs also fit the counter bore diameter and are therefore larger in diameter than the original holes through the vessel head such that they cannot be ejected if the repair welds fail.

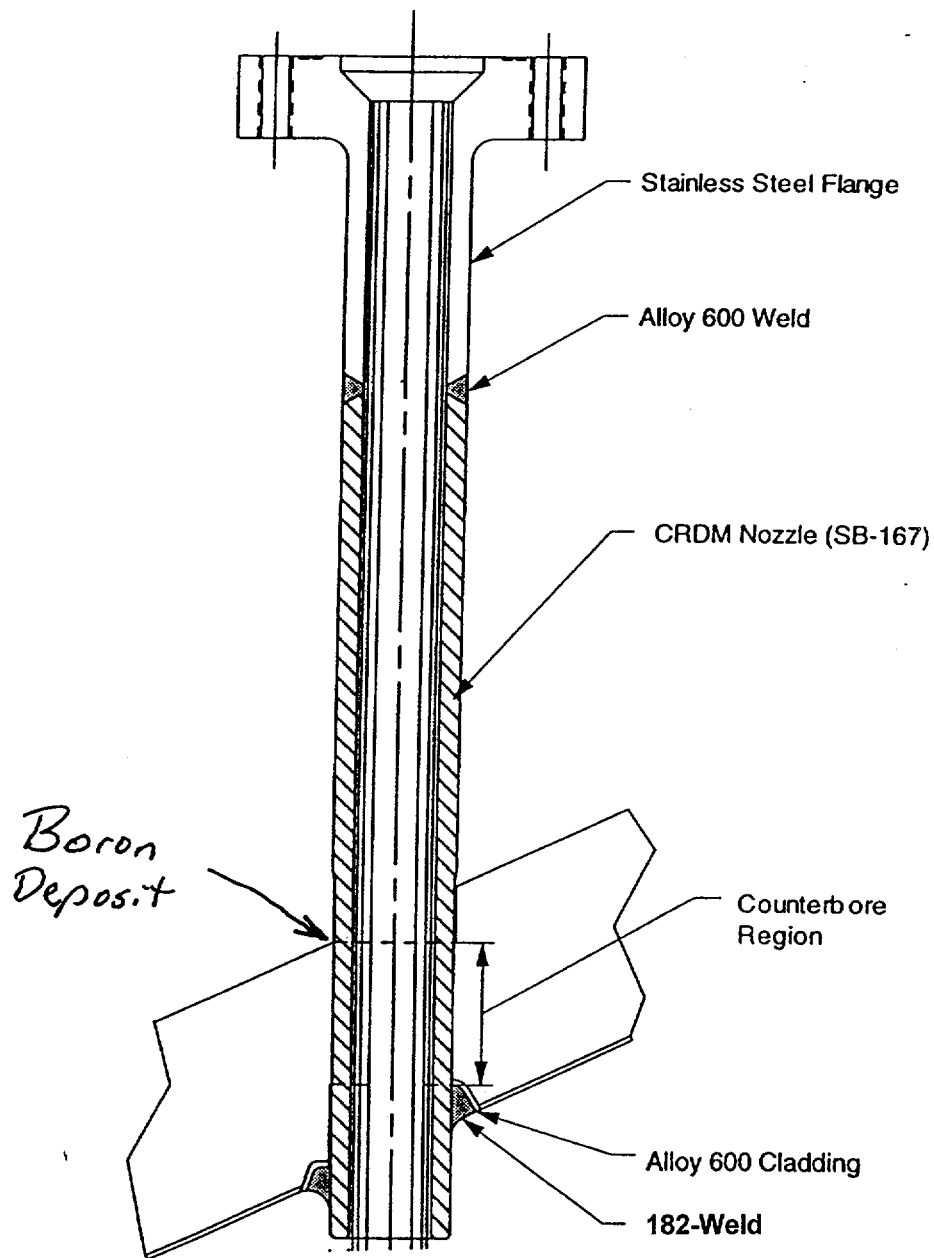
Figure 3

There are 69 Control Rod Drive Mechanism (CRDM) [EIIS: AA] nozzles that penetrate the RPV head. The CRDM nozzles are approximately 5-feet long and are welded to the RV head at various radial locations from the centerline of the RV head (See Figure 1). The nozzles are constructed from 4-inch OD alloy 600 material. The lower end of the nozzle extends about 6-inches below the inside of the RV head.

An EC inspection of CRDM Nozzle 21 on December 7, 2000 did not identify any significant indications that suggested a through-wall leak. Following wire brushing of the CRDM nozzle weld and an area of approximately 2 inches around the nozzle, a liquid penetrant inspection of the nozzle, fillet weld cap and partial penetration J-groove weld was performed on December 9, 2000. Results of this test revealed two non-recordable rounded indications, less than 0.05 inch in diameter, on the face of the fillet weld. The indications were located at approximately the 7 o'clock position on the circumference of the nozzle weld (note that the 12 o'clock position is the uphill orientation and 6 o'clock the downhill). No other indications were noted either on the weld or on the surrounding nozzle base metal.

Following light metal removal in the area of the two rounded indications, a second LP inspection that expanded the examination area around the nozzle to 3-inches was performed on December 12, 2000. This test revealed no indications in the outer perimeter area, but clearly showed the two rounded indications and a new rounded indication approximately the same size as the other two. The new indication was aligned with the first two and was on the nozzle side of the fillet weld face. The spacing between the three indications was approximately equal. The decision was made to perform additional metal removal in the area of the three rounded indications and to perform another PT test. This test revealed a linear indication that was oriented transverse to the direction of the fillet weld and was approximately 0.75 inches long.

After sample removal, the crack was ground out of the CRDM weld and nozzle material exposing a small area of low alloy, steel base metal. One branch of the crack grew from the root of the fillet weld into the nozzle itself, then grew axially along the alloy 600

nozzle material (no more than 0.4 inch depth) and finally, back into the J-groove to the nozzle/weld annulus interface. It was subsequently concluded from the root cause investigation that this branch was likely the source of the CRDM #21 leak.

5. The CRDM #21 nozzle weld cracks and its branches were ground out and the final weld repair performed in accordance with the ASME Code using the temper bead technique. This repair was completed prior to unit restart.
