Subject: 10CFR21 Reporting of Defects and Non-Compliance -
Engine Systems, Inc. Report No. 10CFR21-0081

Refurbished Woodward EGB governor/actuators

Report No. 10CFR21-0081

COMPONENT: Refurbished Woodward EGB governor/actuators

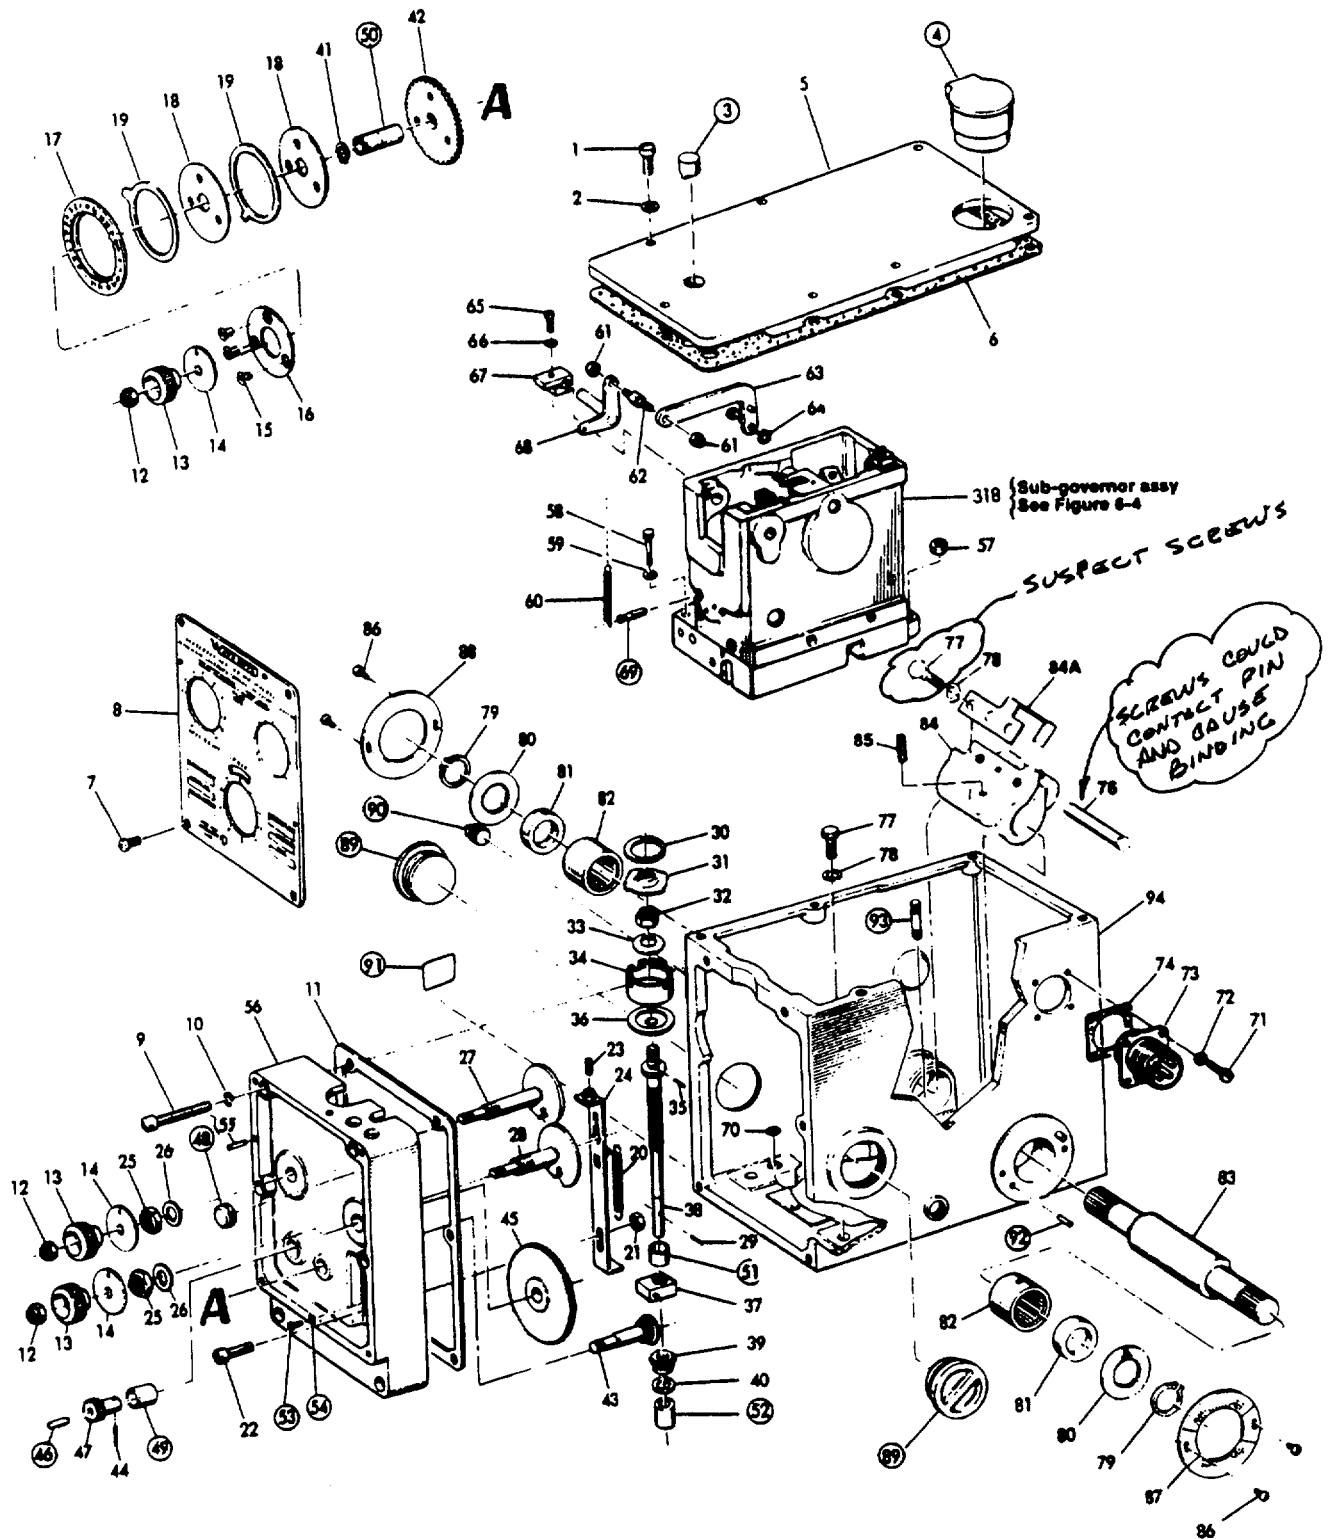
Figure 6-5. Column Assembly Parts for EGB-10P, 13P

Engine Systems Inc. (ESI) has received notification about a potential problem with some refurbished Woodward EGB governor actuators. One problem was recently reported by V.C. Summer Nuclear Station, via Power Reactor Event Number 37788. Apparently, a governor experienced binding of the terminal shaft due to incorrectly applied clamping screws. ESI was not notified about this occurrence until after the Event Report was issue; therefore, ESI was not able to verify/evaluate the actual components involved. Another problem was also reported by J.A. Fitzpatrick Nuclear Plant with this governor. Operability problems were observed and an investigation revealed that the droop lever pivot pin retaining rings were omitted during reassembly of the governor. Due to the missing retaining rings, the pins eventually backed out, releasing the droop lever. This caused the mechanical speed setting to drop and interfere with electric governor operation (limited load carrying capability). A parts breakdown for the EGB is provided in Exhibit 1 with the above parts annotated.

ESI recommends returning the suspect governors to ESI for a completed tear-down inspection. ESI will reassemble and functionally test to Woodward specifications. NOTE: Even though the V.C Summer governor screw length issue was corrected, we still recommend a complete tear-down to verify all refurbishment activity is within specifications. The Fitzpatrick unit (s/n 2185499) was recently returned to ESI to replace the missing terminal shaft retaining rings. A complete tear-down inspection was performed at that time; no further action on this governor is required. Contact ESI's Customer Service Department for return instructions.
