Subject: Licensee Event Report No. 2001-001
Cooper Nuclear Station, NRC Docket 50-298, DPR-46

FACILITY NAME (1) Cooper Nuclear Station				DOCKET NUMBER (2) 05000298		PAGE (3) 1 OF 6						
TITLE (4) Confusing or Incomplete Standards and Administrative Controls Resulted in Failure to Test an Excess Flow Check Valve												
EVENT DATE (5)			LER NUMBER (6)			REPORT DATE (7)			OTHER FACILITIES INVOLVED (8)			
MO	DAY	YEAR	YEAR	SEQUENTIAL NUMBER	REV NO	MO	DAY	YEAR	FACILITY NAME	DOCKET NUMBER		
01	17	2001	2001 - 001 - 00			03	12	2001	FACILITY NAME	DOCKET NUMBER		
									05000			
									05000			
OPERATING MODE (9)		1		THIS REPORT IS SUBMITTED PURSUANT TO THE REQUIREMENTS OF 10 CFR §: (Check all that apply) (11)								
POWER LEVEL (10) 100		20.2201(b)		20.2203(a)(3)(ii)		50.73(a)(2)(ii)(B)		50.73(a)(2)(ix)(A)

SIMPLIFIED ILLUSTRATION OF REACTOR VESSEL HEAD SEAL LEAK DETECTION SYSTEM

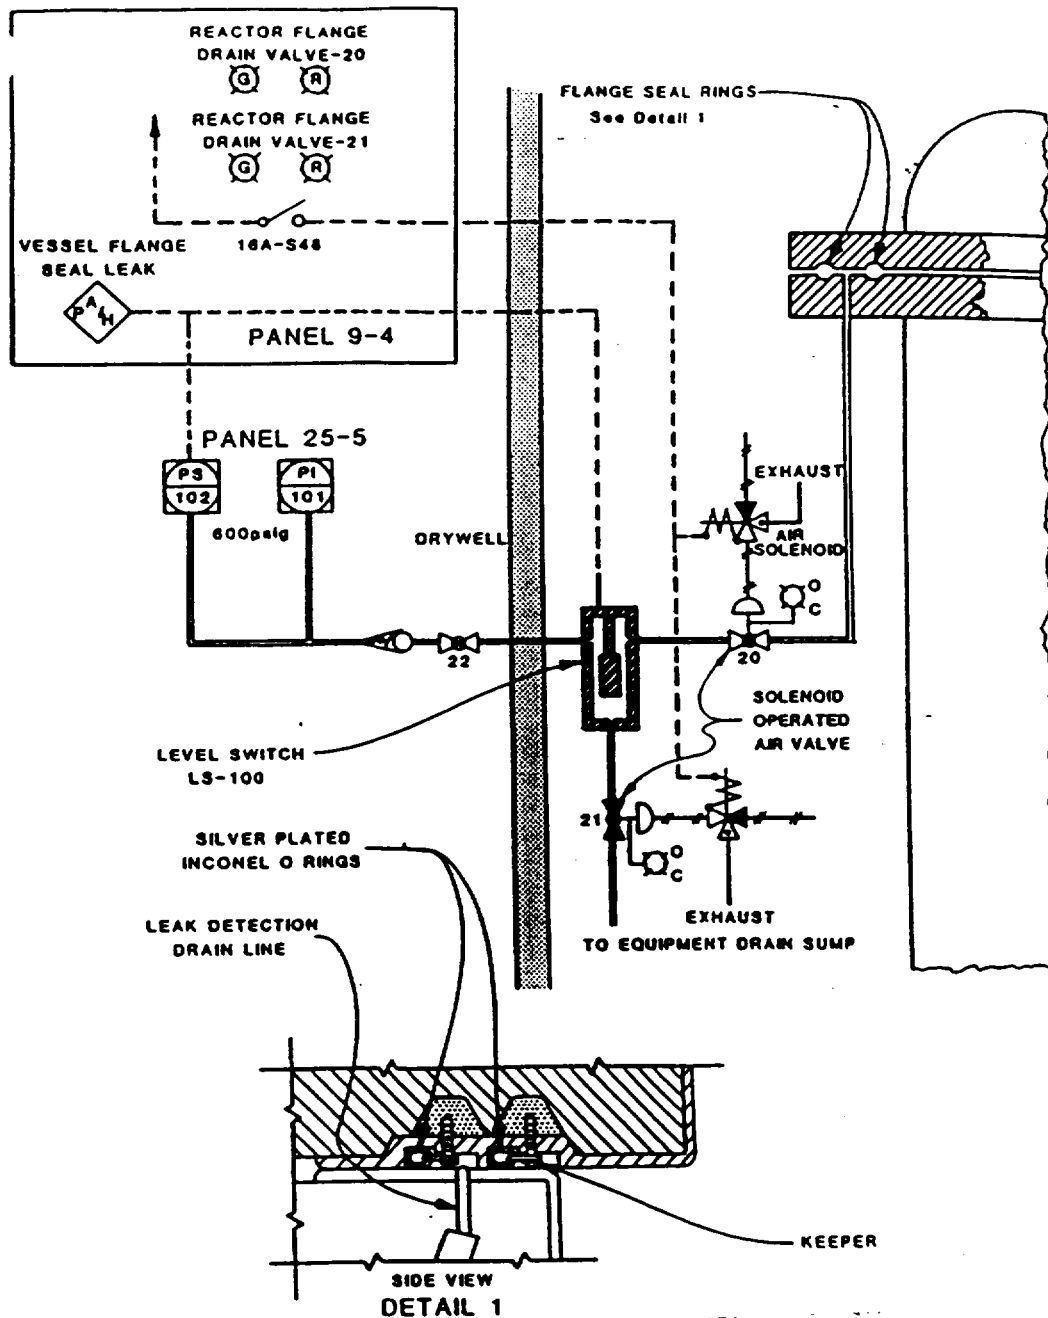
The reactor vessel head seal leak detection system (EISS: IJ) provides the operator with sufficient indication of reactor vessel top head flange leakage during planned operations. Page 6 of this LER provides a simplified illustration of the system and major components.

A connection on the reactor vessel flange is provided into the annulus between the two metallic seal rings used to seal the reactor vessel and top head flanges. This connection permits detection of leakage from inside of the reactor vessel past the inner seal ring. The connection is piped, via a 1.0 inch carbon steel pipe, to a collection chamber installed between two a-c solenoid-operated valves. The upstream valve is normally open, the downstream valve normally closed. A level switch is provided to detect the accumulation of water in the collection chamber. This level switch actuates an alarm in the main control room. A pressure switch is also provided to actuate the alarm in the main control room as pressure in the leakage collection piping becomes abnormally high. A pressure indicator is provided to indicate the pressure inside the piping arrangement. The level switch is located inside the primary containment, and the pressure instruments are located outside the drywell but inside the reactor building. The instrument pipeline (1.0 inch carbon steel line with a 1/4 inch restricting orifice) for the pressure instruments is provided with one manual isolation valve and one excess flow check valve (EFCV)(NBI-CV-48BCV)(EISS: JM). The two solenoid valves are controlled by a switch in the main control room. The positions of the valves are indicated by lights. If leakage past the inner seal ring is indicated, the upstream valve can be closed and the downstream valve can be opened by remote-manual operation from the main control room. This action routes the accumulated leakage to the drywell equipment drain sump. After the collection chamber is drained, the solenoid-operated valves can be returned to their normal positions. The leakage rate can be determined by timing the period until the level alarm is reactivated.

The safety function of the excess flow check valve (NBI-CV-48BCV) is to close on excess flow to maintain the reactor coolant pressure boundary in the event of a leak from the reactor vessel flange inner seal (note the outer seal is assumed to be still intact), coincident with a break in the pressure instrument line downstream of the check valve. The open function of the valve (normally open valve remains open) is not a safety function. In the unlikely event that the EFCV is stuck closed, adequate indication of seal leakage remains available to the operator by utilizing the collection chamber referenced above.
