Subject: 10CFR21 Reporting of Defects and Non-Compliance -
Engine Systems, Inc. Report No. 10CFR21-0081, rev.1

Refurbished Woodward EGB governor/actuators

Report No. 10CFR21-0081
Rev. 0: March 6, 2001
Rev. 1: March 13, 2001

10CFR21 REPORTING OF DEFECTS AND NON-COMPLIANCE

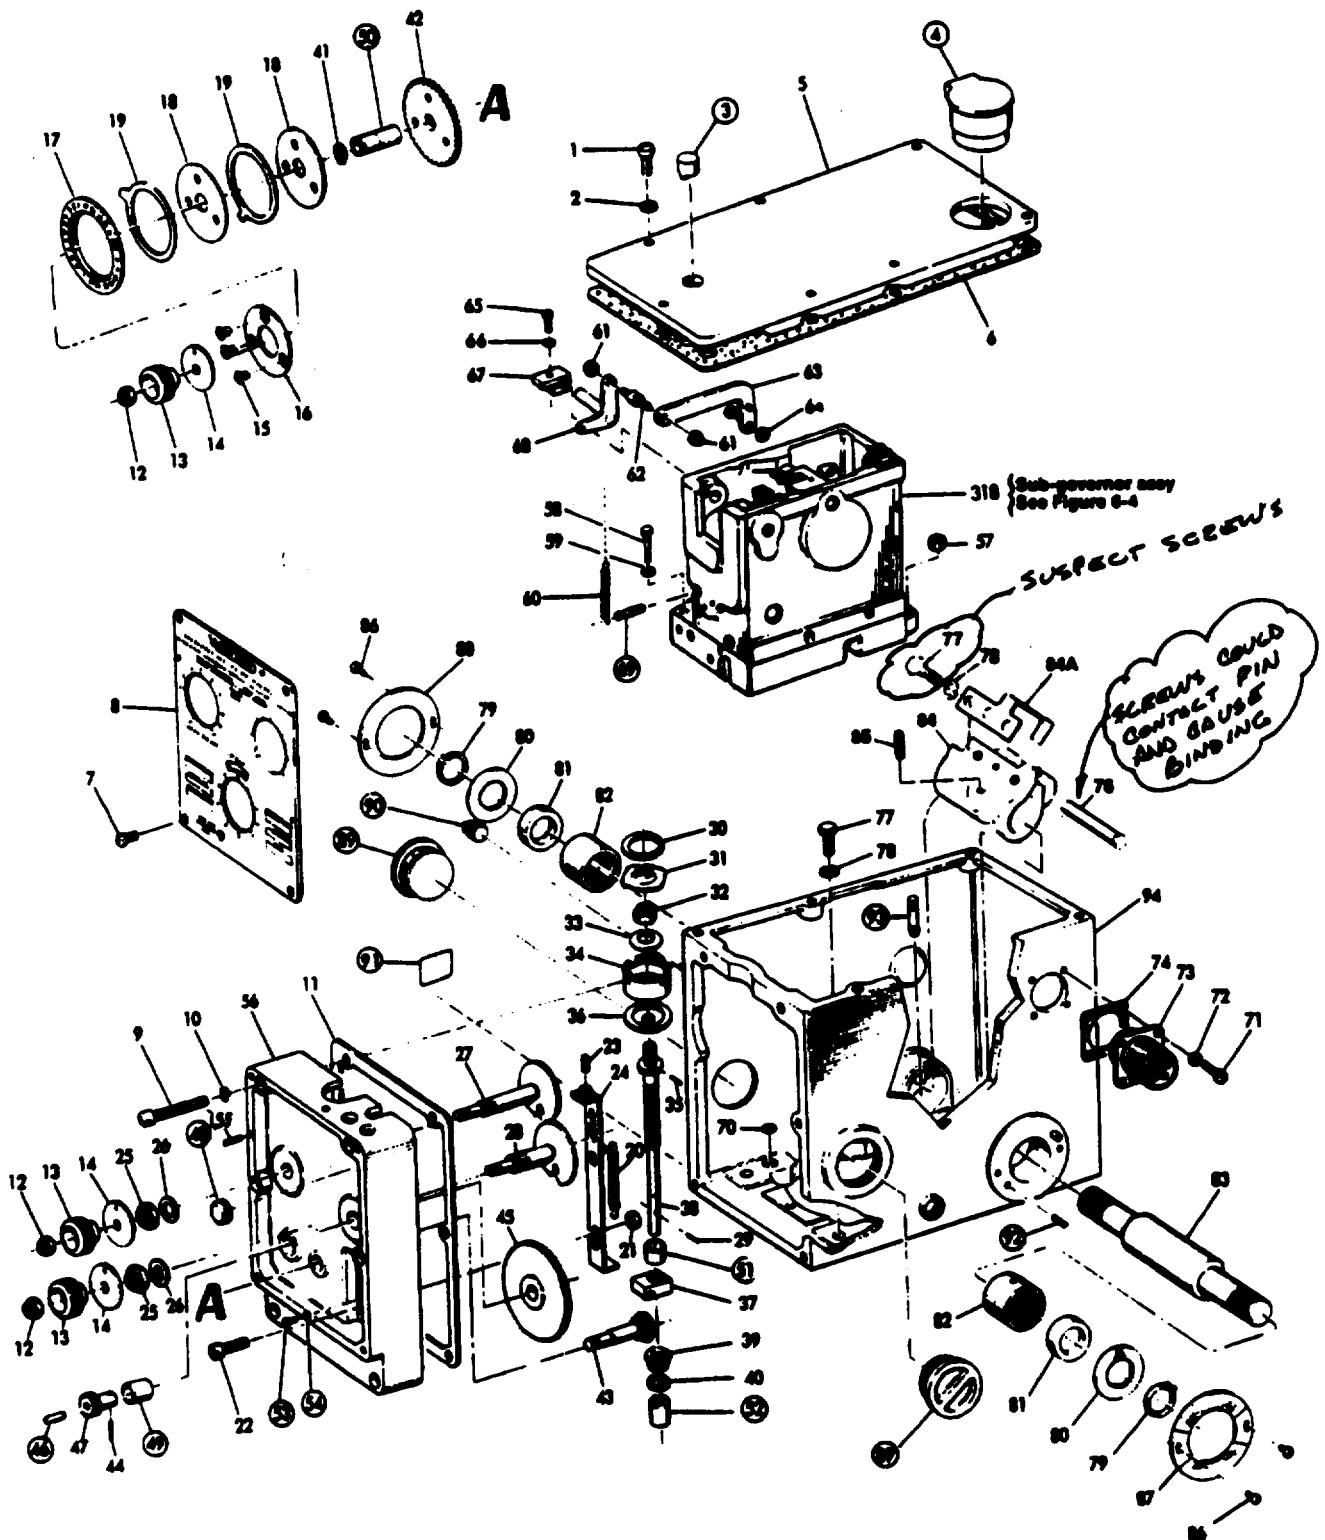
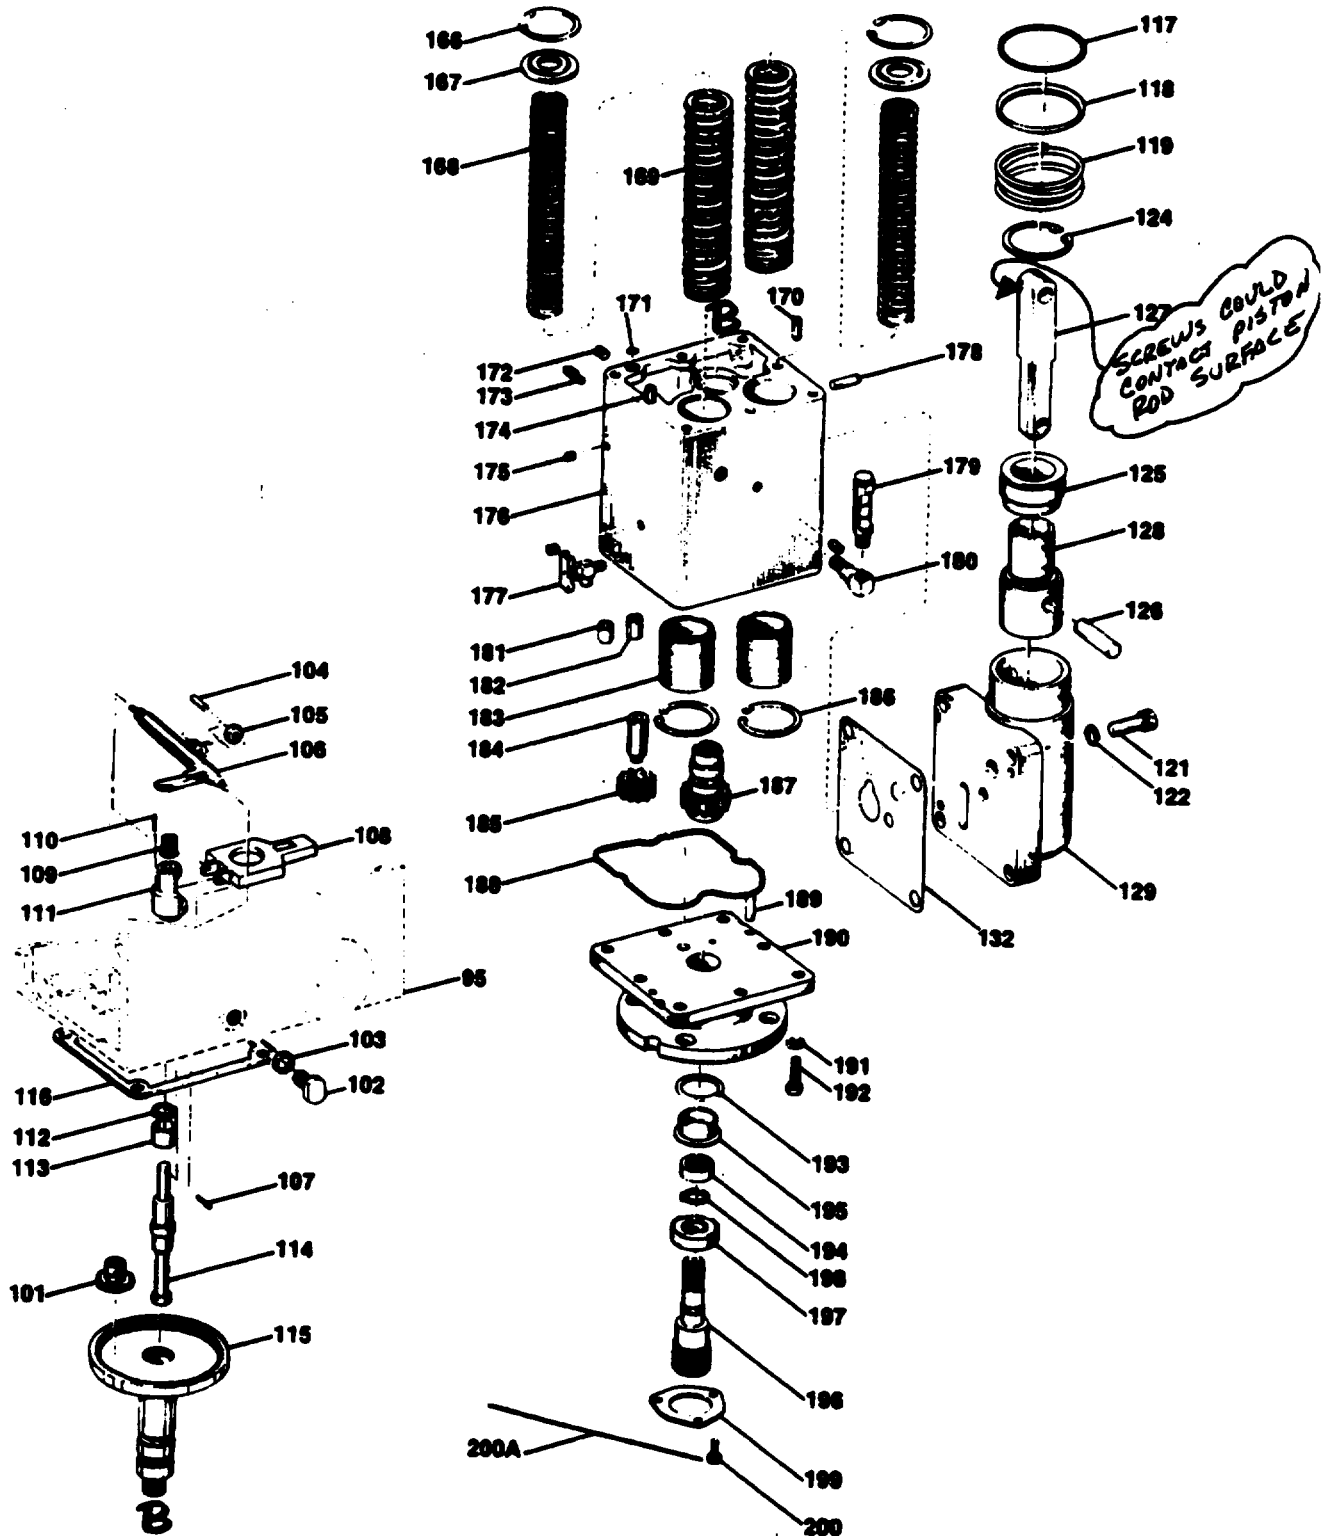
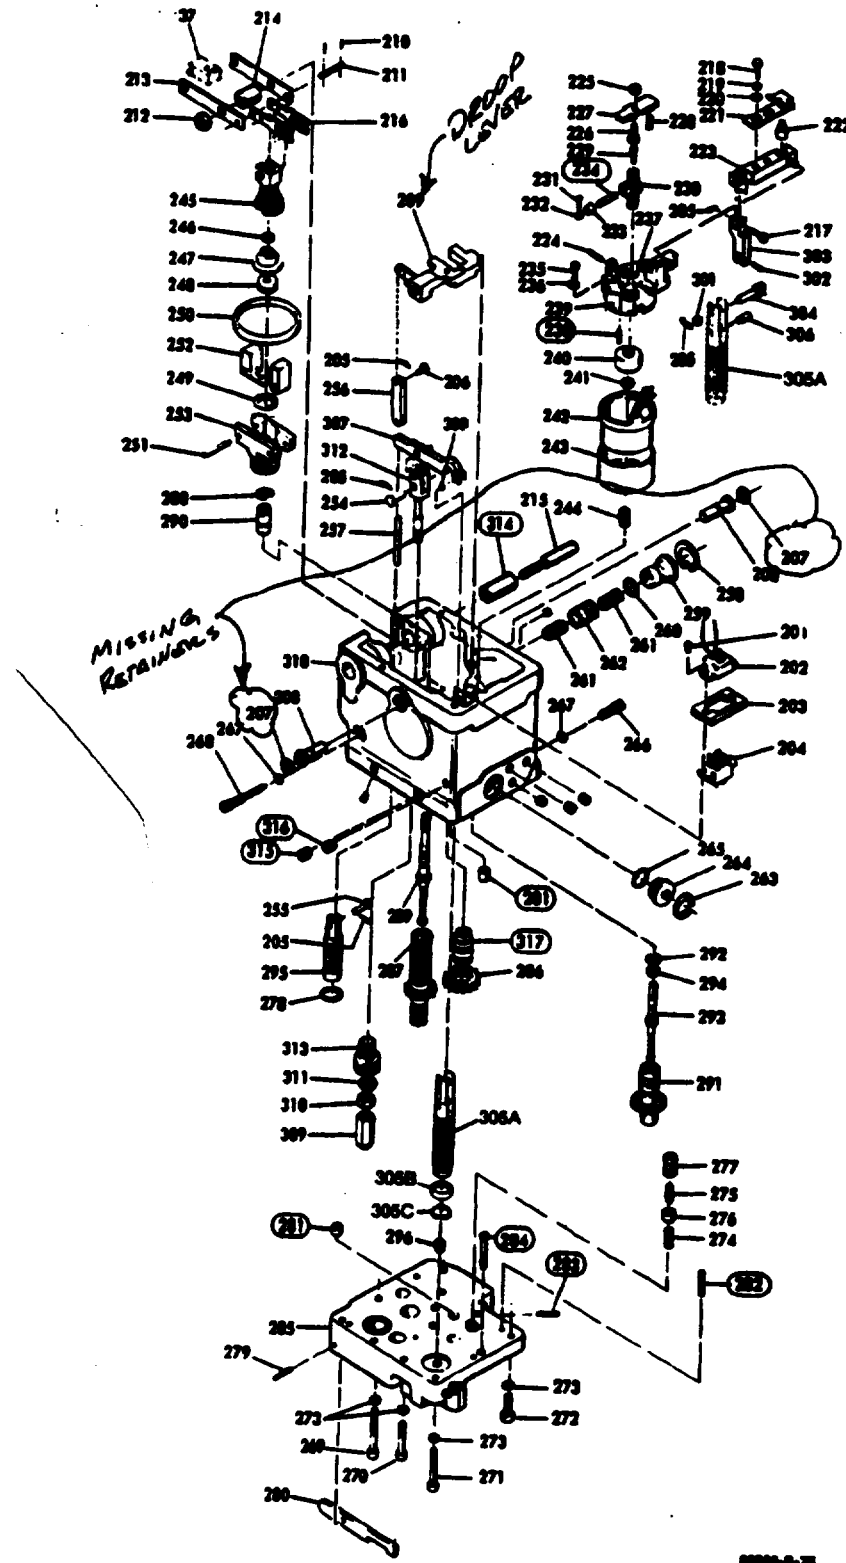
EXHIBIT 1

Engine Systems Inc. (ESI) has received notification about a potential problem with some refurbished Woodward EGB governor actuators. One problem was recently reported by V.C. Summer Nuclear Station, via Power Reactor Event Number 37788. Apparently, a governor experienced binding of the terminal shaft due to incorrectly applied clamping screws. ESI was not notified about this occurrence until after the Event Report was issue; therefore, ESI was not able to verify/evaluate the actual components involved. Another problem was also reported by J.A. Fitzpatrick Nuclear Plant with this governor. Operability problems were observed and an investigation revealed that the droop lever pivot pin retaining rings were omitted during reassembly of the governor. Due to the missing retaining rings, the pins eventually backed out, releasing the droop lever. This caused the mechanical speed setting to drop and interfere with electric governor operation (limited load carrying capability). A parts breakdown for the EGB is provided in Exhibit 1 with the above parts annotated.

ESI recommends returning the suspect governors to ESI for a completed tear-down inspection. ESI will reassemble and functionally test to Woodward specifications. NOTE: Even though the V.C Summer governor screw length issue was corrected, we still recommend a complete tear-down to verify all refurbishment activity is within specifications. The Fitzpatrick unit (s/n 2185499) was recently returned to ESI to replace the missing terminal shaft retaining rings. A complete tear-down inspection was performed at that time; no further action on this governor is required. Contact ESI's Customer Service Department for return instructions.
