LOUIS ALLIS  
Beloit Power Systems

Subject: Reference Telcon on 4/21/82 at 4:26 p.m.  
Between Nick Jackiw of NRC and Rick Haisler,  
Manager, Quality Assurance of BPS

Subject: BPS Generators Provided for Nuclear Standby Service -  
Alternator to Spider Rotor Torque Value Discrepancies,  
Hope Creek Alternator S/N 700510R2

700002 12 PC2 Hone Creek  
BPS Alt S/N 700510R2

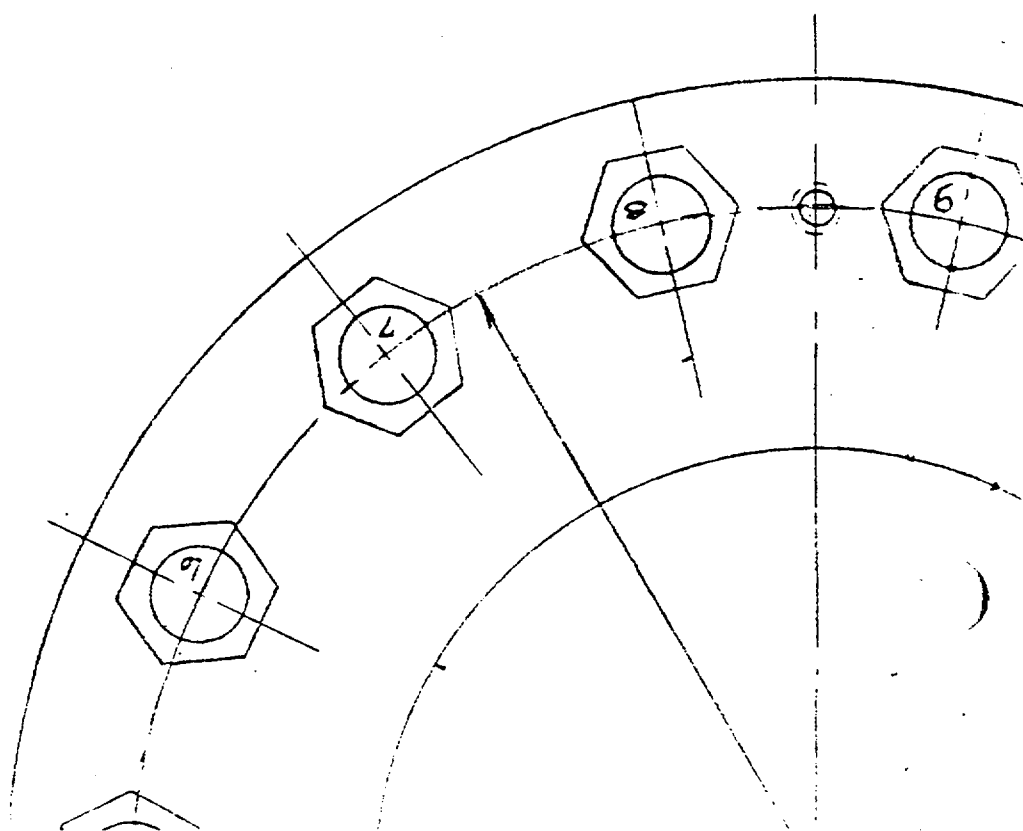
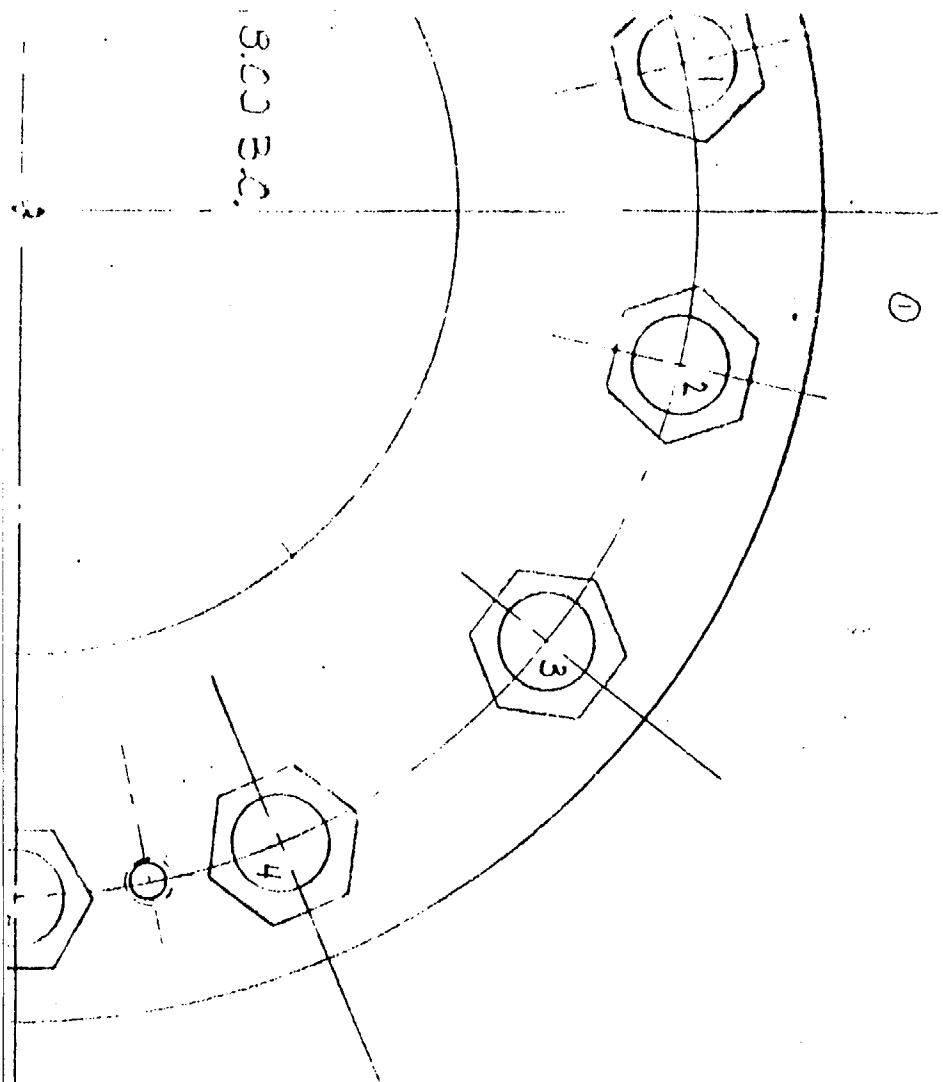
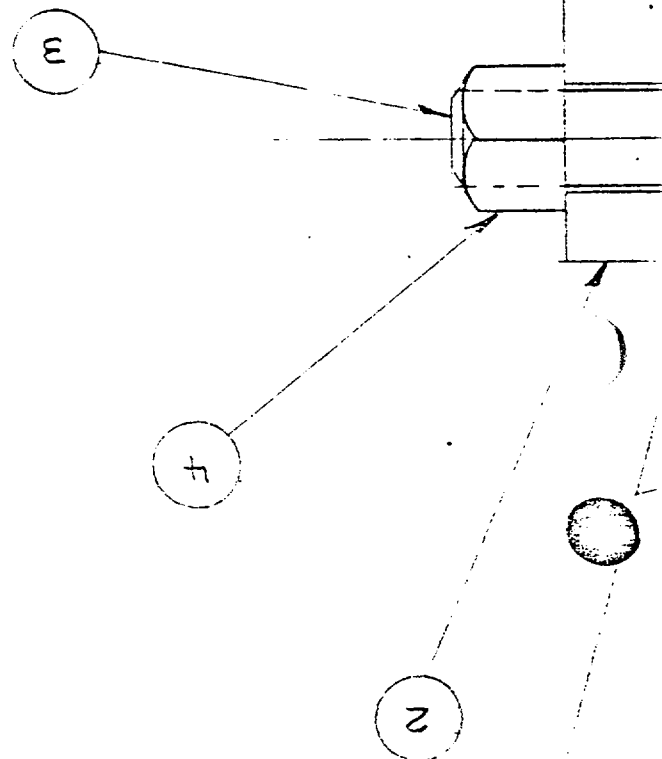
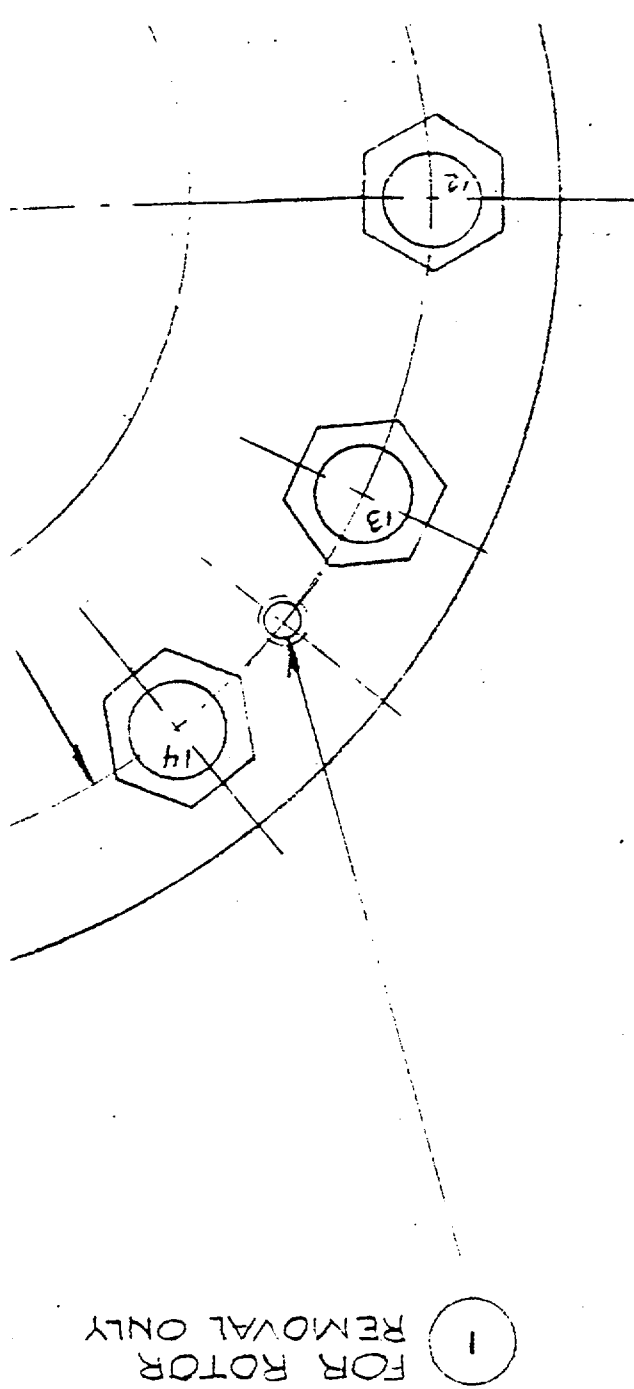
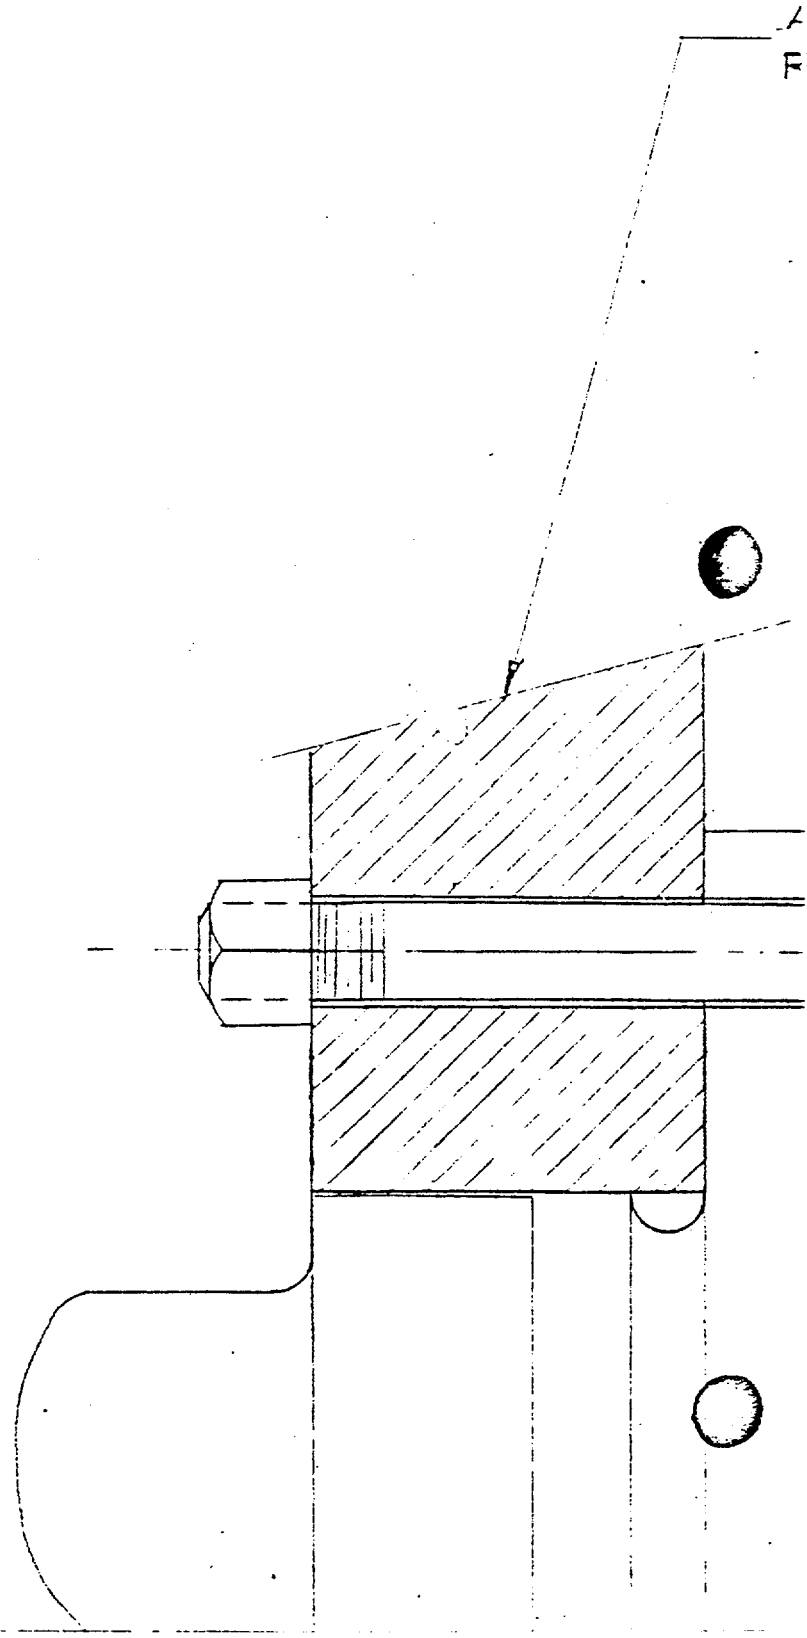
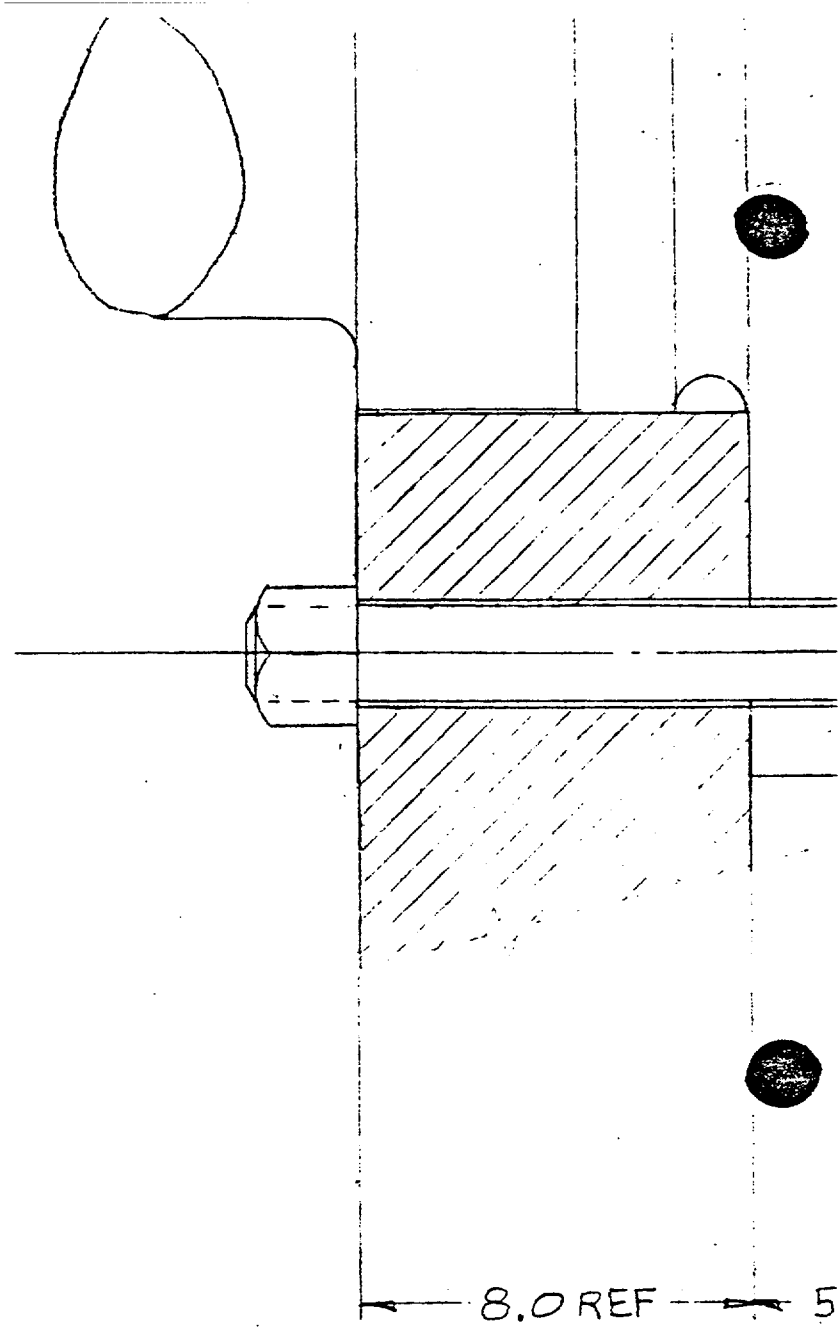
The application of this stud/nut design is shown on Colt Industries Drawing Number 11871439 Attachment (2) submitted for your information.

The 700512R2 stud/nut assembly was torqued on 10/19/81 to the limits as specified by the Colt Industries Dwg. #11871439 and witnessed by personnel from Bechtel, Colt Industries and BPS. Results are tabulated on Attachment (3).
