SUBJECT: TELECON - GERMANE TO SAFETY - SCRAM DISCHARGE VOLUME DRAIN VALVE
COUPLING FAILURE

SUBJECT: SCRAM DISCHARGE VOLUME DRAIN VALVE COUPLING FAILURE

MFN 017-85

SUBJECT: TELECON-GERMANE TO SAFETY - SCRAM DISCHARGE VOLUME DRAIN
VALVE COUPLING FAILURE-SUPPLEMENTAL INFORMATION

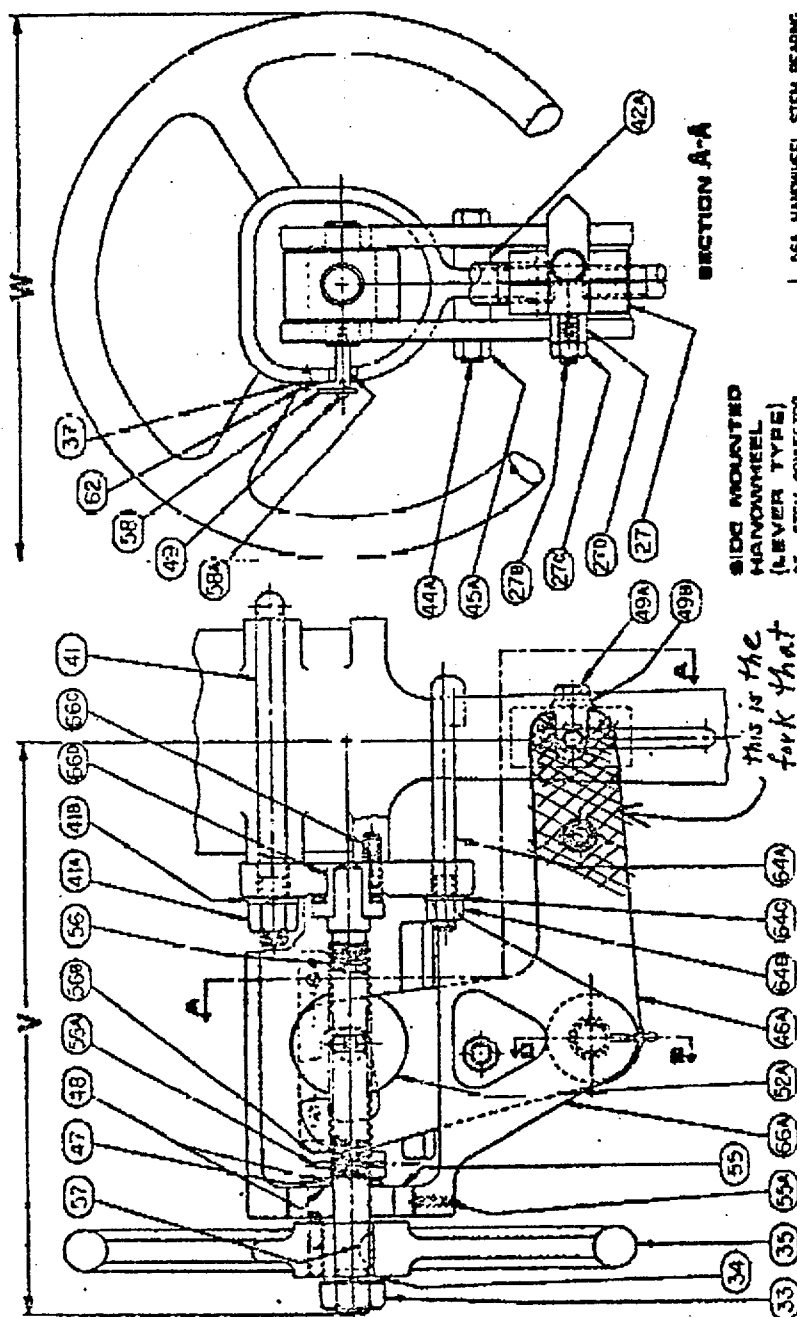
The coupling failure occurred during a five-second delay test at Wyle Laboratory. The cause of failure was determined to be inadvertent engagement of the valve hand wheel during valve setup for test purposes. On valve actuation during the test, coupling loads exceeded design loads. The stem connector deformed allowing disengagement between the stem connector and valve stem.

this is the
fork that
can cause a
problem if
left unadjusted
