LTR-QTS-85-013

MESSAGESUBJECT: TVA-SEQUOYAHENGINE GOVERNOR ACTUATOR ELECTRICAL CONNECTING PLUG

MORRISON-KNUDSEN COMPANY, INC.
POWER SYSTEMS DIVISION10CFR21-002710CFR21 COMMITTEE MEETING HELD SEPTEMBER 6, 1985

Engine Governor Actuator Electrical Connecting Plug

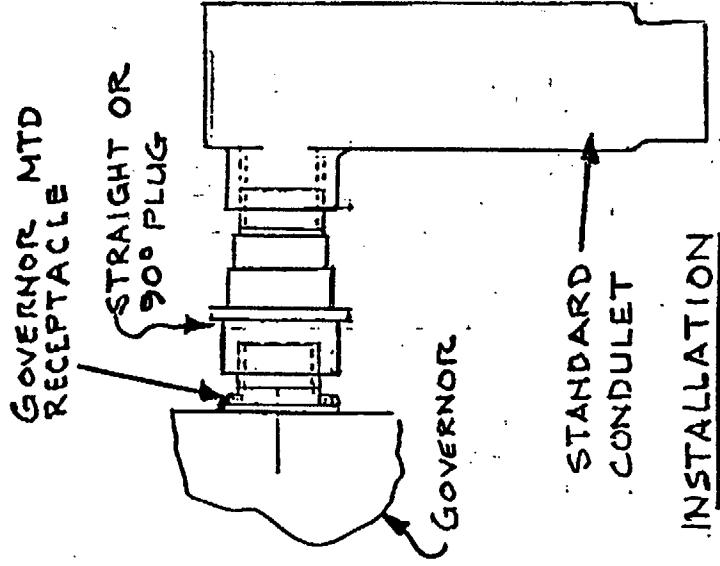
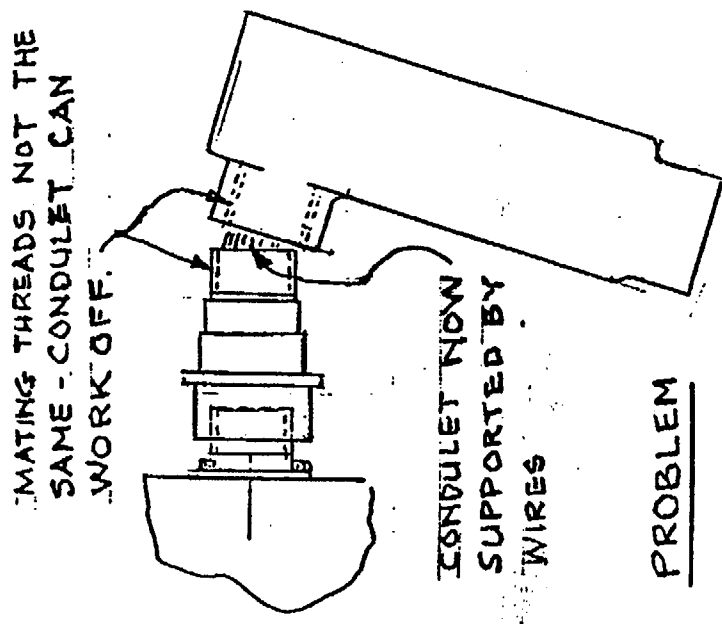
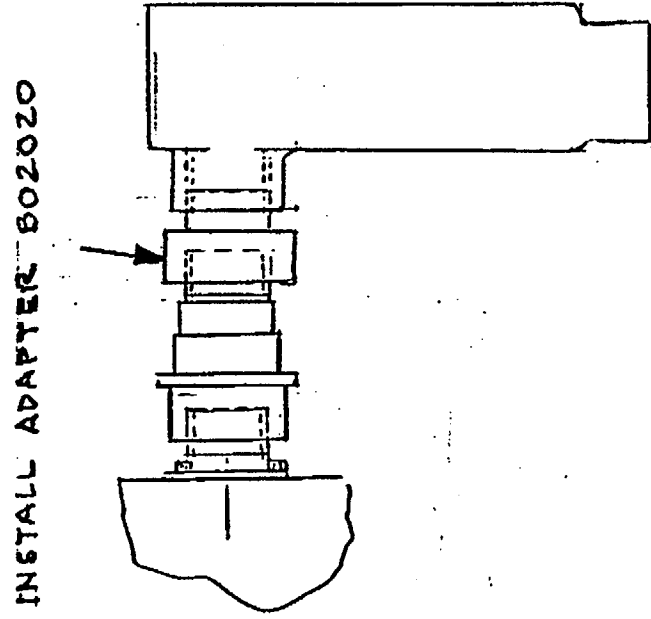
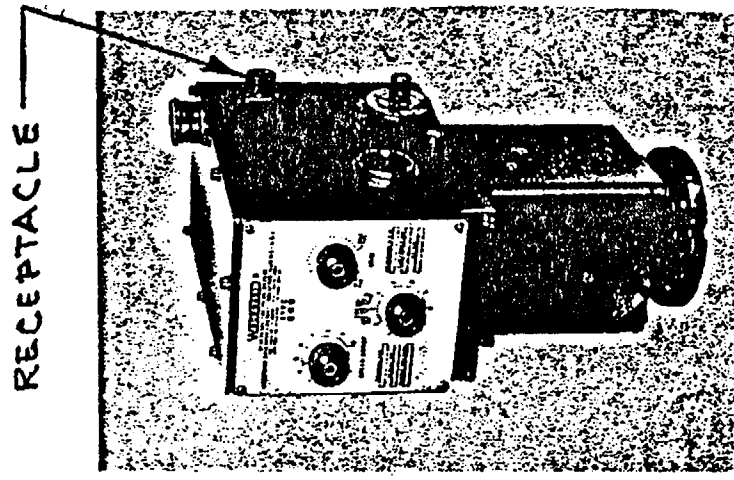
FIG-1

Improper threads on electrical thread connectors to flexible conduit.

Fig. 1 illustrates the problem. The governor actuator is mounted on the diesel engine. A typical governor is shown in Fig. 1 on which an electrical receptacle is identified. All the electrical signals for the electric portion of the governor, the hydraulic governor speed setting motors, the shutdown solenoid and limit switches are supplied through this receptacle.

For diesel-generators furnished prior to 1976, the arrangement as shown on Fig. 1 "Installation" may have been furnished showing the connections to this receptacle. The problem is that the threads in the conduit are not the same as the mating threads on the plug. While the assembly appeared to be tight, there is a potential for the thread joint to loosen, particularly when subjected to engine operating vibration, with the conduit eventually working free. Then the only support for the flexible conduit that connects the plug to the control panel is the control wires inside. The potential then exists for the possible shorting or breaking of wires as a result of operating vibration; thereby, interrupting the signals to the governor and preventing the diesel-generator from performing its safety function.

CORRECTIVE ACTION

The corrective action is to install an adapter P.N. B02020 which provides the correct threads for each component.
