COOPER-BESSEMER RECIPROCATING

July 21, 1986
QCG-3072

REPORT

NIAGARA MOHAWK POWER CORPORATION
Nine Mile Point (Unit 2)
KSV-16-T S/N MO-7190
Starting Air Valve, Valve Seat Insert

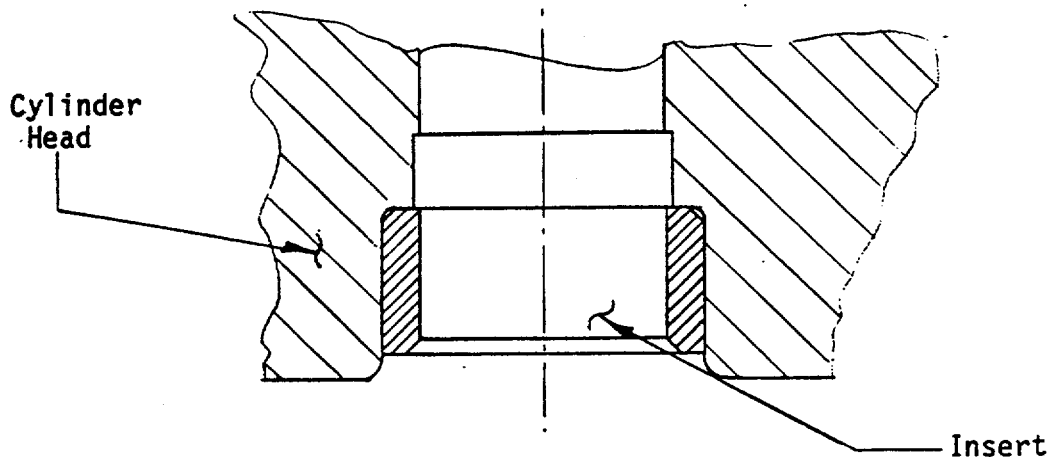
2.1 The sketch below shows the valve insert assembly (Approx. full size)

- 2.2 The insert bore is required to be held within a tolerance of .003". Inserts are selectively fitted to ensure a .001" to .0025" interference fit. Six part numbers of inserts are available, three of which are available as "standard" for production use. Each is bigger in diameter than the next smallest by .0005". The counterbore is measured and the required insert part no. is selected. This number is stamped on the cylinder head. After a complete inspection, the selected insert is frozen and shrunk into the head counterbore.

- 3.1 Inspection records indicate that the insert counterbore was machined oversize, and that it was brought back to size by copper plating. The process used has a wide industrial application and is known by the trade name "Dalic". It is incorporated in the design of many components as well as used for salvage. Various materials such as copper, cobalt, nickel, etc. may be deposited by the process.

The starting air valve insert is located in an area subject to thermal cycling. Although residual temperatures would be between 300 and 400°F there would be expansion of the insert, copper plating and cast iron head. The copper being trapped between the head and the insert would have nowhere to go and so would yield in compression and ultimately would lose its fit, and loosen. The sensitivity of an insert to loosen under such circumstances would be a function of the thickness of the copper plating and the temperature to which the assembly would be subjected. Higher than normal temperatures for example, would increase this sensitivity.

7.5.1 3L - No air in cylinder. The insert depth is greater than the valve stroke. The insert was so loose that when the valve opened the insert would have traveled with the valve aided by air pressure, and acting more like a piston than a valve. It would therefore have blocked off the air supply resulting in no air pressure (at the max. torque position).

8.1 No. 3 left air starting valve insert came loose because of the use of copper plating - the copper yielded due to thermal changes.

- 3.3 We therefore understand why this particular insert loosened. It was removed, the copper bored out and a .030" oversize insert shrunk into place.
