Byron Station, Unit 1
Facility Operating License No. NPF-37
NRC Docket No. STN 50-454

Subject: Supplement to Licensee Event Report (LER) Unit 1-2000-003-00

Enclosure: Byron Station Unit 1 LER 2000-003-01

TITLE (4) Unintentional Violation of Low Temperature Over Pressure Protection System Technical Specification Due to Operator Error

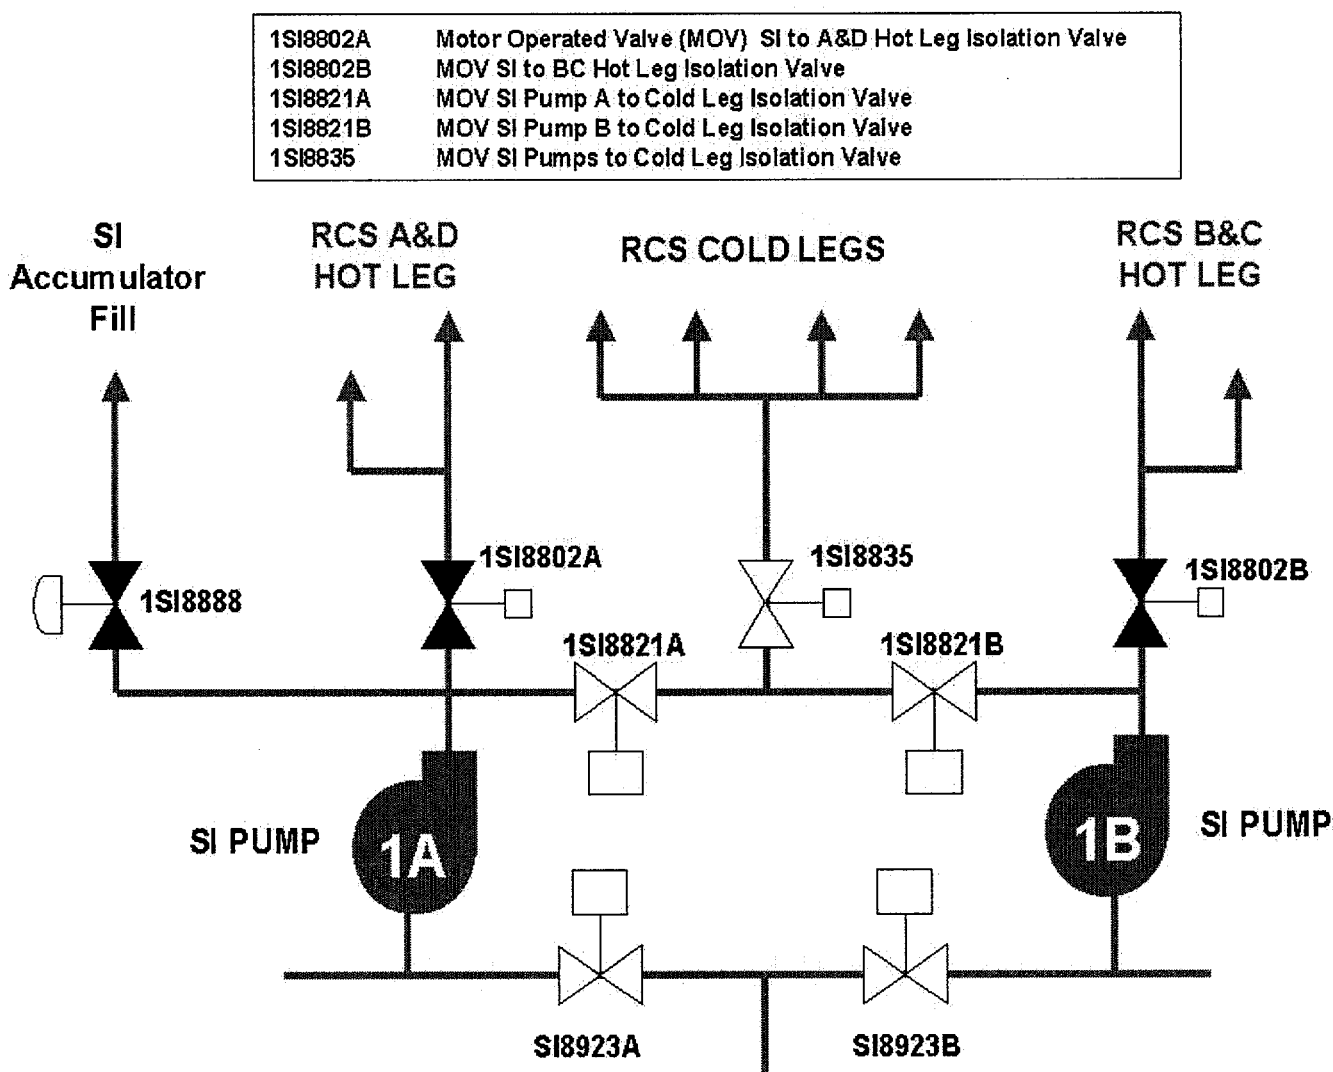
BOP-SI-5 ensured LTOP compliance for the 1A SI pump by closing and de-energizing valves 1SI8835, 1SI88802A, and 1SI8802B (refer to Figure 1). However, LTOP compliance for the 1A SI pump could be also be ensured by only closing and de-energizing 1SI8802A and 1SI8821A. In addition, a similar procedure change to improve LTOP flexibility was successfully used to the same procedure a few days before while attempting to fill the SI Accumulators. The U1 SRO and Shift Manager concurred and authorized a procedure change to allow, but not require, the option to substitute 1SI8821A for 1SI8835 and 1SI8802B. The change did not address the restoration. The U1 SRO later stated that he intentionally did not address 1SI8821A in the restoration step to ensure it would remain closed and de-energized. This possibility of changing the procedure was not discussed at the pre-job brief.

At approximately 2125 hours when 1SI8821A was opened, a direct flow path existed from the 1A SI pump to the RCS cold legs. With the 1A SI pump's motor breaker racked in and the control switch in PTL, two independent means to prevent a mass addition into the RCS did not exist. This condition is in non-compliance with Technical Specifications 3.4.12. On October 9, 2000, at 0129 hours while performing a routine Unit 1 Main Control Board walkdown, another licensed operator not involved in the Accumulator fill evolution discovered the non-compliant situation. 1SI8821A was immediately closed, which restored compliance to Technical Specification 3.4.12. This condition existed for approximately 4 hours and is a condition prohibited by Technical Specification and accordingly, reportable to the NRC in accordance with 10 CFR 50.73(a)(2)(i)(B).

FIGURE 1 - Simplified Diagram of SI Flowpaths to the RCS
