South Texas Project
Unit 2
Docket No. STN 50-499
Special Report on Steam Generator Tube Inspection Results

Special Report on Steam Generator Tube Inspection Results

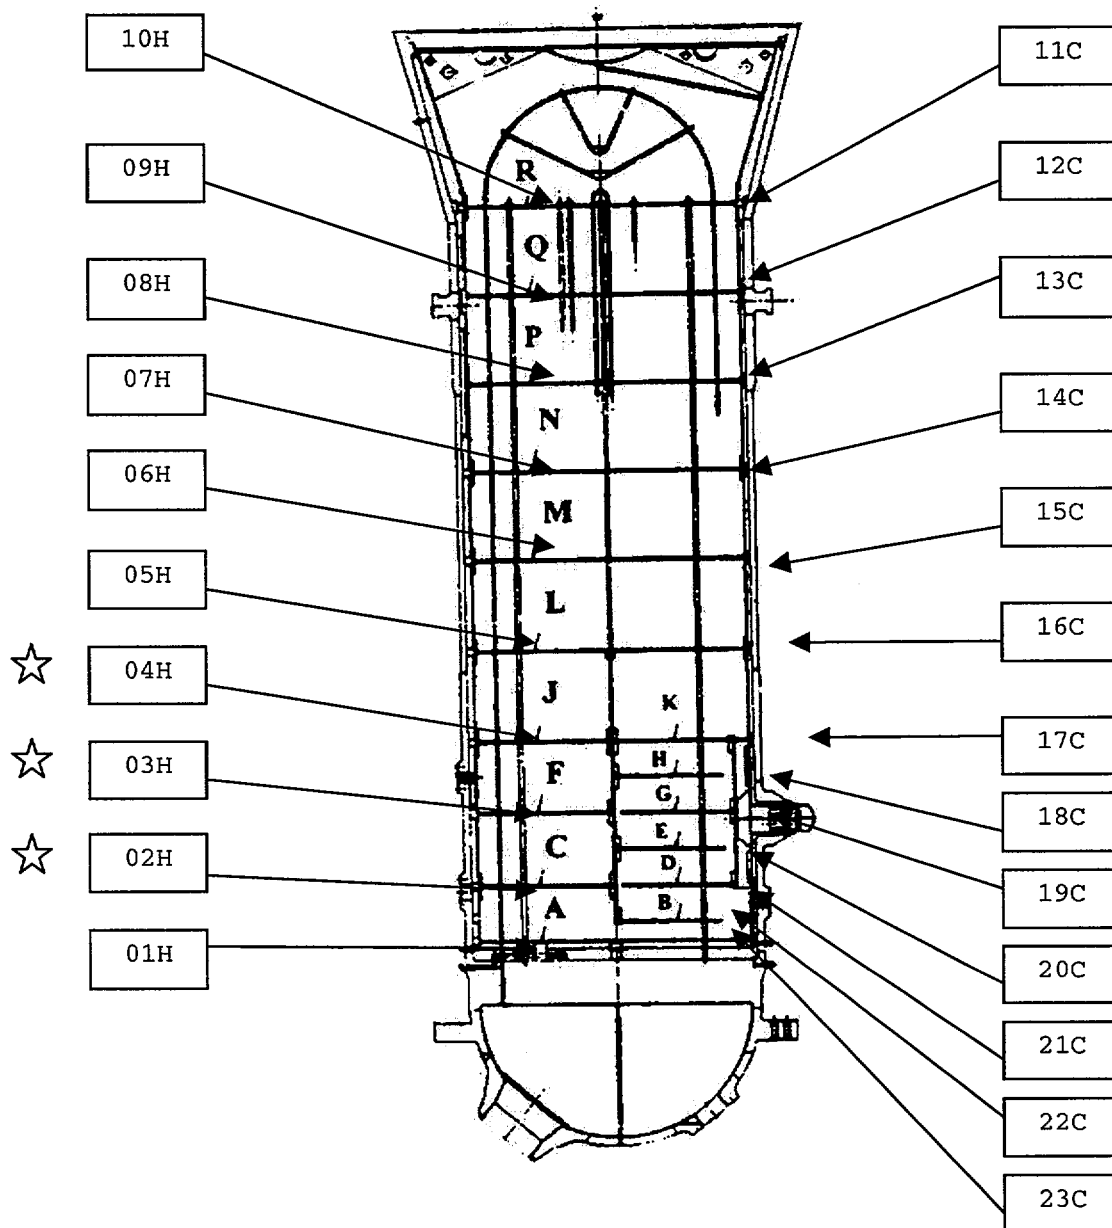
FIGURE 1
TUBE SUPPORT PLATE IDENTIFICATION IN MODEL E SGs

The inspection results are discussed below by degradation mechanism. A summary of how many defective tubes were attributed to each of these damage mechanisms is provided in Table 1. As discussed below, many tubes were also preventively plugged. A summary of all tube plugging is given in Table 2. Figure 1 provides identification of the tube support plates in the Model E steam generators.
