SUBJECT: Oconee Nuclear Station - Unit 3
Docket No. 50-287
Request to use an Alternative to ASME Boiler and
Pressure Vessel Code, Section XI in accordance with
10 CFR 50.55a(a)(3)(ii)

Attachment:
Request for Alternative, Serial Number 01-04

DUKE ENERGY CORPORATION
Oconee Nuclear Station, Unit 3

Request for Alternative to the Requirements of the
ASME Boiler and Pressure Vessel Code, Section XI

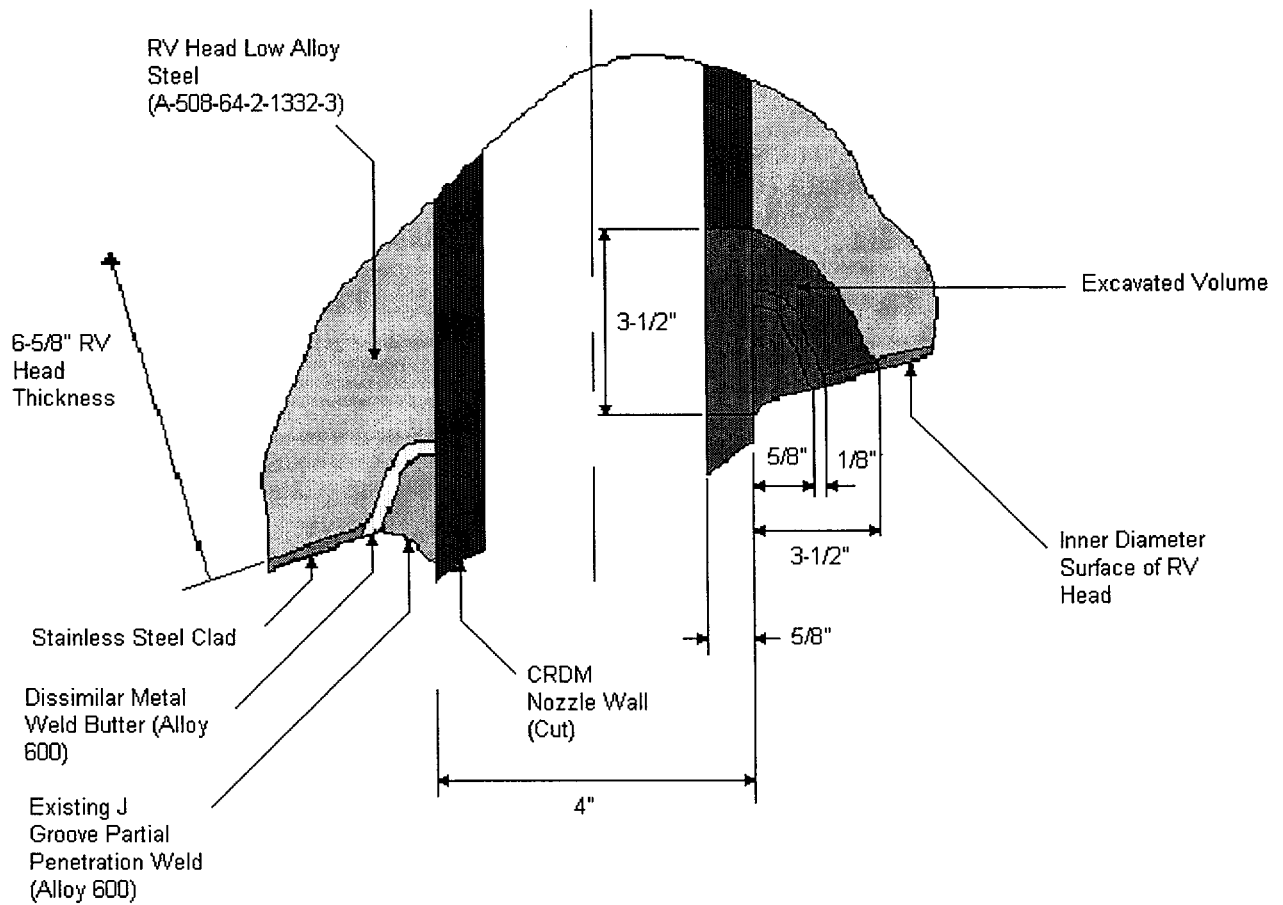
Figure 1
Ocone Nuclear Station
CRDM Nozzle Excavation Detail

To gain access for the repair of the Unit 3 Control Rod Drive Mechanism (CRDM) nozzle Nos. 50, 56, 34 and 63 (if needed¹) in the Reactor Vessel (RV) head and the associated J groove partial penetration welds, it was necessary to excavate up to three inches of the RV head base metal (See Figures 1 & 2)

In order to remove the indications in both the CRDM nozzles and J groove partial penetration welds, manual grinding and arc air thermal cutting were utilized. The depth of the excavation necessary to remove the indications and provide access for weld repair in the nozzle walls and welds resulted in the removal of portions of the RV head low alloy steel beyond the 3/8 inch depth limitation imposed by IWA-4530.

In lieu of the 3/8 inch base metal repair depth limit requirement of IWA-4530, it is proposed that the repair depth limitation be increased to three inches. This increase in the depth limit, while retaining the other restrictions of IWA-4530, would allow repair of the excavations into the RV head, repairs to the CRDM nozzles, and repairs to the J groove partial penetration welds by the temper bead technique per IWA-4532 in lieu of repairs requiring additional post weld heat treatment.

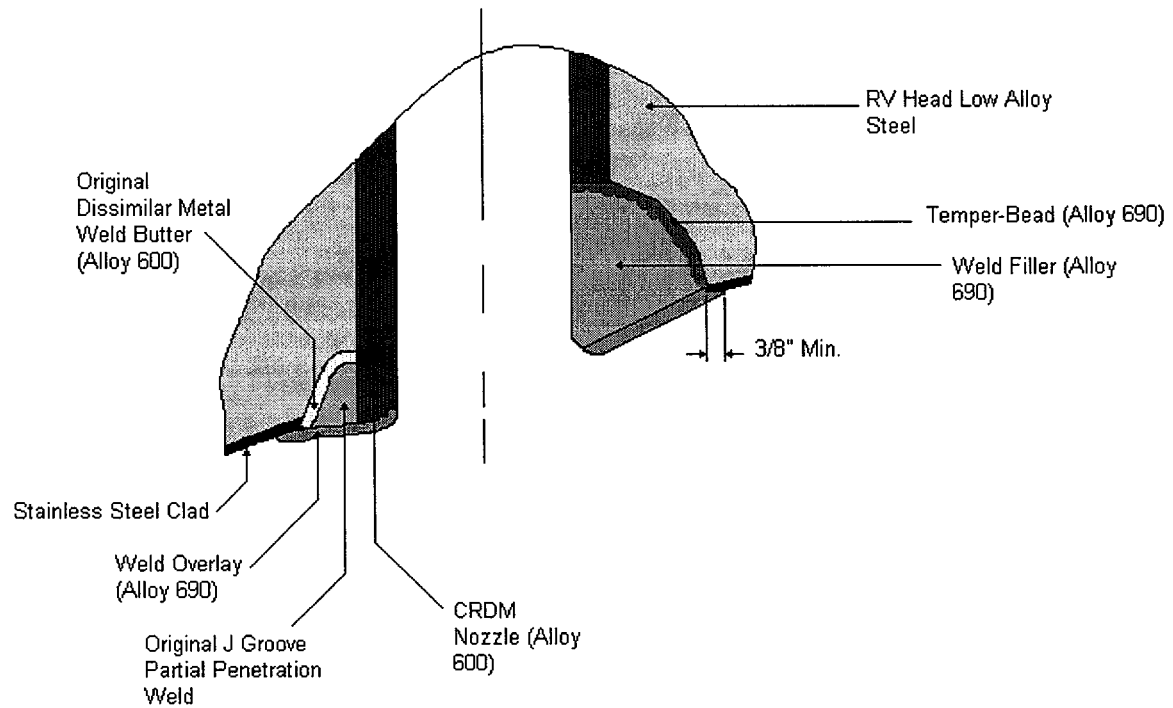
Figure 3
Oconee Nuclear Station

excavations, the similar metal procedure would be used to repair the base metal. For the repairs described herein, the as-repaired geometry (See Figure 3) and the choice of filler metal will satisfy the Section III design rules without fully restoring the base metal to its original geometry. In lieu of restoring the RV head base metal to its original geometry with a similar metal temper bead repair and then completing the attachment weld to the CRDM nozzle with a dissimilar filler material, it is proposed that the dissimilar metal temper bead weld procedure be used to repair the base metal as well as the dissimilar metal weld. The temper bead procedure has been fully qualified for the type repairs described herein. The dissimilar metal temper bead weld procedure will produce an acceptable tempering in the heat affected zone (HAZ) of the base metal. The extent of the HAZ is independent of the excavation limit. However, the HAZ could be a function of the overall depth of repair and therefore, the current IWA-4530 and Procedure Qualification Report (PQR) joint depth limits will be retained. The PQR qualified a similar P43 material (Alloy 600) to that being used in the repair (Alloy 690).

Detail of CRDM Nozzle Repaired Configuration
