# Integrity Assessment for Reactor Vessel Head Penetration Nozzles at B&W-Design Plants

## **Oconee Unit 1 & Unit 3 Reactor Vessel Head Leakage**

**Cracking of RV Head Penetrations  
Due to Primary Water Stress  
Corrosion Cracking (PWSCC)**

M.R. Robinson, Duke Power Company  
April 12, 2001

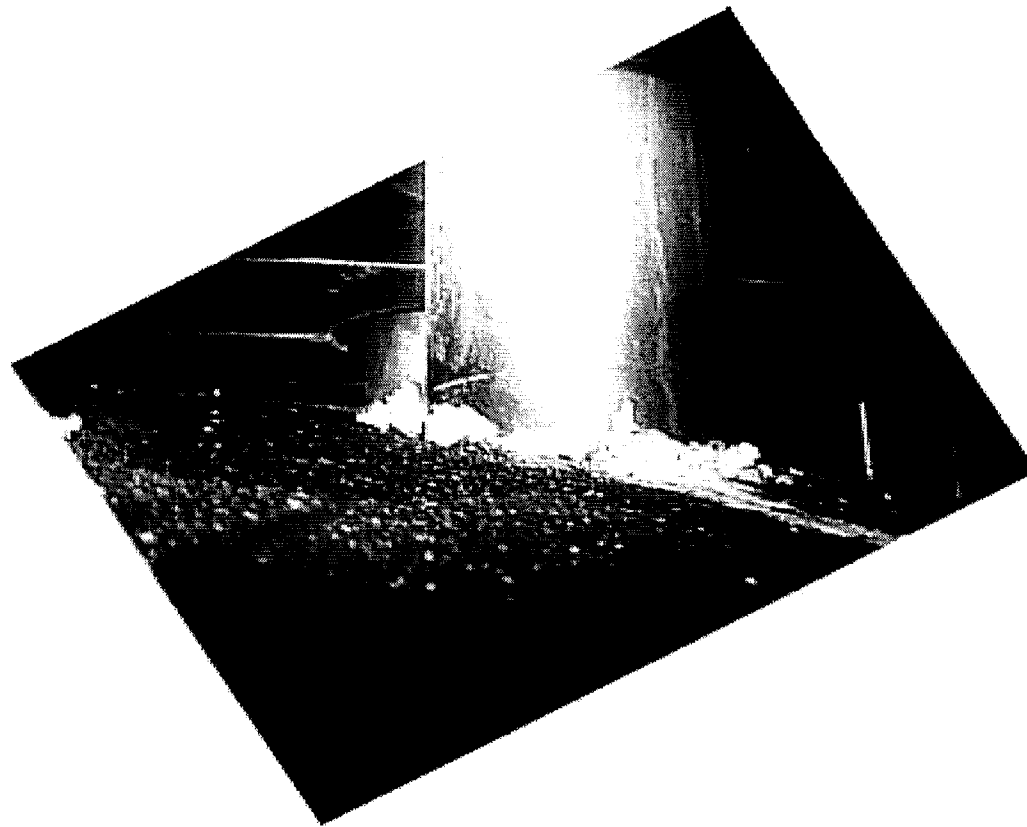
# ONS-1 RV Head Showing Boric Acid At CRDM Nozzle 21

- All eight thermocouple nozzles contained flaws predominantly axial in orientation
  - Five nozzles identified as leaking
  - ID cracking observed on all eight nozzles
  - Cracking penetrated into all eight nozzle welds
- CRDM nozzle 21 did not contain ID flaws
  - Flaws in weld material, predominantly axial/radial in orientation, identified as leak source
  - Flaw propagated through the weld area along the nozzle OD

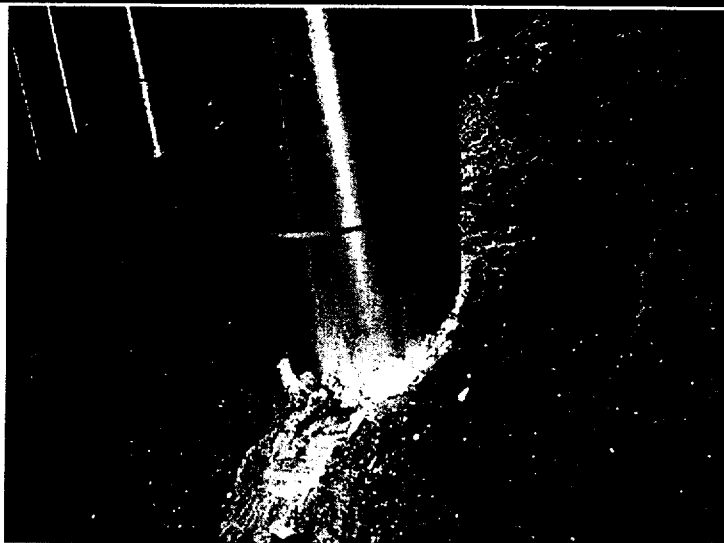
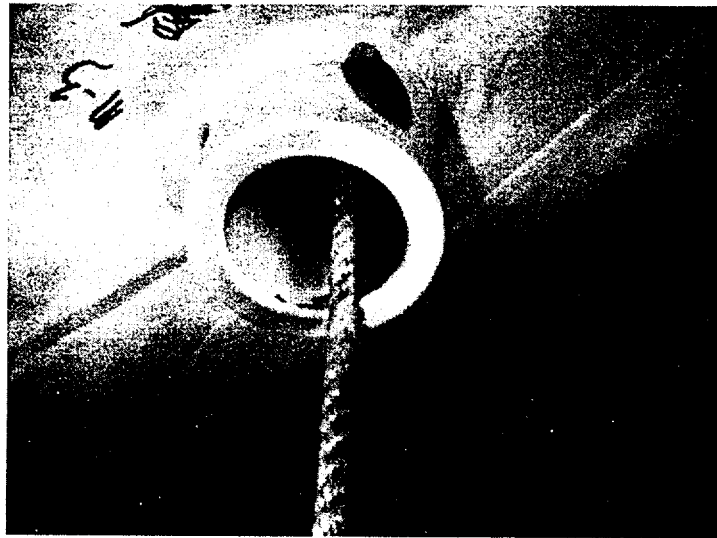
## CRDM Nozzle #56

- CRDM nozzle 56 found leaking
  - No ID axially oriented flaws identified
  - One OD-initiated circumferential flaw that turned axial identified
  - Flaw propagated through the weld area along the nozzle OD

Nozzle	
#56	<ul style="list-style-type: none"> <li>3 Axial and 1 Circumferential Cracks</li> <li>1 axial thru wall, One 38% thru wall, One 11% thru wall</li> <li>Thru wall is 1.7" long, mid depth .75" long, shallow is 1.6" long</li> <li>Circ crack above weld near high side and about 2.4" long</li> </ul>
#3	<ul style="list-style-type: none"> <li>7 Axial and no circumferential cracks</li> <li>No Axial thru wall, all between 33% and 65% thru wall</li> <li>All between .3" and 1" long</li> <li>Areas of crazed cracking below weld at high side</li> </ul>
#7	<ul style="list-style-type: none"> <li>1 Axial and no Circumferential Cracks</li> <li>Axial is 87% thru wall, 2.3" long</li> <li>Areas of crazed cracking below weld at high side</li> </ul>

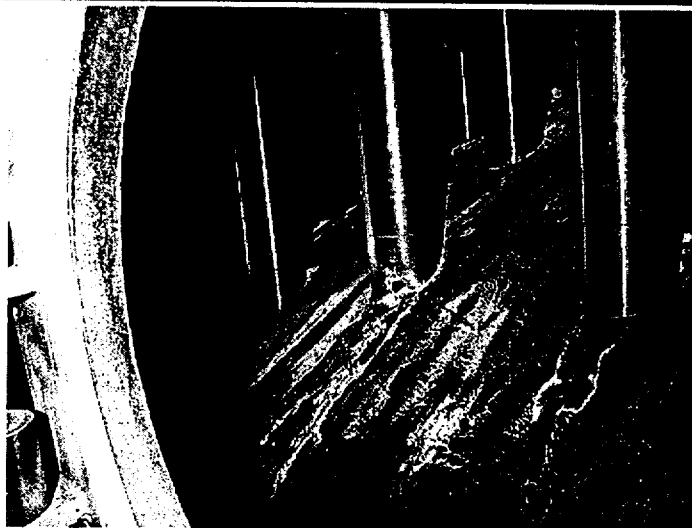
## CRDM Nozzle #50

- ◆ Discovered during post weld repair NDE of Nozzles 50 & 56
- ◆ Circumferential cracks followed the weld profile contour and were O.D. initiated.
- ◆ Both ECT and UT inspections identified indications in these areas but were dispositioned as crazed cracks with unusual characteristics
- ◆ The original NDE characterization for nozzles 50 and 56 subsequently changed.
- ◆ This change in interpretation of the NDE signals is related to the flaw orientation with respect to the sound beam of the UT search units.
- ◆ Actions taken as a result of this discovery were:
  - All Unit 1 and 3 ECT and UT data has been re-reviewed applying the LLs
  - EPRI NDEC is leading an independent review of ONS 1 & 3 data to confirm results and findings

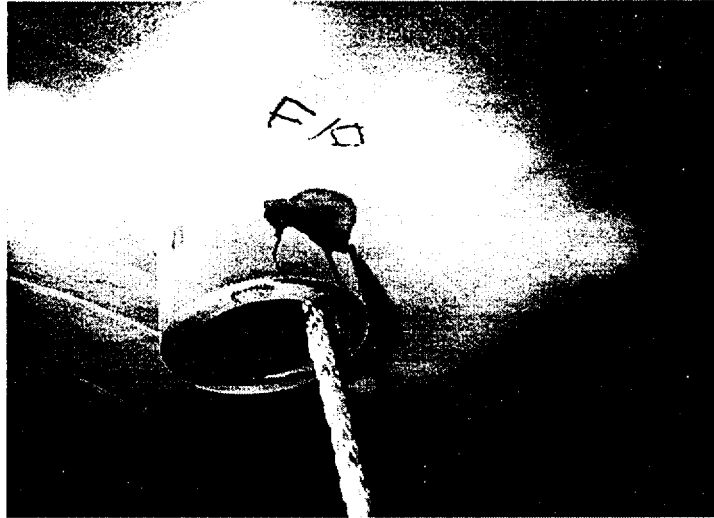
## CRDM Nozzle #11

Nozzle	
# 11	<ul style="list-style-type: none"> <li>7 Axial and 3 Circumferential Cracks</li> <li>3 Axial thru wall, 2 &gt; 75% thru wall, 2 about 50% thru wall</li> <li>3 thru wall are 3" long, 2 &gt; 75% are 3" long, 2 about 50% &lt; 1" long</li> <li>All circ below weld, 1 is 10%, 1 is 57%, 1 is 70% thru wall</li> <li>Deep circ crack is about 5.3" long, mid circ crack is 3.9" long</li> <li>Areas of craze cracking above and below weld at high side</li> </ul>
#23	<ul style="list-style-type: none"> <li>6 Axial and 2 Circumferential Cracks</li> <li>2 Axial thru wall, 4 are 30% to 67% thru wall</li> <li>2 thru wall are .6" and 3.8" long, 4 are 0.5" to 1.1" long, both circ below weld, 1 is 77% thru wall, other is 67% thru wall</li> <li>Circ cracks are about 2" long</li> <li>Areas of crazed cracking above weld at high side</li> </ul>

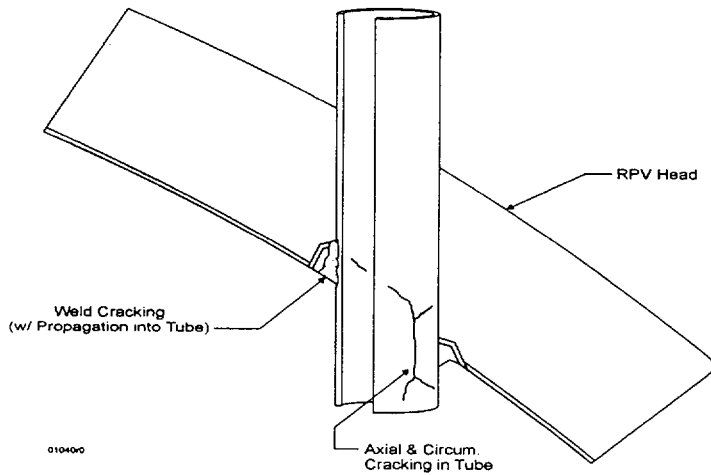
## CRDM Nozzle Cracks at ONS 1 & 3

- ♦ Total of 48 indications in the nine leaking CRDMs
  - 39 are axial and located beneath the weld at the uphill and downhill
  - 16 indications thru wall (39%); all are axial, and occur on 6 of 9 nozzles
- ♦ Confirmed two (2) above the weld circumferential cracks
  - Nozzle 56 crack was thru wall
  - Nozzle 50 except for pin hole indications on ID was not thru wall
  - Inspection and metallurgical results indicate the circumferential cracks were O.D. initiated.
- ♦ Unit 3 CRDMs extent of condition inspections (9 additional nozzles):
  - Cluster indications above and/or below the J groove weld.
