UNITED STATES
NUCLEAR REGULATORY COMMISSION
WASHINGTON, D.C. 20555-0001
April 20, 2001

FACILITY: Sequoyah Nuclear Plant, Unit 1

SUBJECT: SUMMARY - APRIL 11, 2001, MEETING REGARDING SEQUOYAH UNIT 1
STEAM GENERATOR INSPECTION PLAN FOR CYCLE 11 REFUELING
OUTAGE

Steam Generator Inspection
Unit 1 End of Cycle 11
Less Than 2 Volt Dents

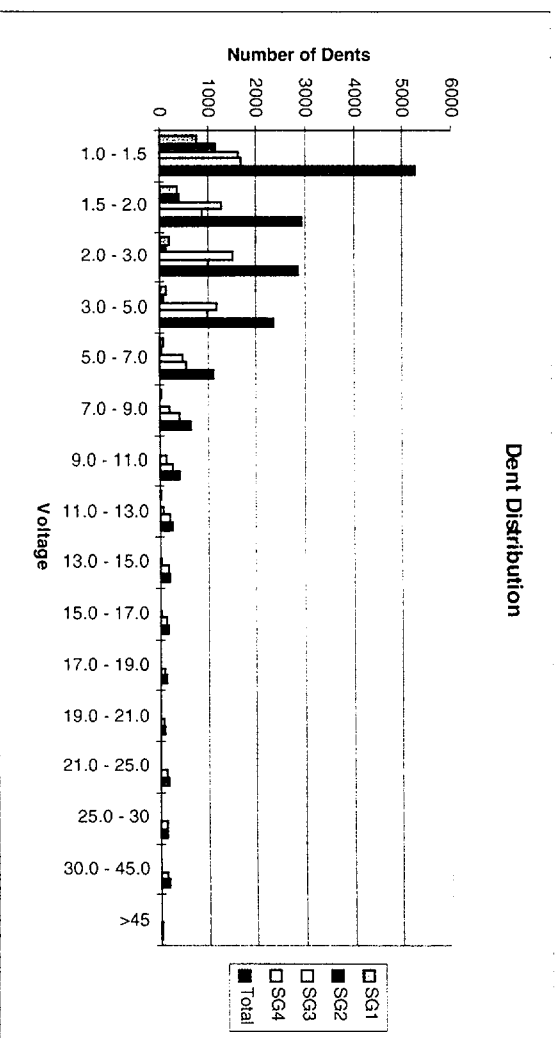
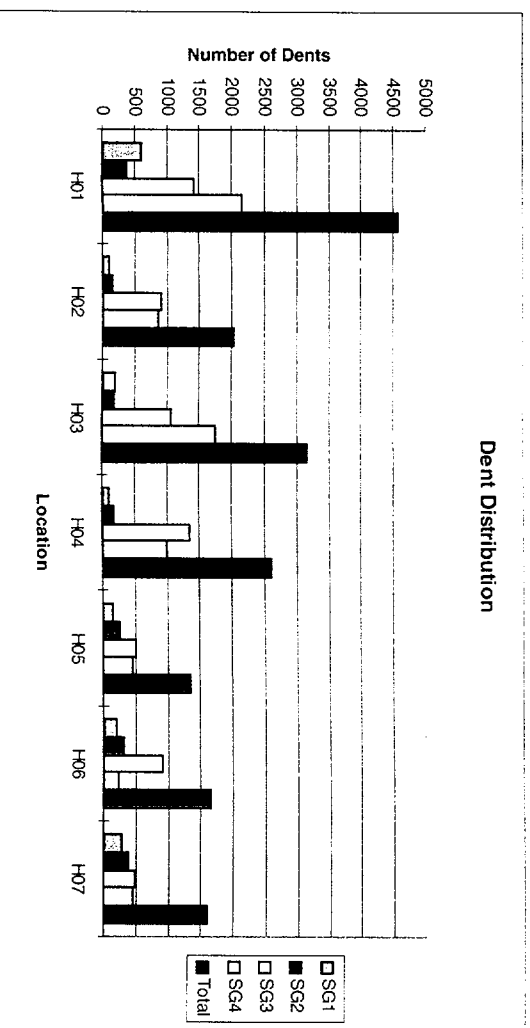
Population of Dented Intersections

- **After the U1C10 inspection, the population of dents below 2 volts were evaluated**
 - Due to NRC's concerns, a population of dents below 2 volts was defined
 - The population below 1 volt is inconclusive and subjective as to whether a dent exists or not

- **The new threshold for Sequoyah Unit 1 will be 1 volt**
 - Dented intersections greater than or equal to 1 volt will be inspected in all 4 steam generators
 - ✦ *15,774 dent inspections with plus point compared to base scope of 8,360 at end of Cycle 10*
 - No circumferential crack has been identified in a dent less than 1.5 volt
- **Bobbin calls will continue to be plus point inspected regardless of dent voltage**
 - 1,647 additional plus point exams were performed end of Cycle 10

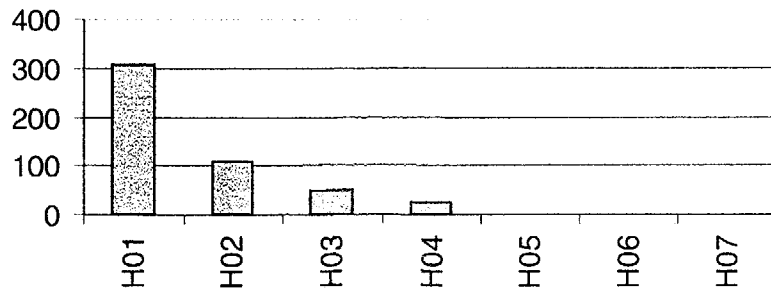
Cycle 7 - Cycle 10 ID Axial Indications vs Location

Cracking at Dented Intersections

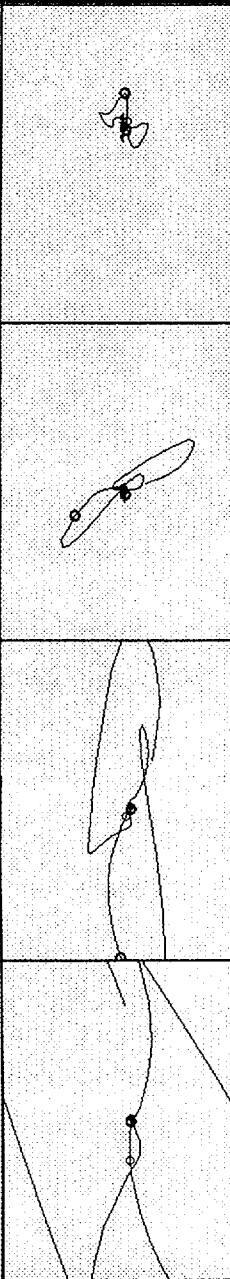
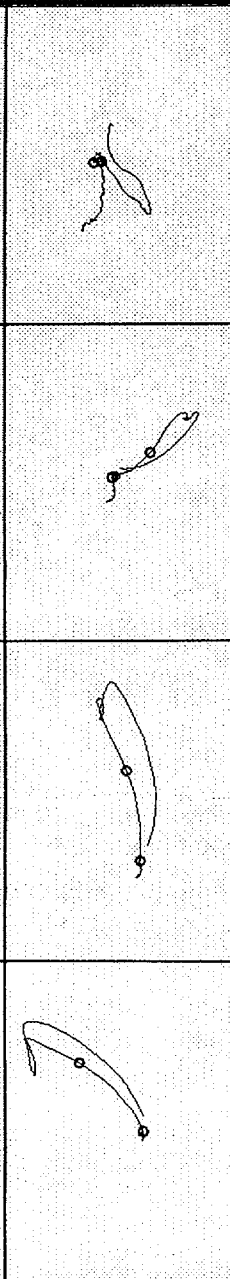
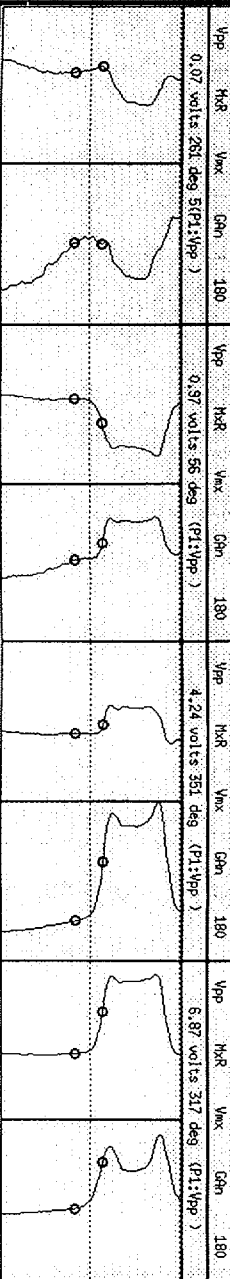
0.47 volt burst
occurs 1000 Hz
below output port
