Subject: Oconee Nuclear Station, Unit 3  
Docket Nos. 50-287  
Licensee Event Report 287/2001-001, Revision 0  
Problem Investigation Process No.: O-01-00587

**Reactor Pressure Vessel Head Leakage Due to Stress Corrosion Cracks Found in Nine Control Rod Drive Nozzle Penetrations**

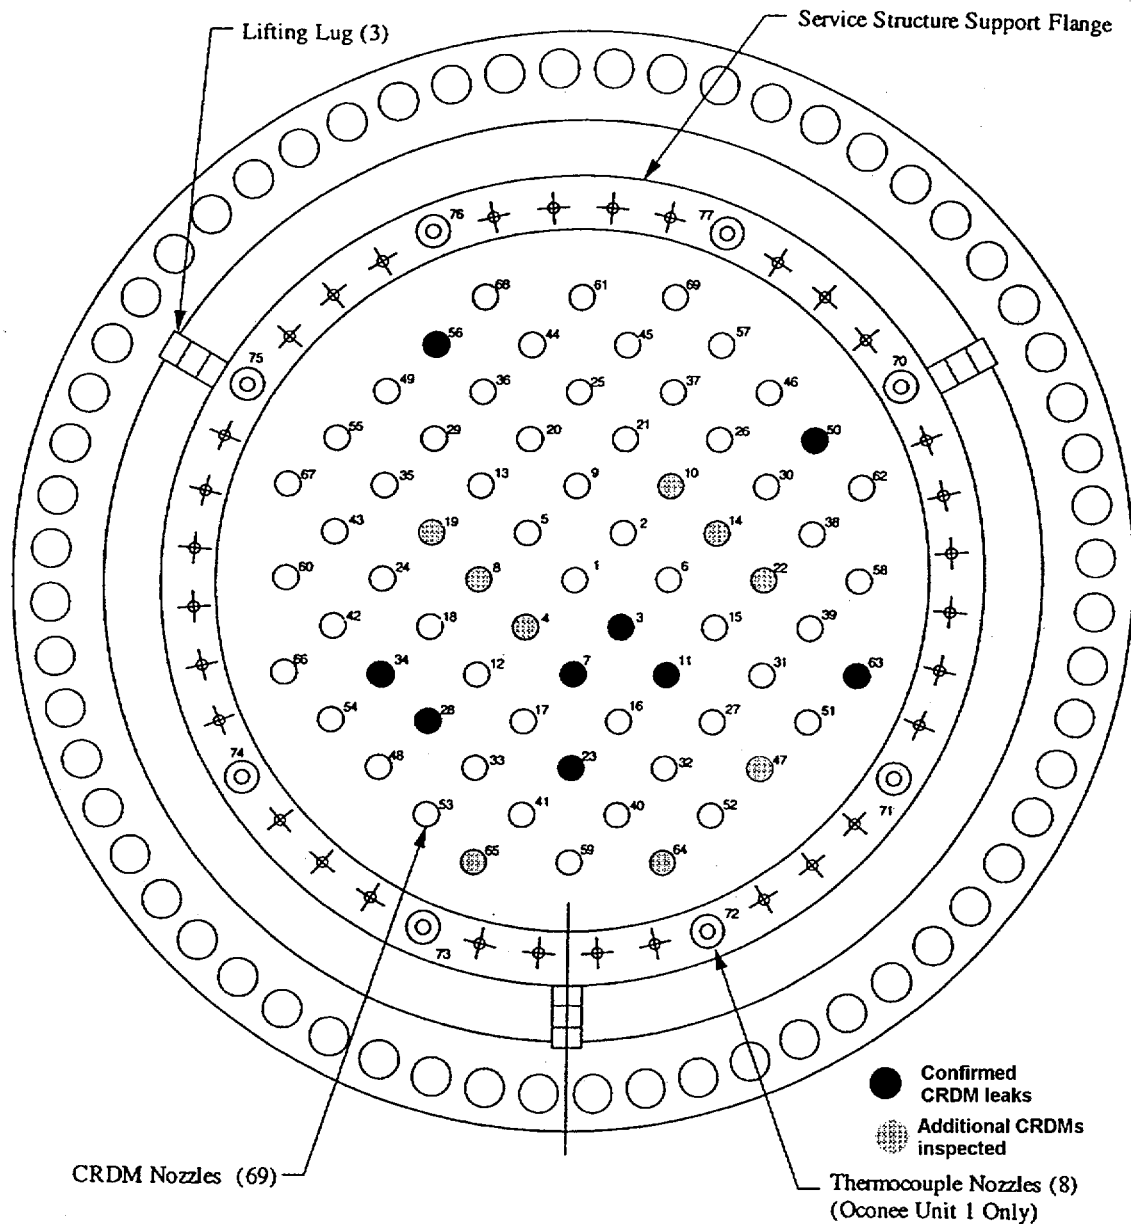
Figure 1

The boric acid deposits were identified around nine (Nos. 3, 7, 11, 23, 28, 34, 50, 56, and 63) of the sixty-nine total CRDM nozzles. The amount of boric acid around each of the CRDM nozzles was estimated to be no more than a few cubic inches but ultimately signified that reactor coolant system pressure boundary leakage had occurred. After confirming that the Reactor Coolant System (RCS) pressure boundary had been compromised, a February 18, 2001, 8-hour notification was made to the Staff in accordance with 10CFR50.72(b)(3)(ii)(B) reporting requirements. Subsequent non-destructive testing was performed on a total of eighteen CRDMs in order to effectively evaluate, characterize the leak mechanism, and determine extent of the condition.

In addition to the original nine leaking CRDMs, nine additional nozzles (Nos. 4, 8, 10, 14, 19, 22, 47, 64 and 65) from the same heat<sup>1</sup> of material as the initial nine CRDMs were EC and UT inspected for "extent of condition" purposes (see Figure 1). Results of this inspection are also given in Attachment 1.

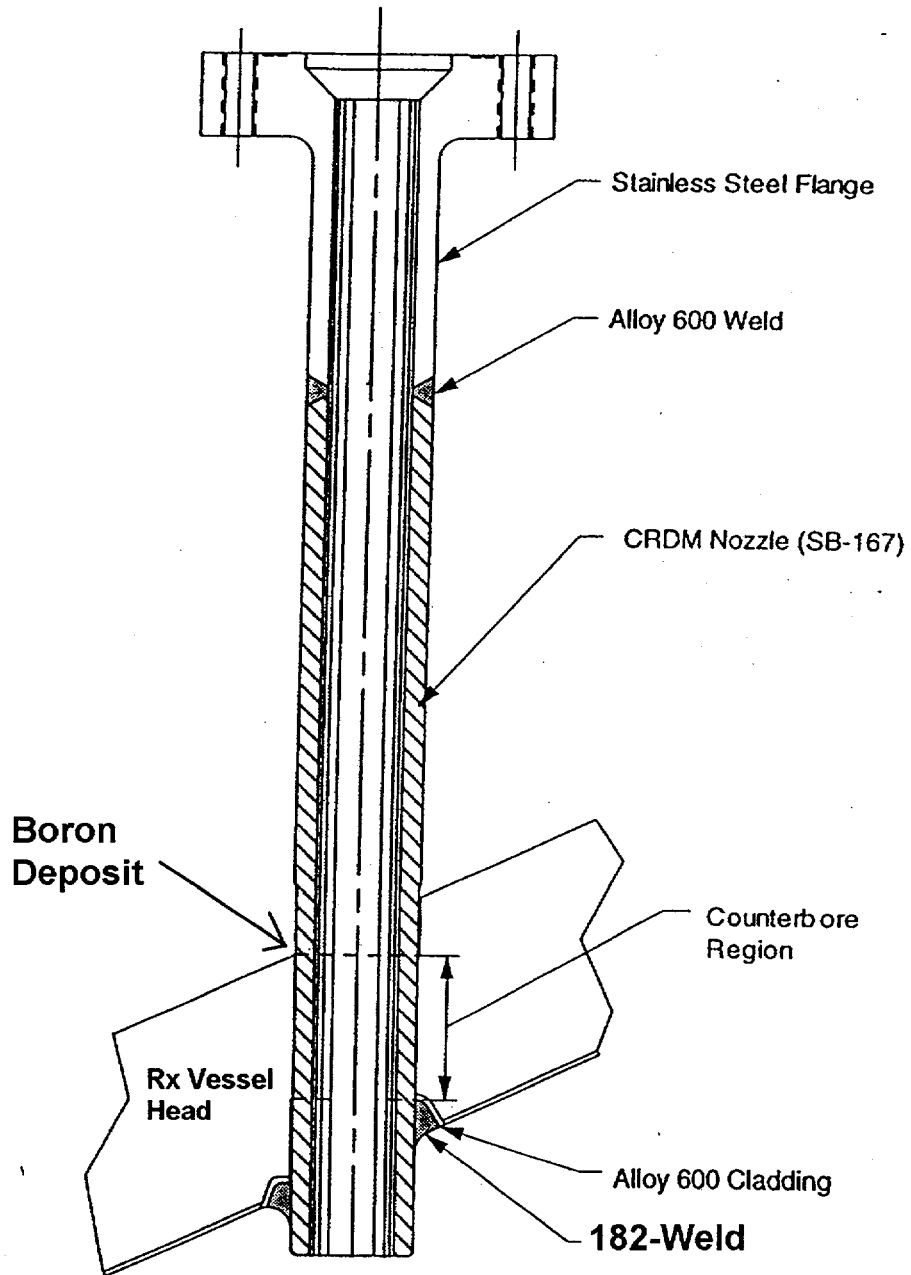
Figure 2

There are 69 Control Rod Drive Mechanism (CRDM) [EIS:AA] nozzles [EIS:NZL] that penetrate the reactor pressure vessel (RPV) [EIS:RCT] head (see Figure 1). The CRDM nozzles are approximately 5-feet long and are welded to the RPV head at various radial locations from the centerline of the RPV head. The nozzles are constructed from 4-inch outside diameter (OD) alloy 600 material. The lower end of the nozzle extends about 6-inches below the inside of the RPV head (see Figure 2).

Subsequent surface dye-penetrant test (PT) inspections of the nine nozzles' weld area and Outside Diameter (OD) identified several deep axial cracks that had initiated near the toe of the fillet weld had propagated radially into the nozzle material as well as axially along the OD surface. Some of these cracks had reached the bottom end of the CRDM nozzle housing. These potentially deep cracks were the most likely leakage pathway that lead to the visible accumulations of boric acid crystals found on the Unit 3 RPV head. Eddy Current (EC) examination of the nine leaking CRDM nozzles revealed cracks on several of the nozzles.

PWSCC is generally thought to initiate at the nozzle inside surface adjacent to the partial penetration J-groove welds. This area has been shown to have high residual stresses resulting from the weld process and, in some cases, from surface distress due to machining, grinding or reaming operations. In thin wall product forms, this area could also have an altered microstructure from welding (weld heat affected zone). It is well established that PWSCC can occur in materials provided that three conditions are present:

The general repair process was to remove all crack indications and weld repair the individual excavation(s) for each CRDM nozzle. The cracks were first ground out of the nozzle material (initially by manual grinding, later by air arc gouging followed by shallow surface grinding), sometimes exposing a small area of low alloy steel base metal for some nozzles. The final surface was PT examined prior to preheating for the weld repair process.

Following weld repair of the individual excavations, a protective weld overlay of alloy 52/152 material (alloy 690 type) was deposited over the CRDM repairs where original weld material (82/182 alloy 600) remained after the repair process. Five of the repaired nozzles (Nos. 3, 7, 11, 50, and 56) had this protective overlay. Nozzles 23, 28, 34, and 63 did not require a weld overlay since the entire weld was replaced with 52/152 material. This nonstructural weld material acts as a protective layer to the existing material, improving its resistance to PWSCC attack.
