SUBJECT: TEXAS FOLLOW-UP INVESTIGATION REPORT FOR EVENT
NOTIFICATION NO. 37542 AND NMED ITEM NO. 000886

Attached is information provided by the State of Texas about the investigation of the incident involving the shipment of Ir-192 brachytherapy seeds from Baylor University Medical Center, Dallas, Texas to Best Industries of Springfield, Virginia.

Incident Report
Shipment of Ir-192 Sealed Sources
Texas Department of Health Incident Number 7675

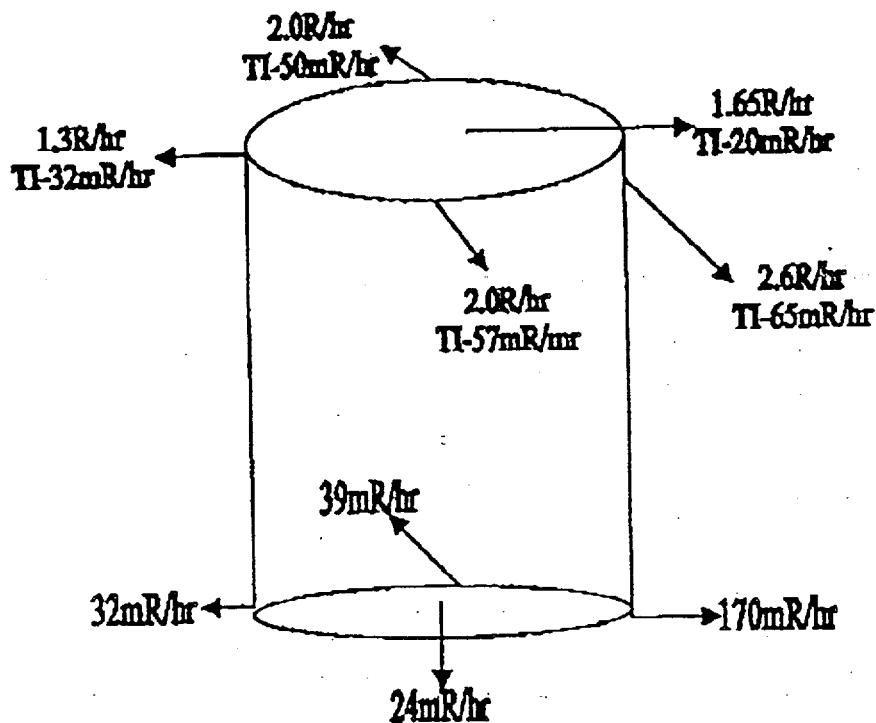
Drum Survey From Baylor University Medical Ctr.

All swipes were relative to background (see Attached)

Enclosure 1: Radiation levels on
Package, determine by Best Industries,
Springfield, Virginia

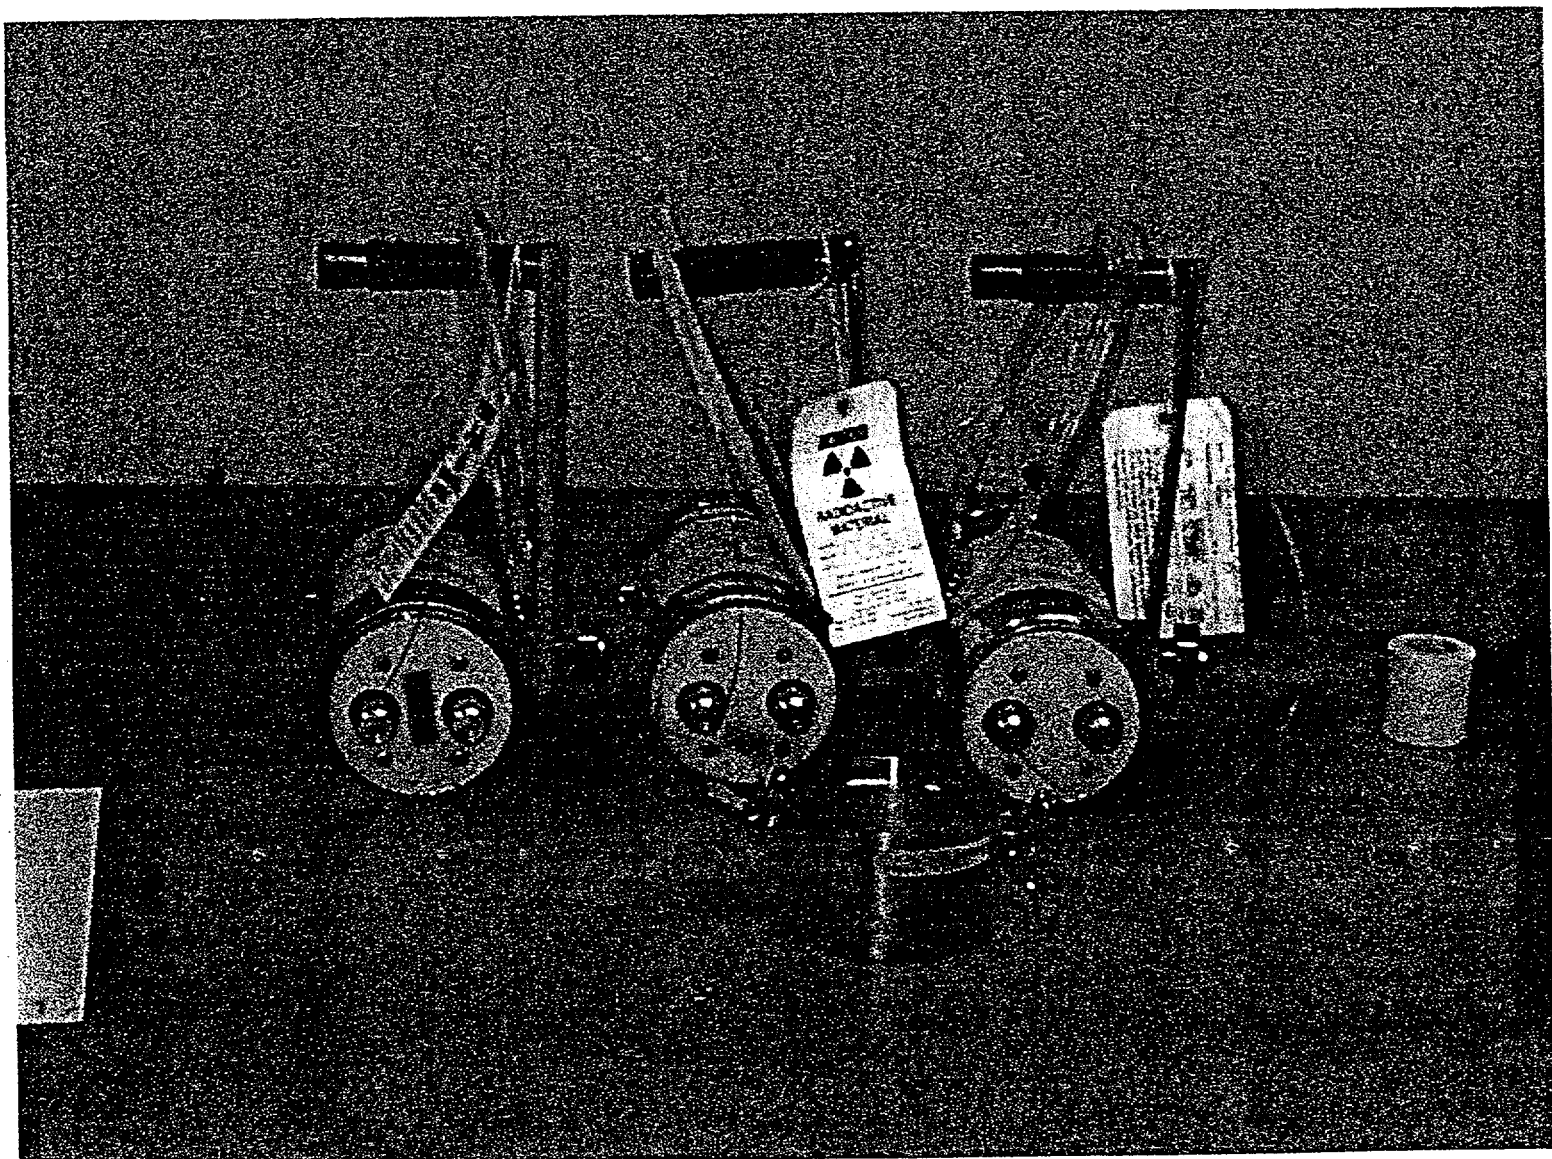
Enclosure 2: Three Pigs used to ship
—IR-192 seeds. From left to right, 6- —
seeds, 10-seeds, and 14-seeds.

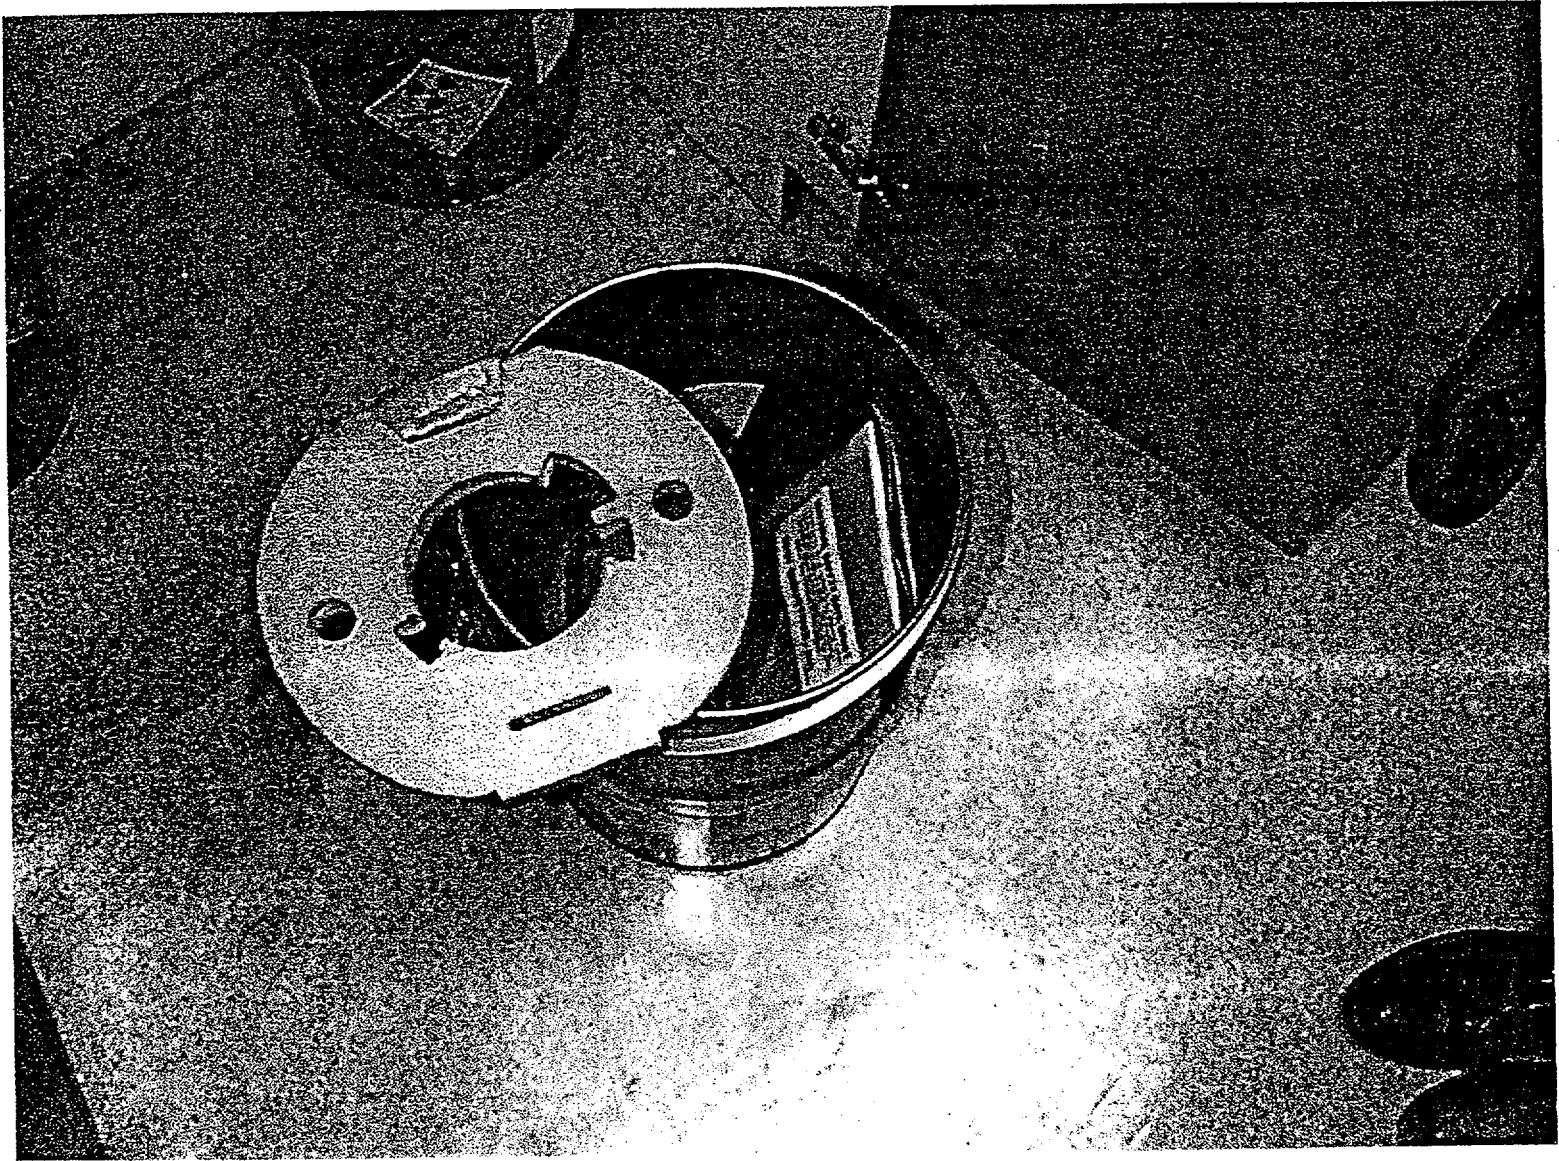
Encolusre 3: Interior view of shipping
-container, with packing material.

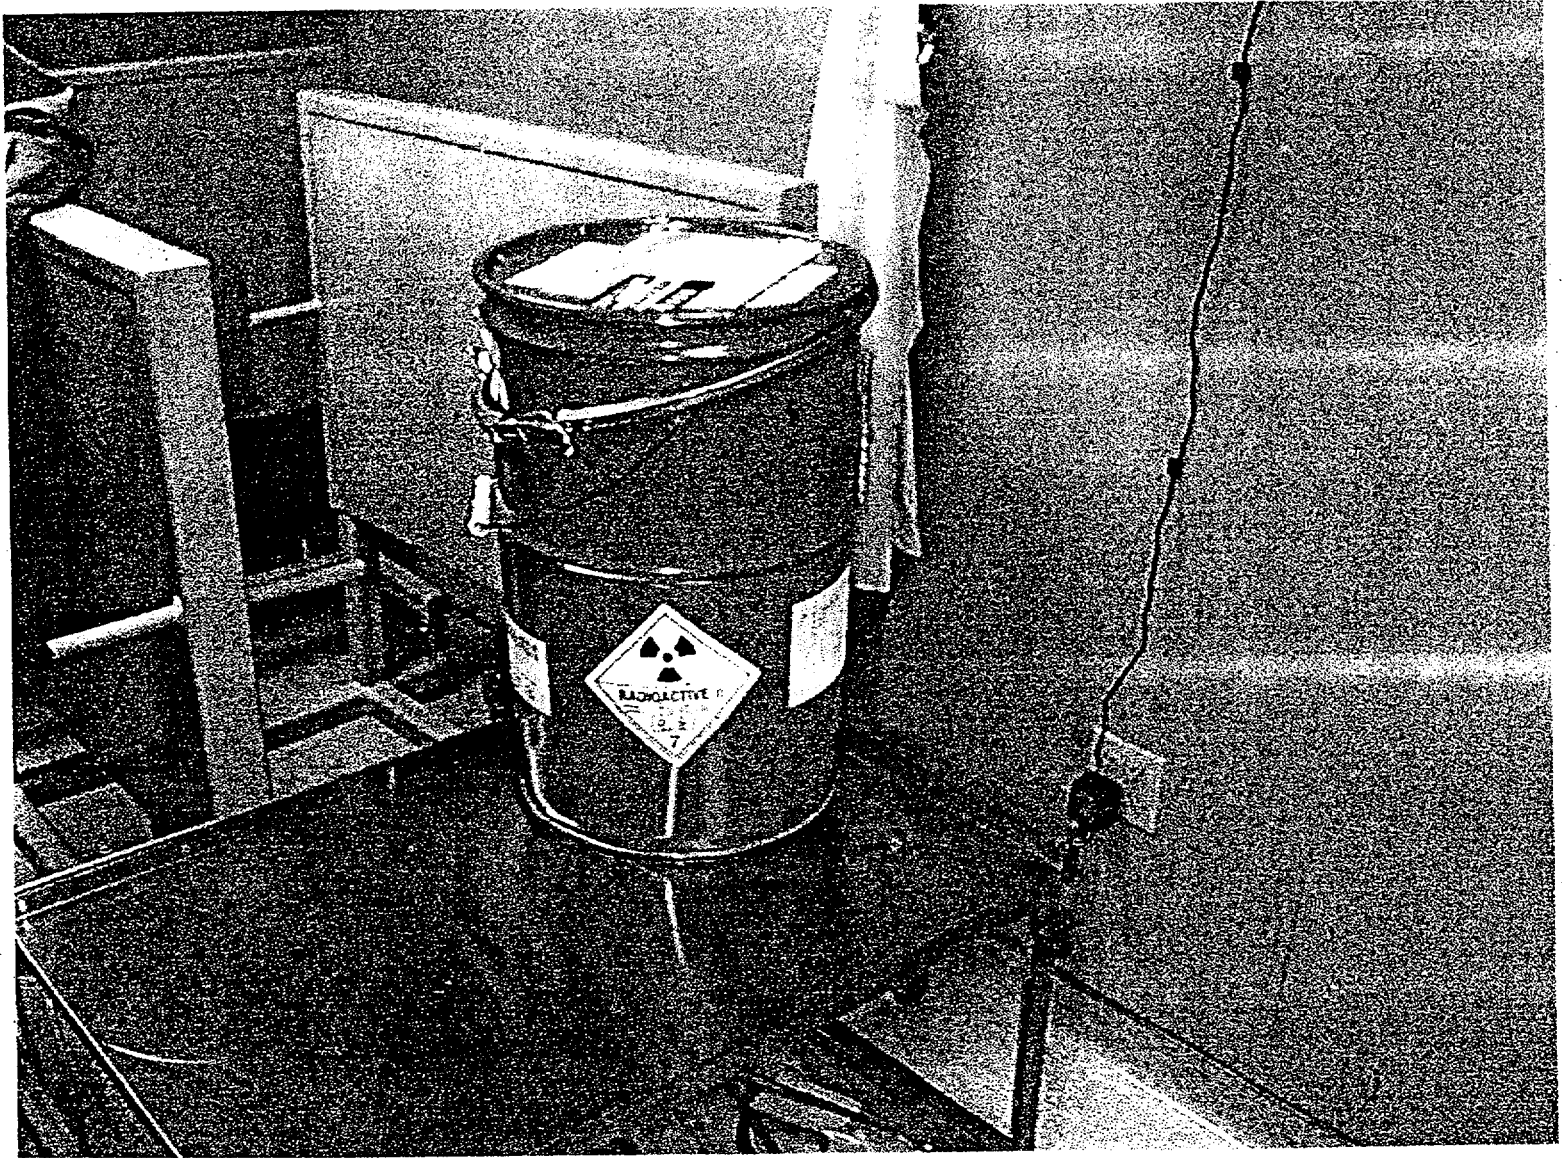
Enclosure 4: Type 7A shipping
container.

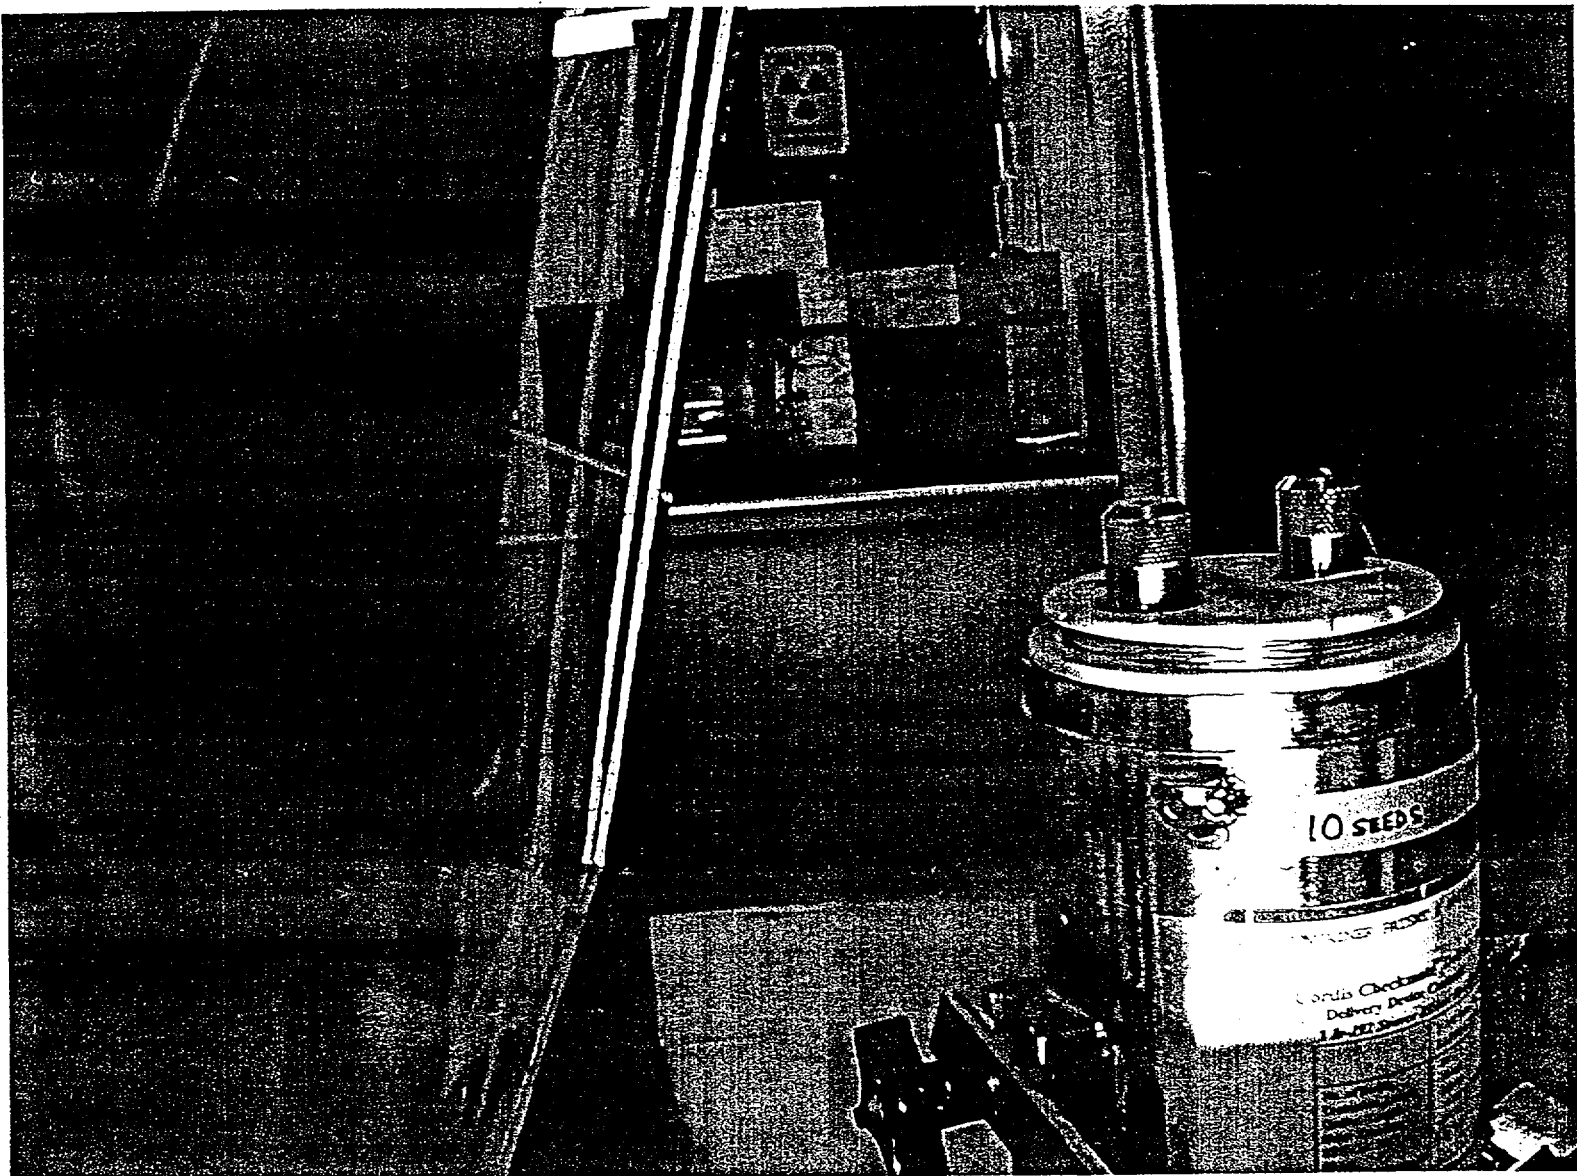
(See photos at Enclosures 8, 9, 10, and 11 of the delivery device in a glovebox during unpackaging.) These photos demonstrate that the nylon ribbon is: secure at the knurled knob (Enclosure 8); tightly wrapped around the reeling device (Enclosure 9); apparently not showing any color on the visible ribbon (Enclosure 10); and showing approximately four seeds which "popped" out of the locking mechanism when the lock was released with tension still on the reeling device (Enclosure 11).

The source ribbon was clearly improperly packaged, as the knurled nut was tight upon arrival at Best Industries and the reeling device remained in the tightened position. So an in-transit accidental release of the seeds from the shipping devices can safely be ruled out in this incident. This conclusion points to a problem in the packaging and survey of the shipment before leaving the Baylor University Medical Center's Hotlab (See photos at Enclosures 12, 13, 14 and 15).

Enclosure 8: 10-seed Pig in glovebox
—at Best Industries, demonstrating
security of ribbon upon arrival.

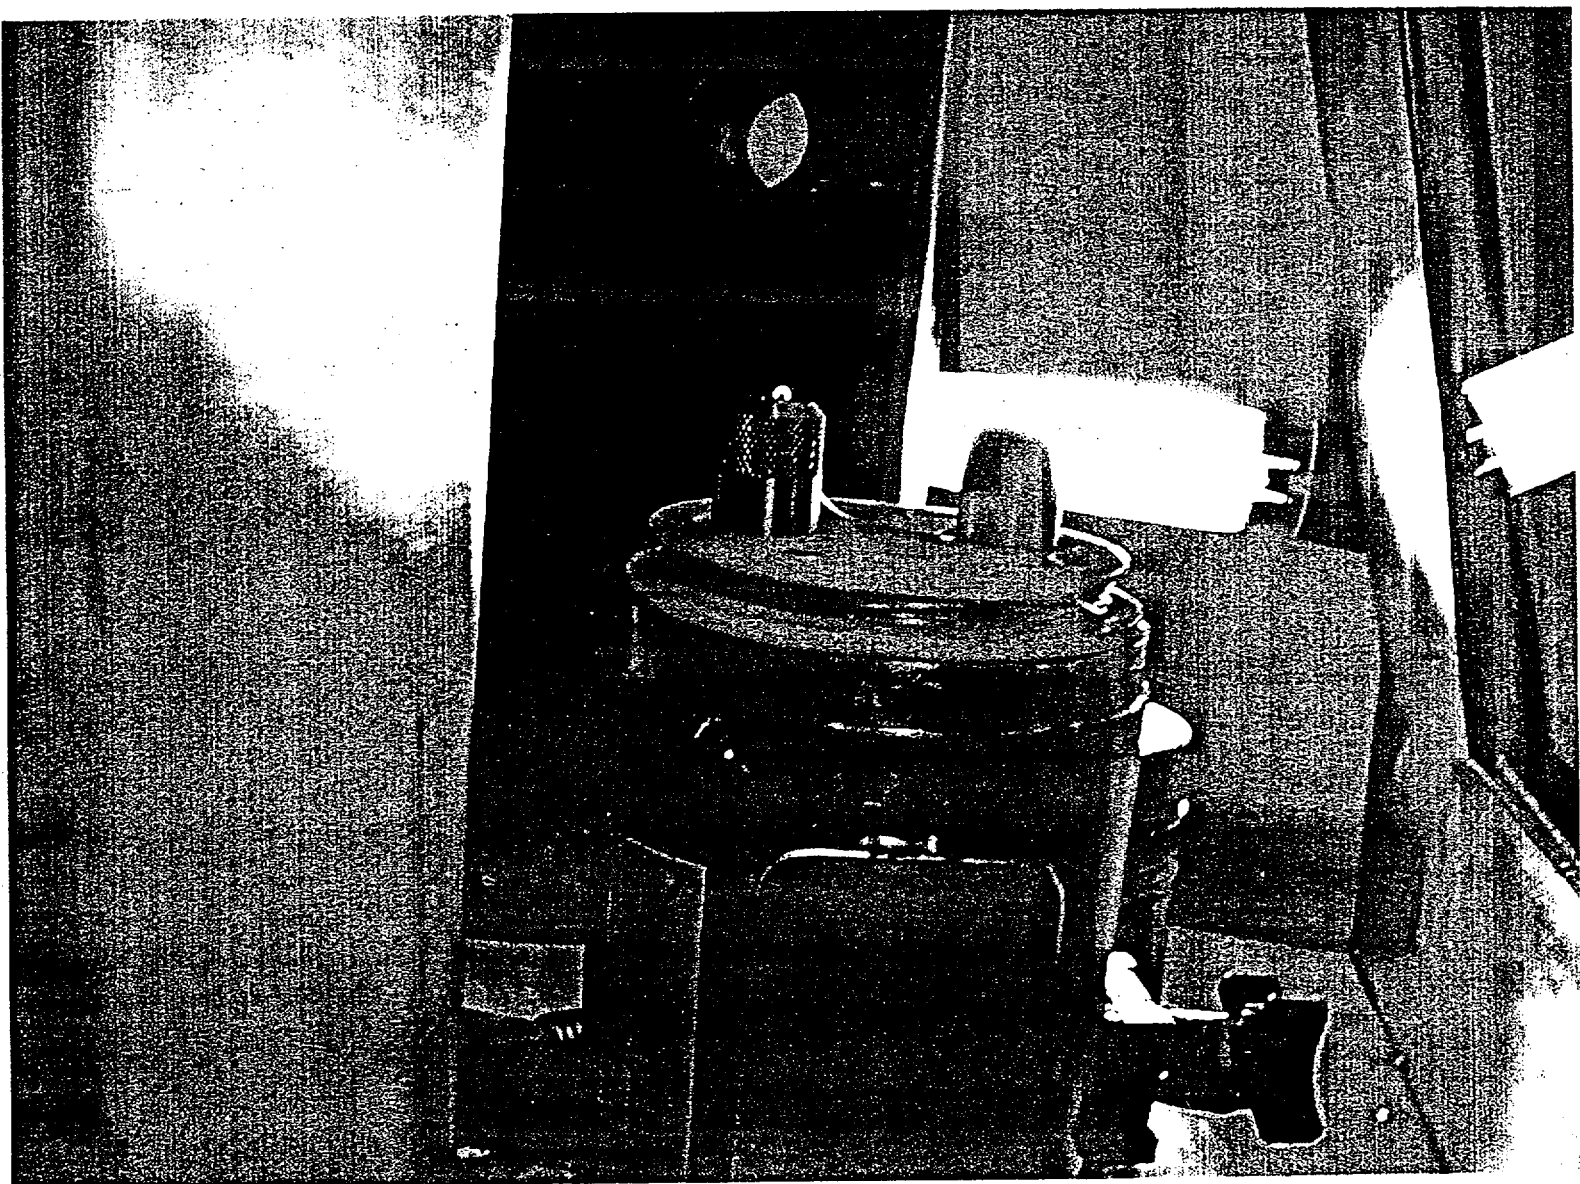
Enclosure 9: 10-seed Pig at Best
Industries, demonstrating ribbon
secutiry on reeling device.

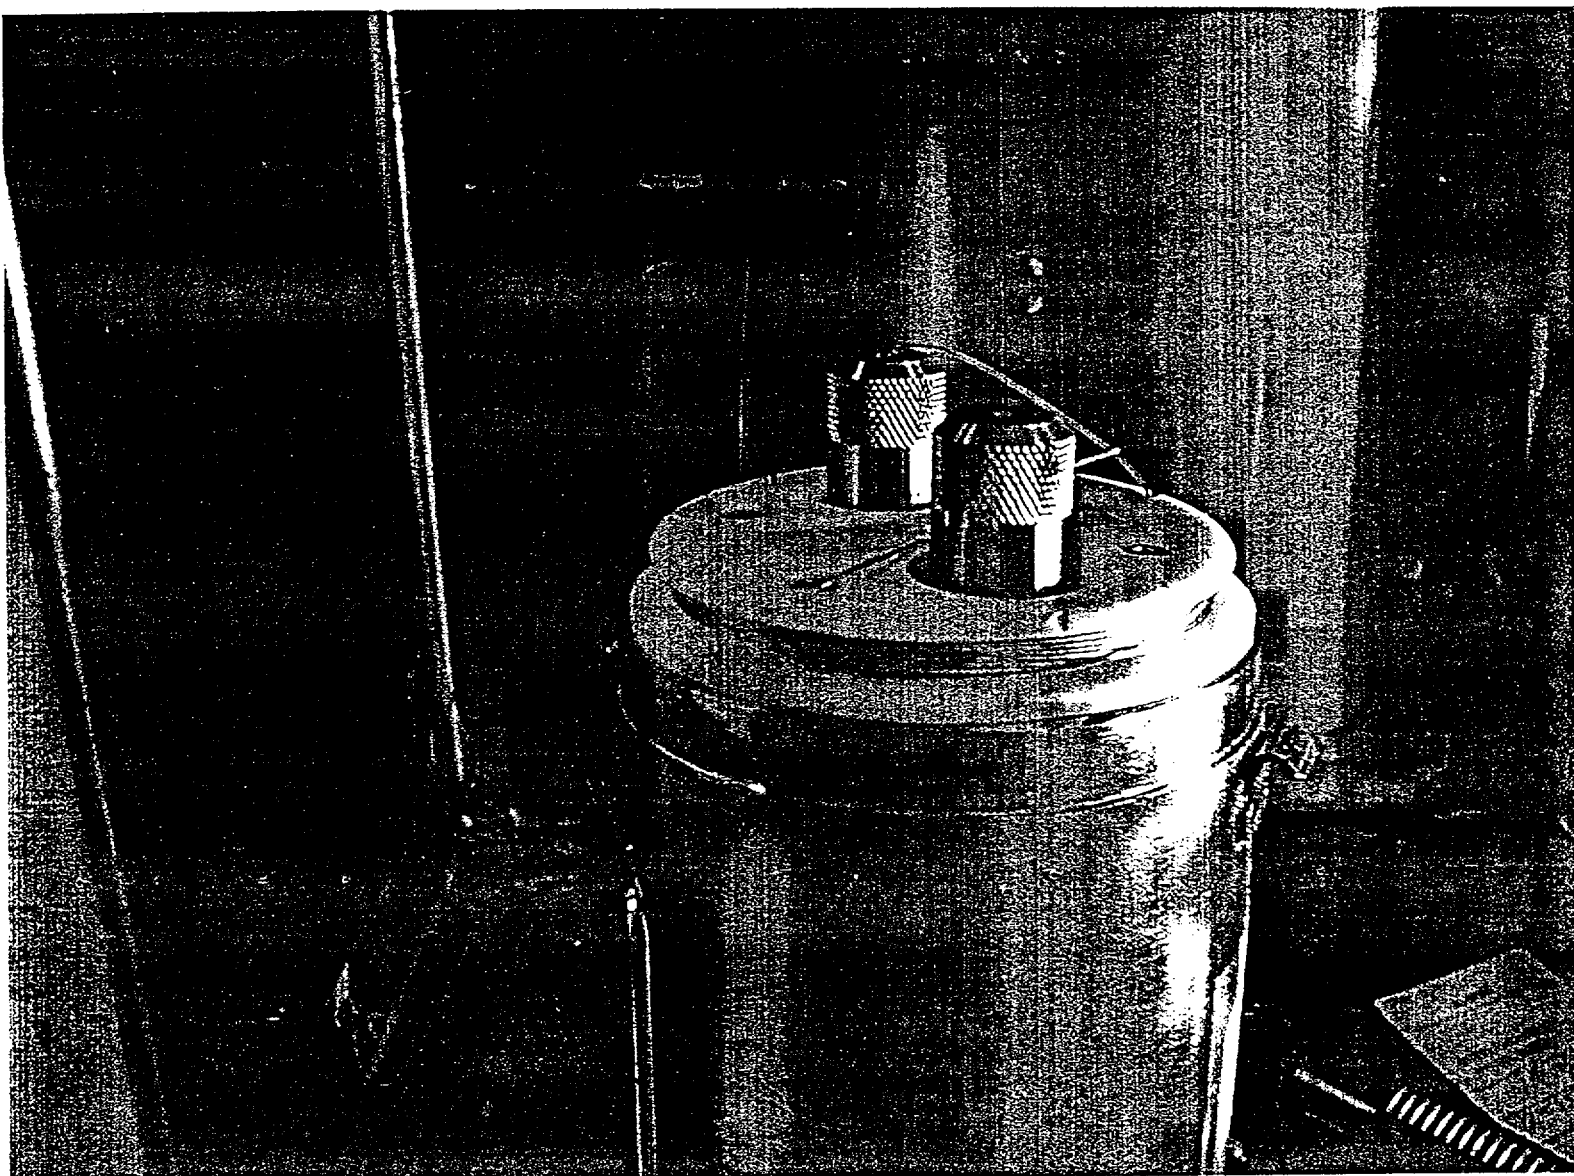
Enclosure 10: 10-seed Pig at Best
—Industries showing lack of color on
secure ribbon. —

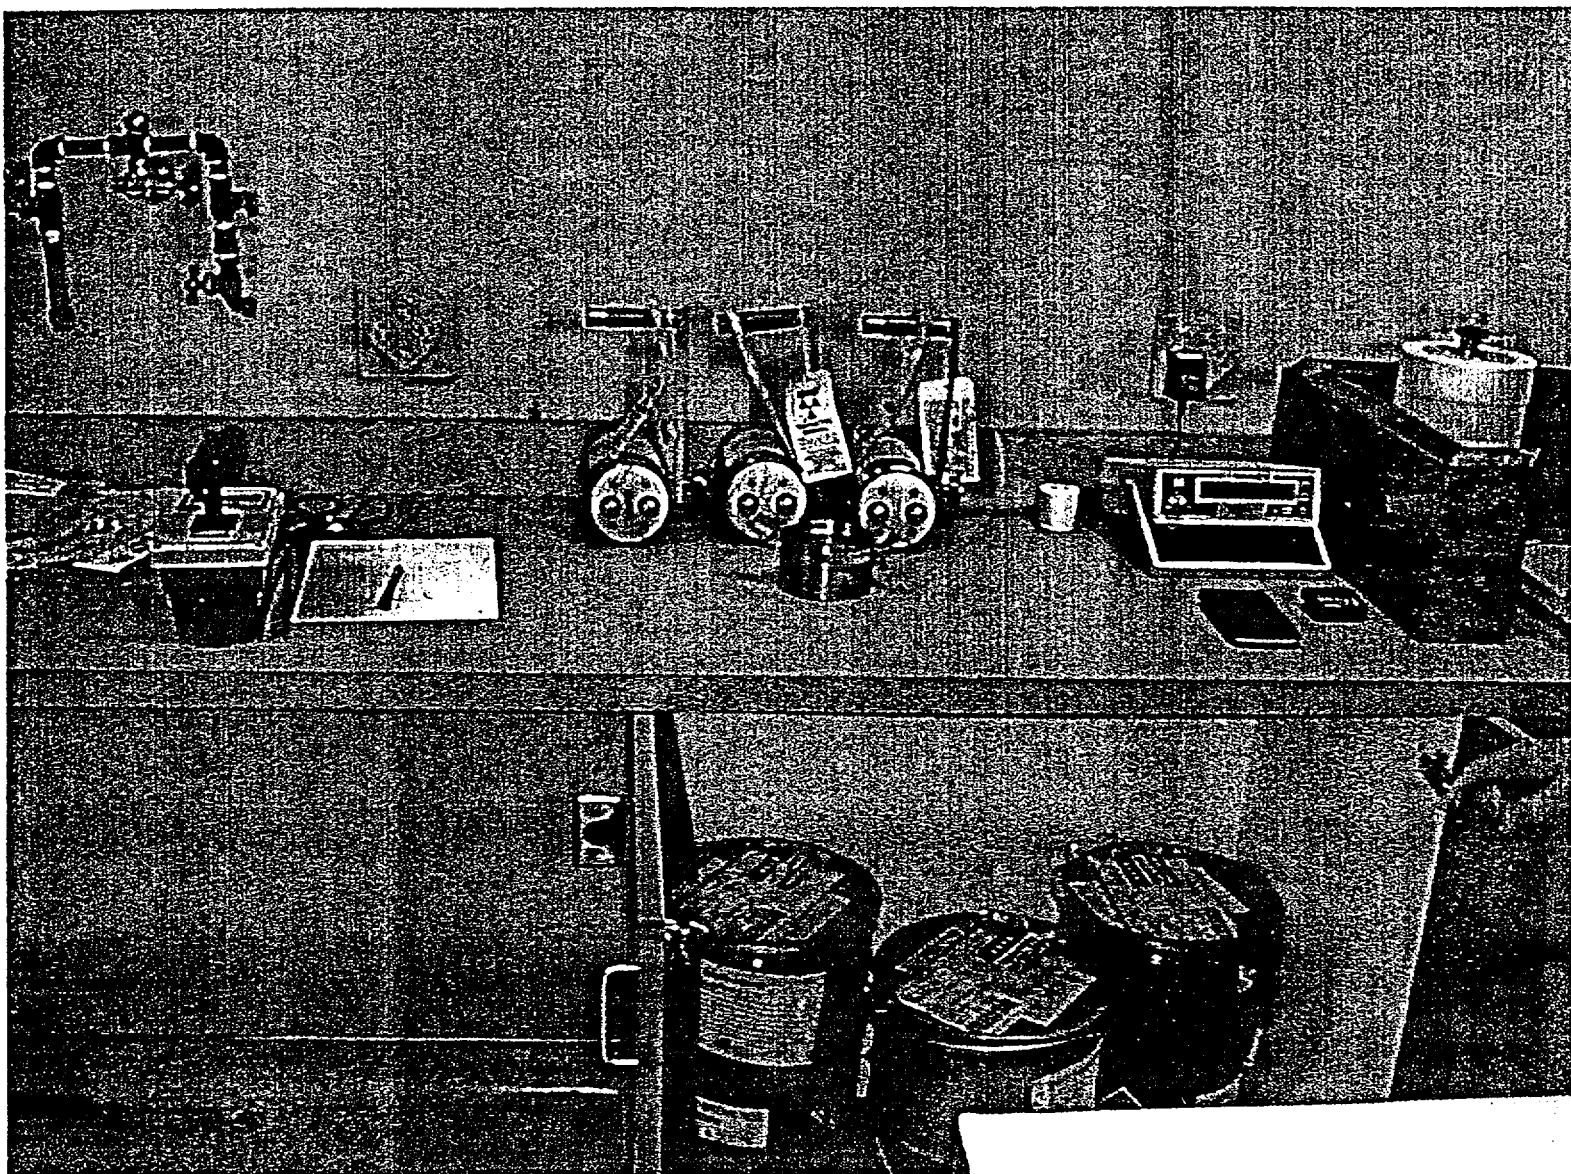
Enclosure 13: Interior of Baylor
Hotlab with Pigs on the counter and
showing container storage.

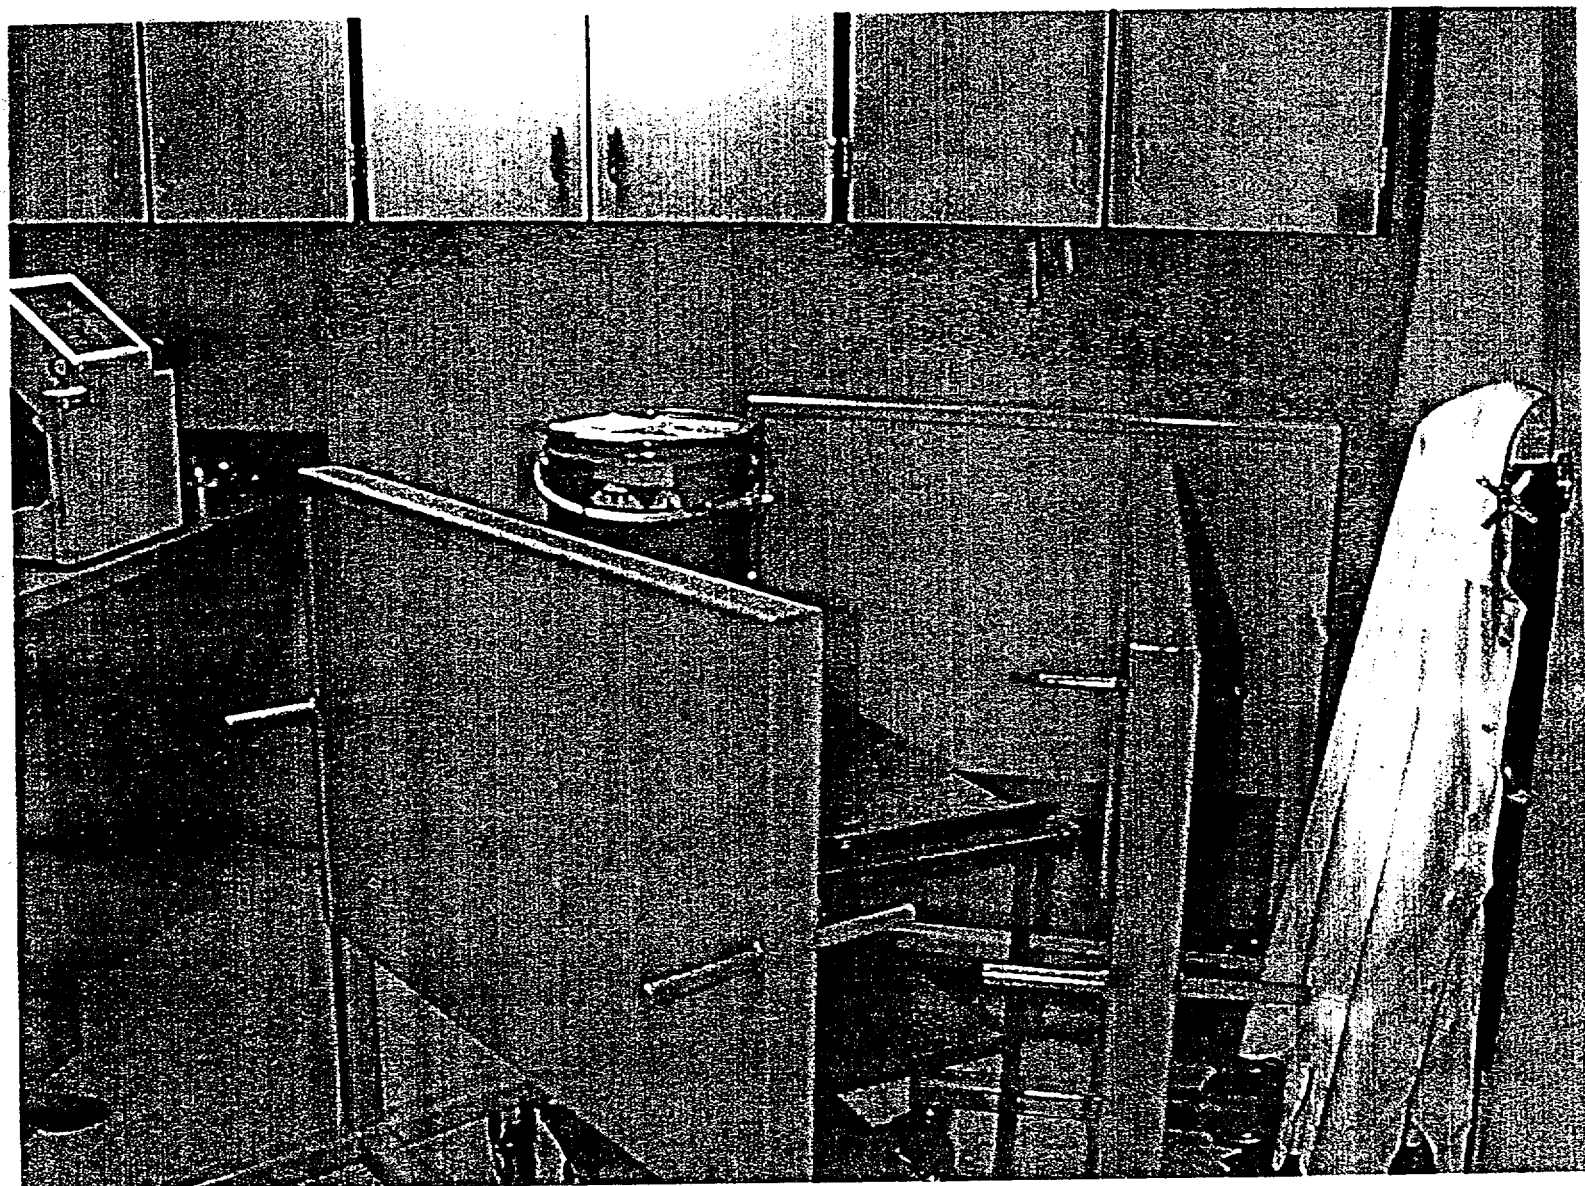
The Agency also concludes that the primary cause of the incident was failure to perform an adequate inspection and survey of the Type A container prior to shipment. Due to the confined space in the facility's hotlab, it is the Agency's opinion that it was possible to miss the activation of the Nuclear Associates, Prime Alert 10, Model 05-433 visual alarm. This is due to two primary factors: 1) the lense of the detector was broken and held in place on the detector with surgical tape which effectively dimmed the flashing light of the alarm; and 2) the placement of the alarm on the rear wall of the hotlab had the alarm behind the operator who was packaging the radioactive materials (See photo at Enclosure 14). Since the detector had no audible alarm, it could have been missed. The alarm was fully functional during inspection of the Hotlab on January 30, 2001. Even if the visual alarm was missed, the radiation survey of each package should have demonstrated the inadequate packaging of the 10 seed package. The visual alarm and all survey instruments used for the surveys were within calibration (See Enclosure 17). Individual responses of the individuals involved in the packaging process do not adequately address the inadequacy of the survey. Survey meters used to perform the package survey were in working order with current calibrations (See Enclosure 17).

Enclosure 14: Shipping container in
— packaging/unpackaging mode, between —
3 lead shields inside the Hotlab.

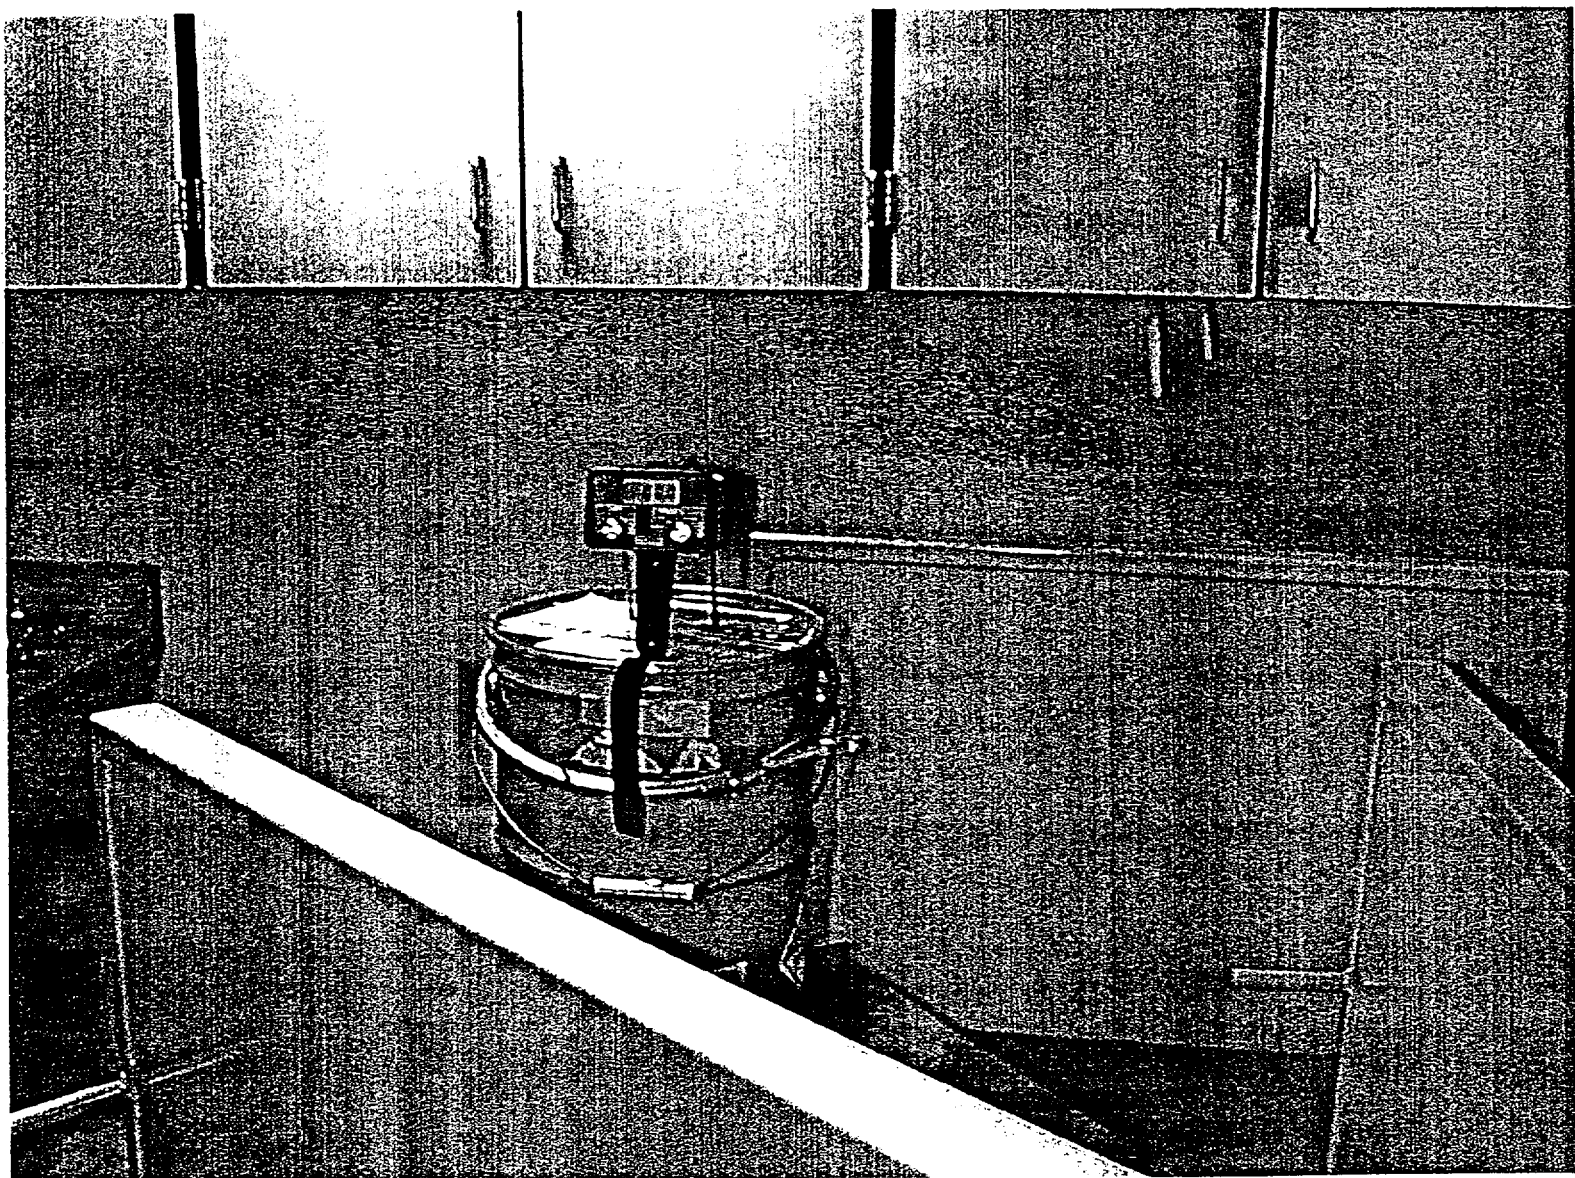
Enclosure 15: Interior view of Hotlab
—with shields and packaged Pig on
portable table used for transport.
