June 1, 2001

On behalf of the Commission, I am writing in response to your letter of April 13, 2001, concerning the partial loss of offsite power at the Seabrook nuclear plant on March 5, 2001, during a winter storm. Responses to your questions are enclosed.

1. Responses to Questions
2. NRC Special Inspection Team
Report No. 05000443/2001-005

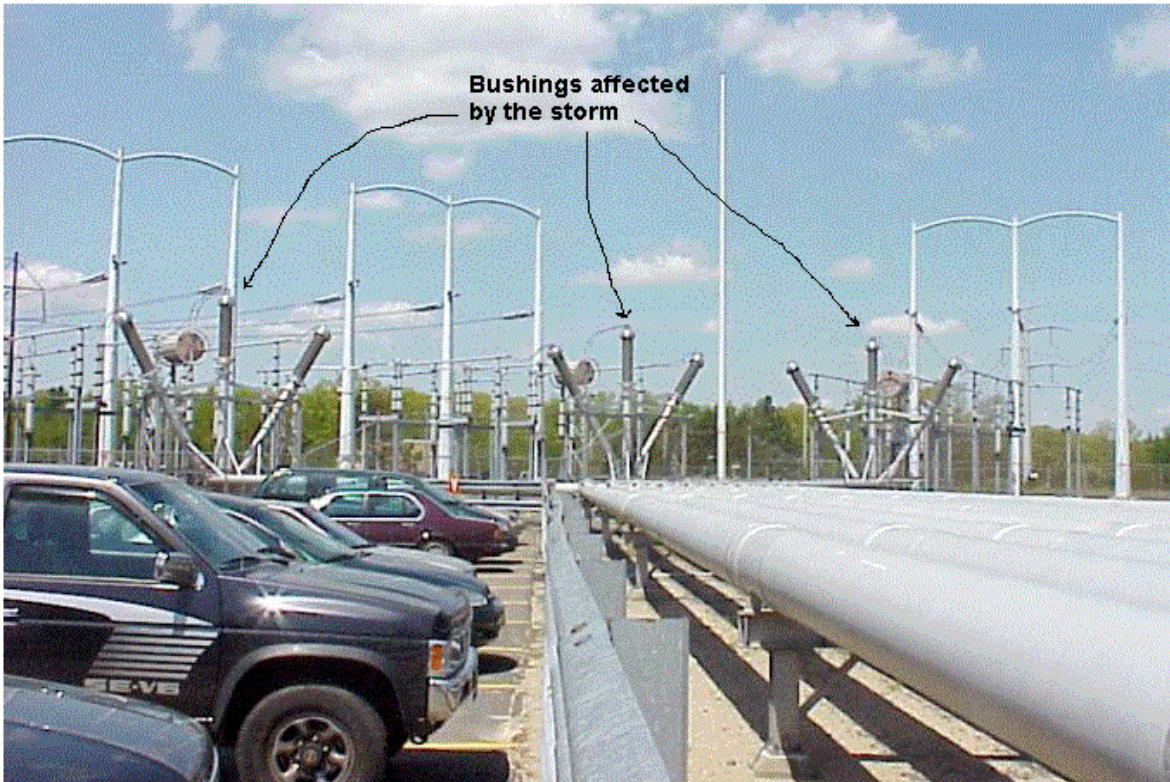
Looking away from plant toward 345kv lines

physically independent circuits be operable from the offsite transmission network to the onsite vital buses; otherwise the plant must be shut down and cooled down to a cold shutdown condition. The problem at Seabrook during this storm was arcing at the bushings in the 345 kV termination yard. The bushings provide a transition point from the overhead 345 kV lines to the insulated bus sections of the 345 kV buses. For each of the offsite 345 kV lines, two of the three phase bushings are angled and the third bushing is mounted vertically. During the March 5, 2001, storm, wet, heavy snow was driven by high winds onto the bushings. Most of the snow and ice fell off the angled bushings but adhered to the vertical bushings, eventually causing a flashover (arcing) from the line to ground.

The NRC special inspection team reviewed this previous experience. The team found that the partial loss of offsite power during March 2001 had the same cause as the 1997 event. Snow buildup on the vertical bushings for the termination yard caused a short to ground, which opened circuit breakers in the offsite power switching station. After the EDGs energized the vital buses during the event in March 2001, the operators had the ability to restore power to the vital buses from offsite power. However, the operators decided to wait until the problem with the bushings was investigated.

The licensee is evaluating longer-term actions to improve the reliability of the bushings in the termination yard during storm conditions. This shutdown from full power during a snowstorm was within the design basis of the plant. The March 5, 2001, event was the first reactor shutdown caused by a weather related event at Seabrook in its 10 years of operation. During this event, there was always at least one transmission line providing power to the plant switching station. The NRC will monitor the licensee's efforts to put enhancements in place, but further restrictions on plant operation are not warranted for this event due to its infrequent occurrence, low safety significance, and the fact that the plant is designed to respond to such conditions. The following is a more detailed discussion of the event.

Based on the March 2001 event, the licensee implemented procedure changes to improve the response to flashover at the bushings during severe weather. The operating crews now have specific instructions on performing timely restoration of the circuit connections to the transmission lines. The NRC special inspection team viewed this measure as an appropriate, interim corrective action. Seabrook also entered this condition into its corrective action program to determine what, if any, long-term solutions or enhancements should be implemented. The NRC will monitor the licensee's corrective actions through the normal baseline inspection program.
