Subject: **Docket Nos. 50-361 and 50-362**
60-Day Report
Licensee Event Report No. 2001-002
San Onofre Nuclear Generating Station, Units 2 and 3

FACILITY NAME (1) San Onofre Nuclear Generation Station (SONGS) Unit 2					DOCKET NUMBER (2) 05000-361		PAGE (3) 1 of 4																			
TITLE (4) Incorrect Technical Specification Surveillances on Reactor Protection System Logic																										
EVENT DATE (5) <table border="1" style="width:100%; border-collapse: collapse;"> <tr> <th style="width:33%;">MONTH</th> <th style="width:33%;">DAY</th> <th style="width:33%;">YEAR</th> </tr> <tr> <td style="text-align: center;">02</td> <td style="text-align: center;">28</td> <td style="text-align: center;">2001</td> </tr> </table>			MONTH	DAY	YEAR	02	28	2001	LER NUMBER (6) <table border="1" style="width:100%; border-collapse: collapse;"> <tr> <th style="width:33%;">YEAR</th> <th style="width:33%;">SEQUENTIAL NUMBER</th> <th style="width:33%;">REVISION NUMBER</th> </tr> <tr> <td style="text-align: center;">2001</td> <td style="text-align: center;">- 002 -</td> <td style="text-align: center;">00</td> </tr> </table>			YEAR	SEQUENTIAL NUMBER	REVISION NUMBER	2001	- 002 -	00	REPORT DATE (7)

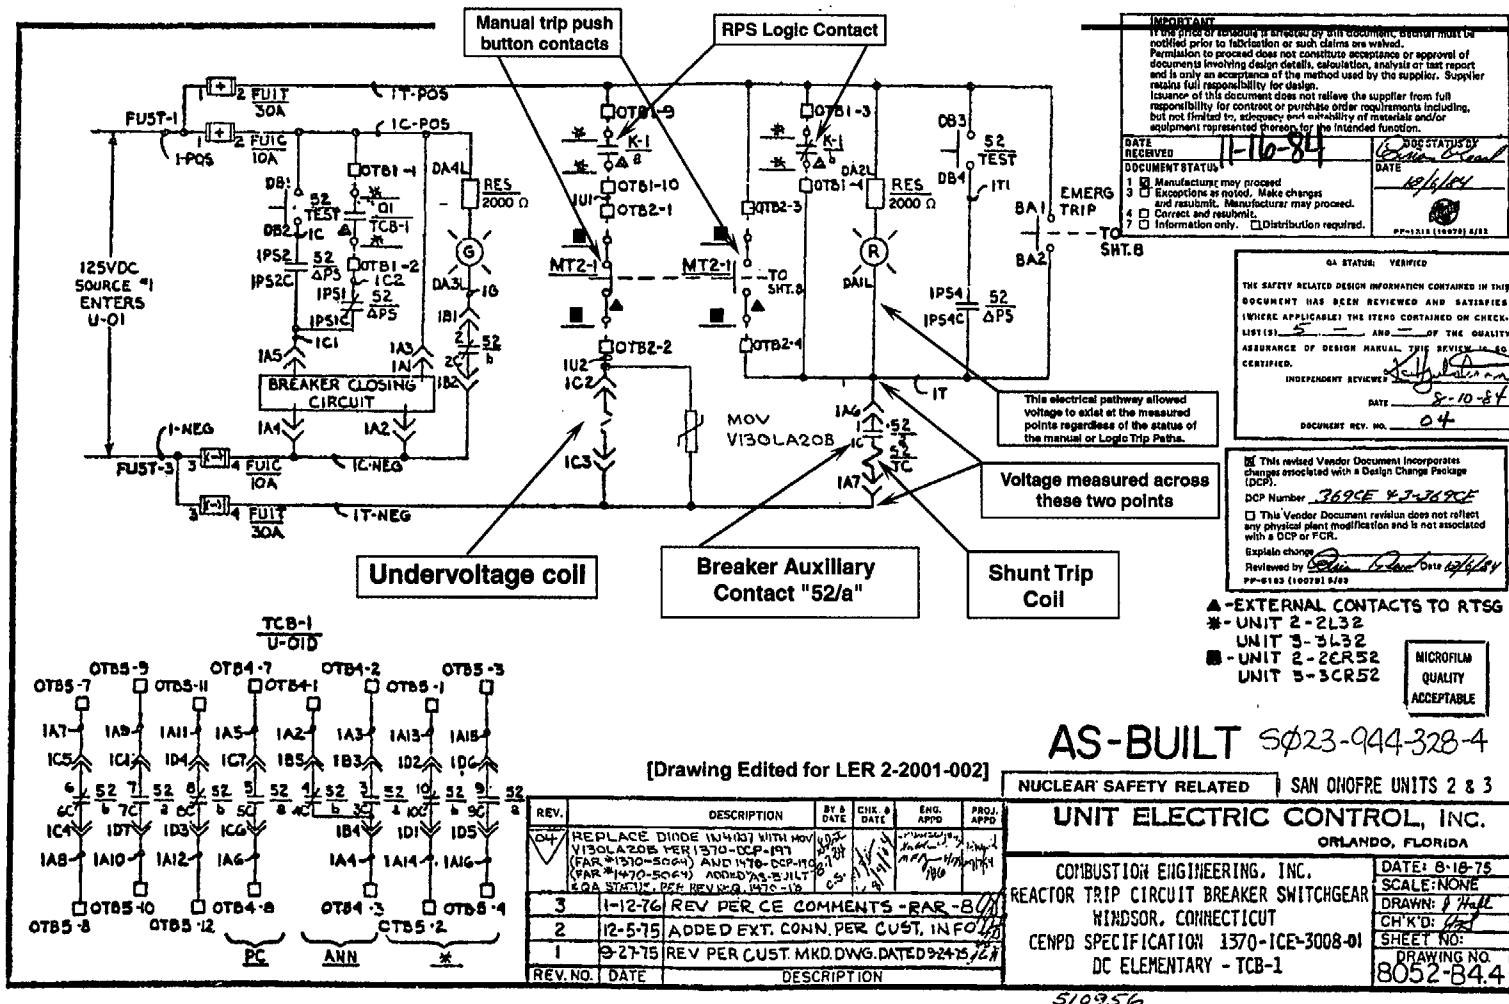
Figure 1

On 2/28/01, SCE recognized that the breaker auxiliary contact was in series with the shunt coil between the two points used to verify voltage across the coil circuit. The RTCB Switchgear design contains a resistor and a light that provide a parallel pathway around both the RPS Logic K-relay contact and the manual push button contact. Therefore, because of this parallel voltage path and series auxiliary contact, SCE's test method did not satisfactorily implement TS SR 3.3.4.2 or TS SR 3.3.4.4. SCE is reporting this event in accordance with 10 CFR 50.73(a)(2)(i)(B). SCE performed the verification of the K-relay contacts and the manual push button contacts after removing the parallel voltage pathway. Because the RTCBs contain redundant trip devices (i.e., both a shunt trip coil and an undervoltage trip coil) and the successful completion of the TS SRs, this issue has no safety significance.

On February 28, 2001 (discovery date), while assessing the Unit 3 plant response associated with the February 2001 fire (reported in LER 3-2001-001), the RTCB cognizant engineer recognized that the breaker auxiliary contact was in series with the shunt coil between the two points used to verify voltage across the coil circuit (see Figure 1). The RTCB Switchgear [SWGR] design contains a 2000 Ohm resistor and a red indicating light [IL] that provide a parallel pathway around both the RPS Logic K-relay [RLY] contact and the manual push button contact. Although the breaker auxiliary contact opens when the breaker is tripped, voltage is always present at the measured test points through the parallel pathway, regardless of the position of the manual trip pushbutton contact or the K-relay contact. Therefore, because of this parallel voltage path and series auxiliary contact, SCE's test method did not satisfactorily implement TS SR 3.3.4.2 or TS SR 3.3.4.4 (AR 010201704).

SCE performed the verification of the K-relay contacts and the manual push button contacts after removing the parallel voltage pathway.
