South Texas Project  
Unit 2  
Docket No. STN 50-499  
Licensee Event Report 01-002  
Manual Reactor Trip

<b>FACILITY NAME (1)</b> South Texas Unit 2					<b>DOCKET NUMBER (2)</b> 05000 499		<b>PAGE (3)</b> 1 OF 4			
<b>TITLE (4)</b> Manual Reactor Trip as a Result of Switchyard Breaker Failure										
<b>EVENT DATE (5)</b>			<b>LER NUMBER (6)</b>			<b>REPORT DATE (7)</b>			<b>OTHER FACILITIES INVOLVED (8)</b>	
MO	DAY	YEAR	YEAR	SEQUENTIAL NUMBER	REV NO	MO	DAY	YEAR	FACILITY NAME	DOCKET NUMBER
03	01	2001	01	- 002 -	00	04	23	2001	FACILITY NAME	DOCKET NUMBER
										05000
										05000
<b>OPERATING MODE (9)</b>		1		<b>THIS REPORT IS SUBMITTED PURSUANT TO THE REQUIREMENTS OF 10 CFR §: (Check all that apply) (11)</b>

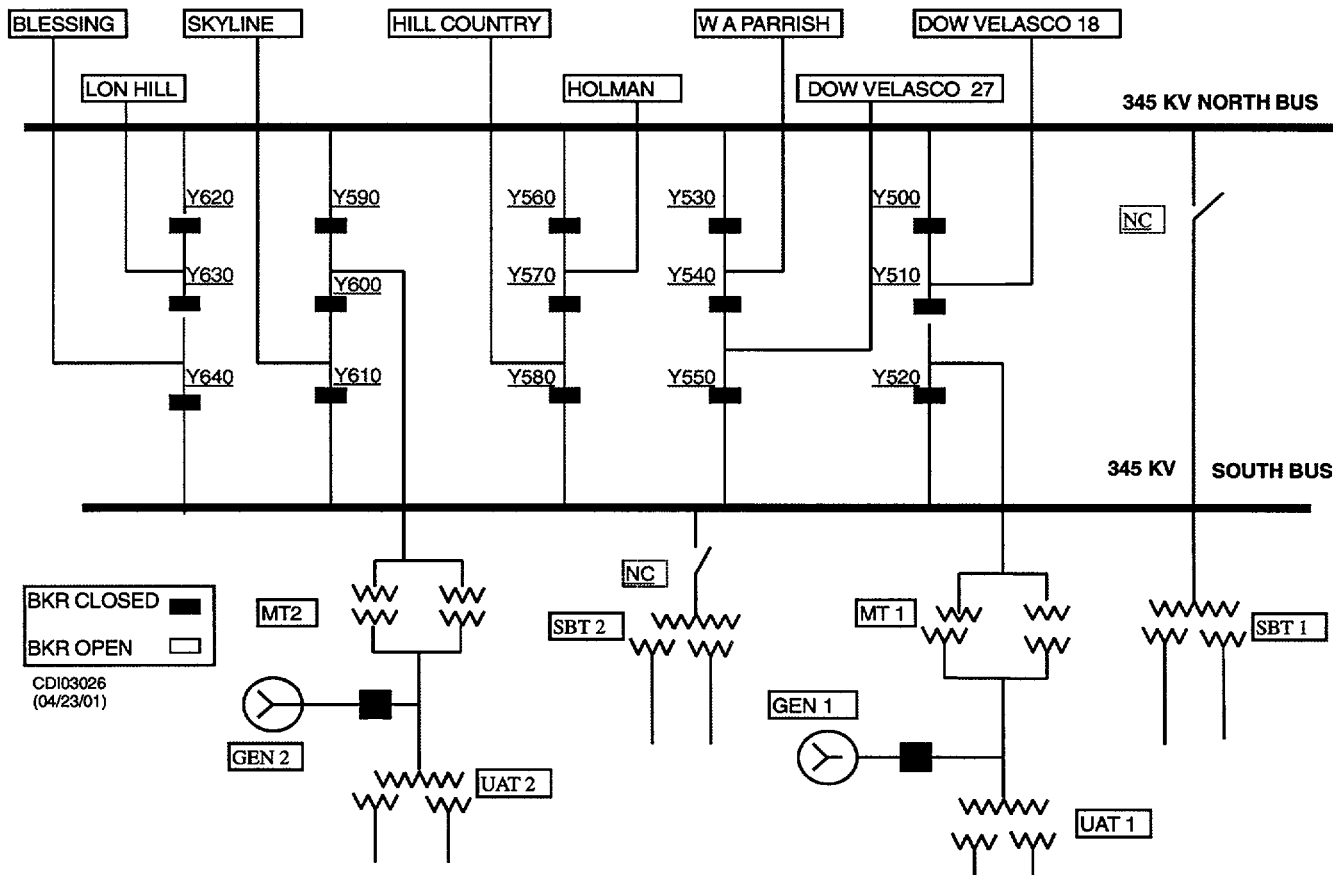
## 345 kV Switchyard Normal Operation

On March 1, 2001, preparations were underway to align the main 345kV switchyard breakers for North Bus maintenance. At approximately 0700 CST switchyard breakers Y600 and Y610 were opened. The manual disconnect for the "Skyline" offsite transmission feed was then opened to take the "Skyline" circuit out of service while the North Bus was out of service. After the "Skyline" manual disconnect was opened, breakers Y600 and Y610 were closed. Unknown to the operating and switchyard crews, the C phase pole of breaker Y600 remained opened (indicated fully closed). At 0821 switchyard breaker Y590 was opened. With the C phase pole of breaker Y600 still opened, the Control Room received electrical panel alarms and Circulating Water Pump 21 tripped offline on a phase balance current relay (46 relay). The open C phase pole created a phase imbalance condition that was sensed by generator and Circulating Water motor protection relays once breaker Y590 was opened. Standby Bus 2F and Auxiliary Bus 2H high voltage alarms and a generator negative phase sequence current alarm were received. This was followed closely by the trip of the remaining operating Circulating Water Pumps 22 and 24, requiring the operating crew to initiate a manual reactor trip in accordance with plant procedures. All control rods fully inserted. The Auxiliary Feedwater System actuated on low-low steam generator water level as expected. All safety equipment operated as required. The control room crew closed the main steam isolation valves due to the condenser not being available.
