Amersham International plc

Packaging Design Group

Test Report No. 1901

1.1 Package Design No 3750A.

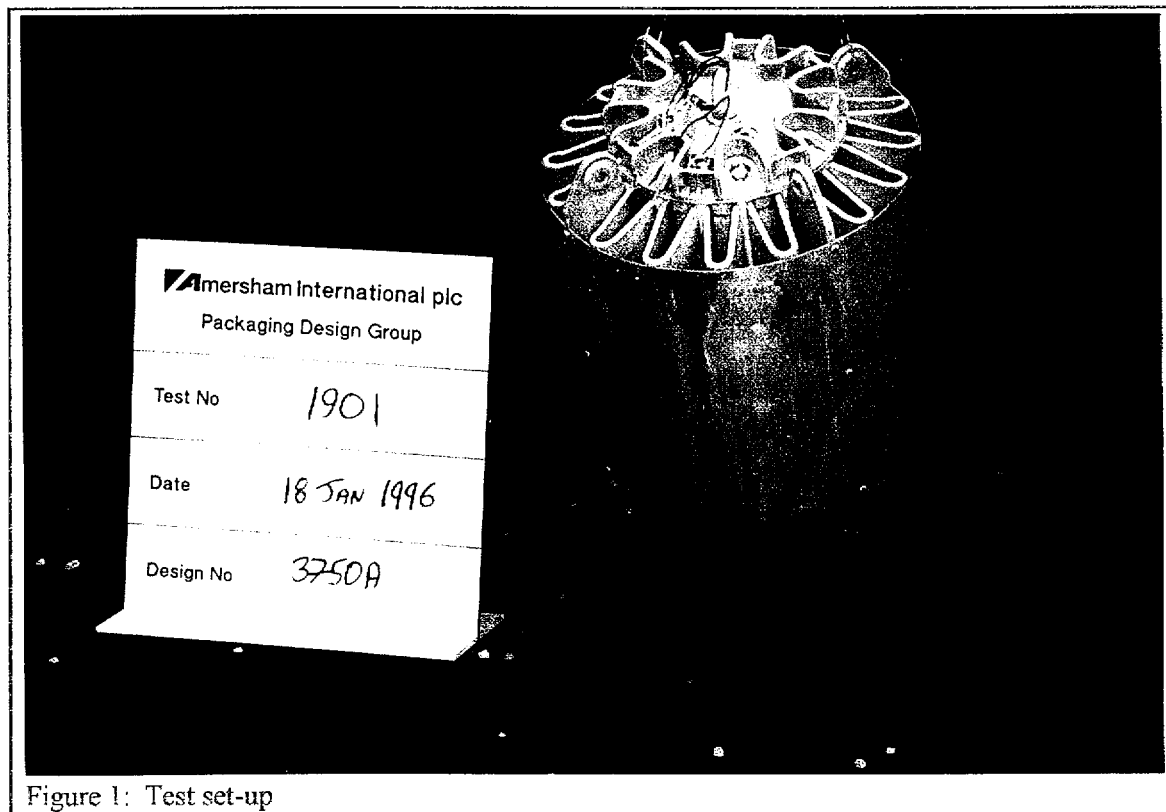
Figure 1: Test set-up

1.4 Orientation The cask was slung at an angle of 24° from the vertical, placing the centre of gravity over the point of impact (fig 1).

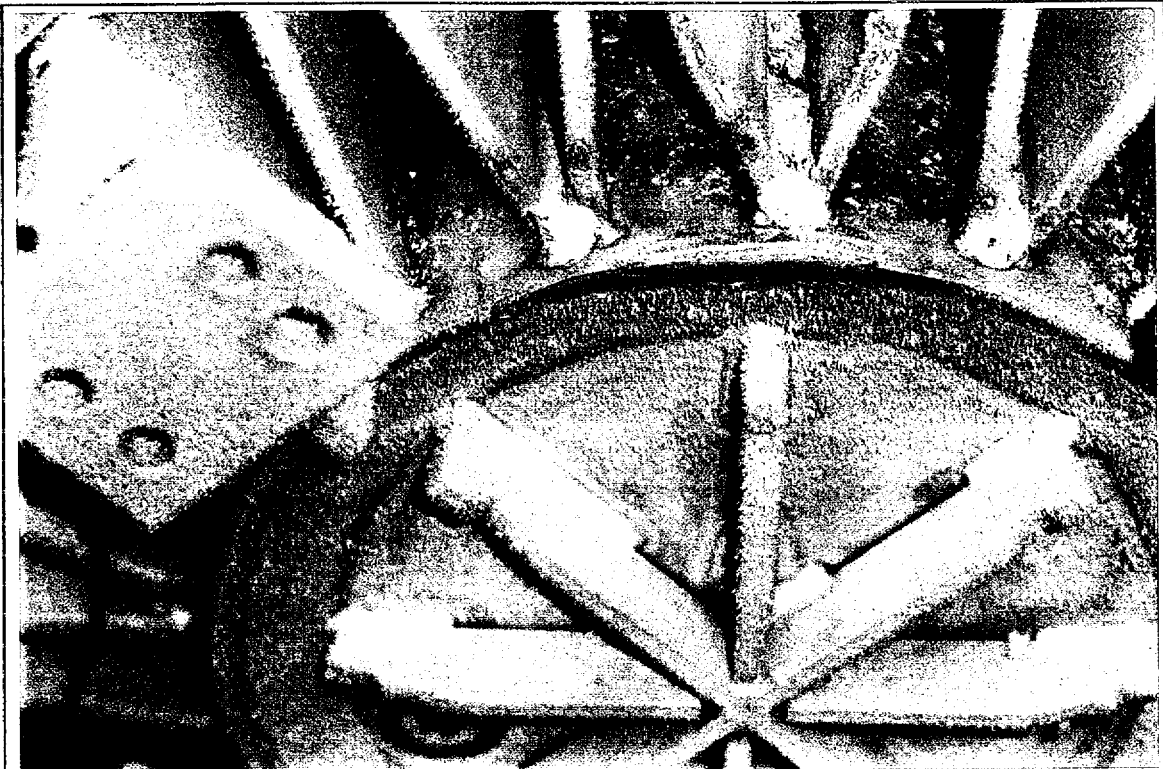
4.4.3 Cask body: The cask and jacket were undamaged except for a bruise on the lower edge of the cask shell 35 mm long x 5 mm maximum width (fig 4). The test caused no damage to the base fins, the base plate, its weldment or the leak test point. The edges of the cooling fins nearest the shell bruise were indented to a maximum depth of 3 mm over a 15 mm length (fig 5). All eight closure studs and nuts were undamaged, secure and unscrewed freely. All twelve jacket screws were undamaged, secure and unscrewed freely.

Figure 4: Cask base showing bruise to shell

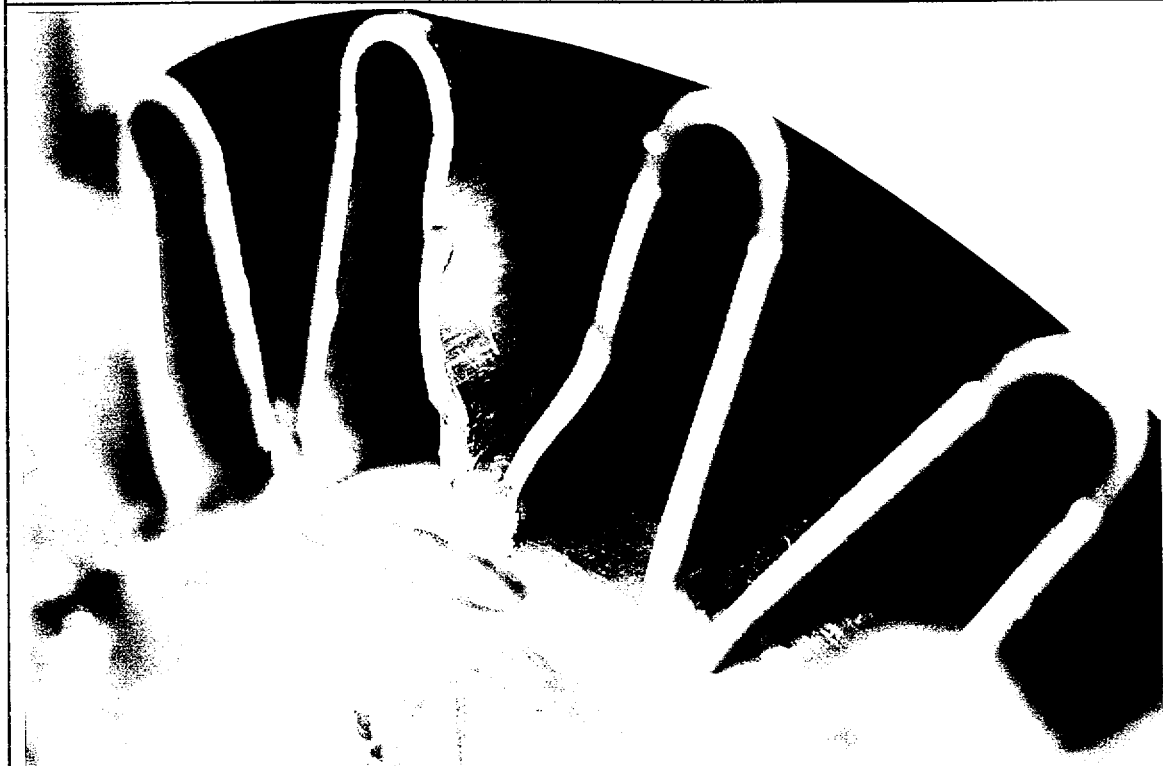
Figure 5: Cask base showing secondary indentations to cooling fins

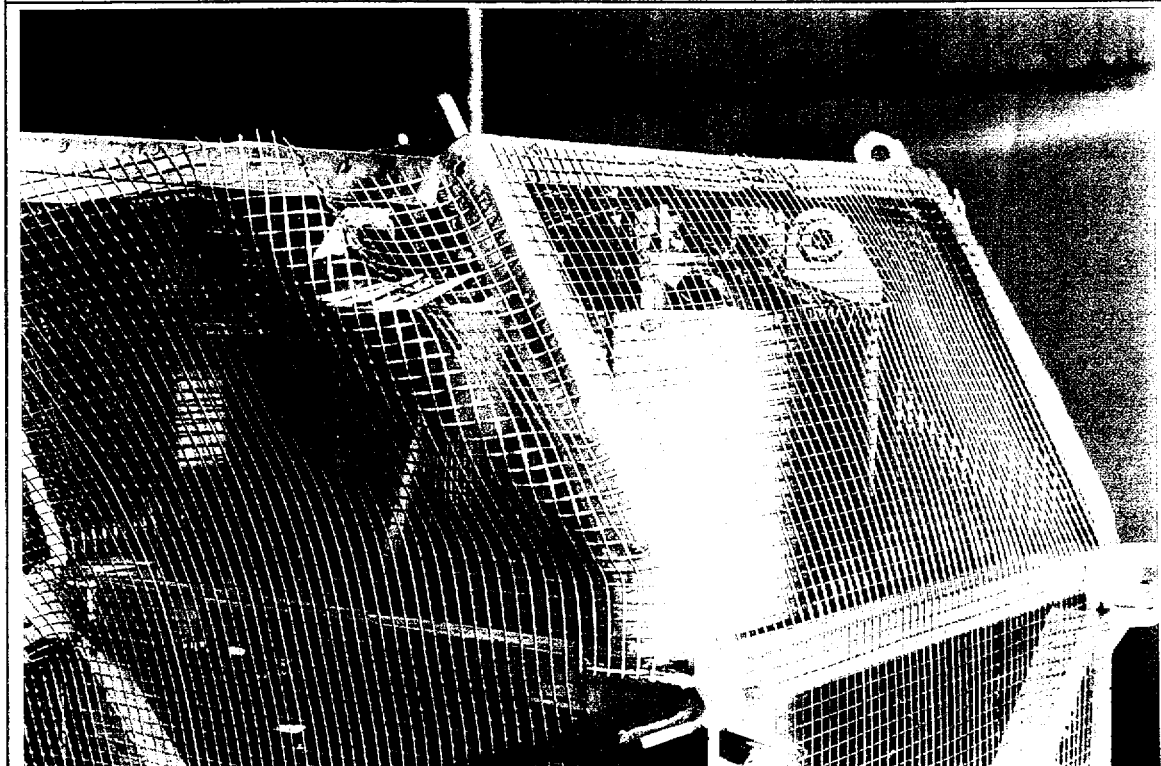
Figure 5: Distortion in upper section of cage

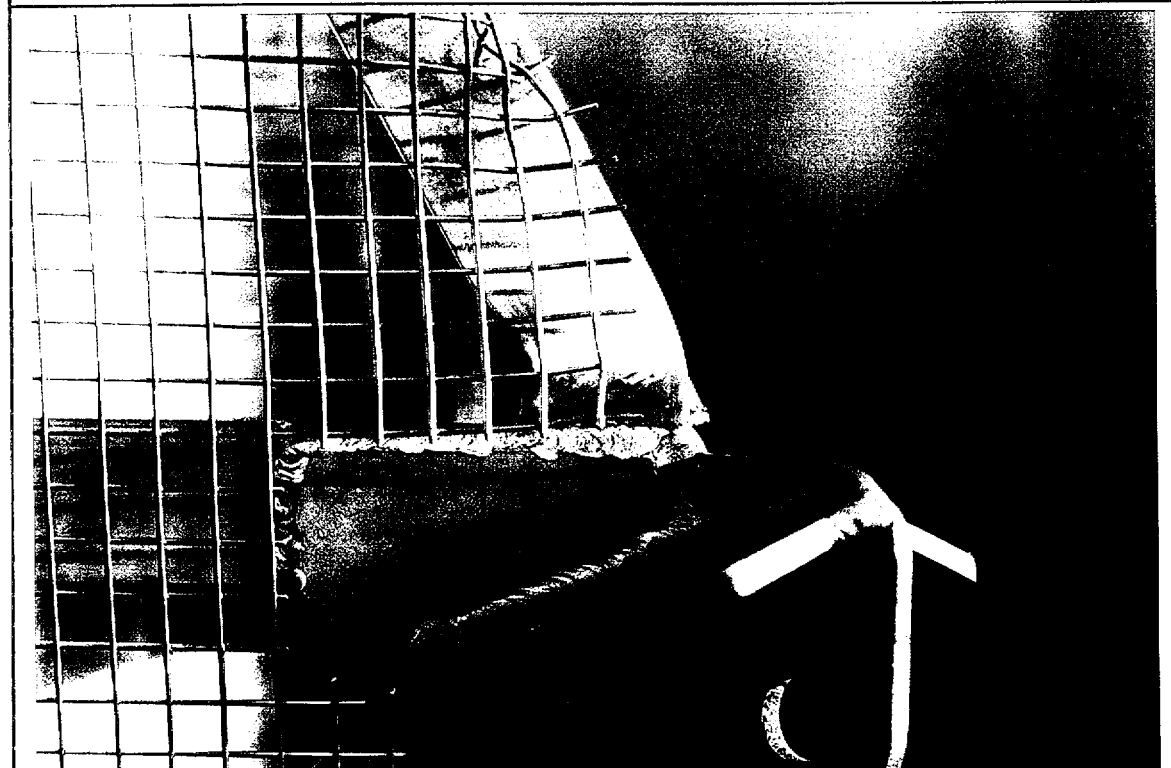
Figure 7: Buckled joint in cage

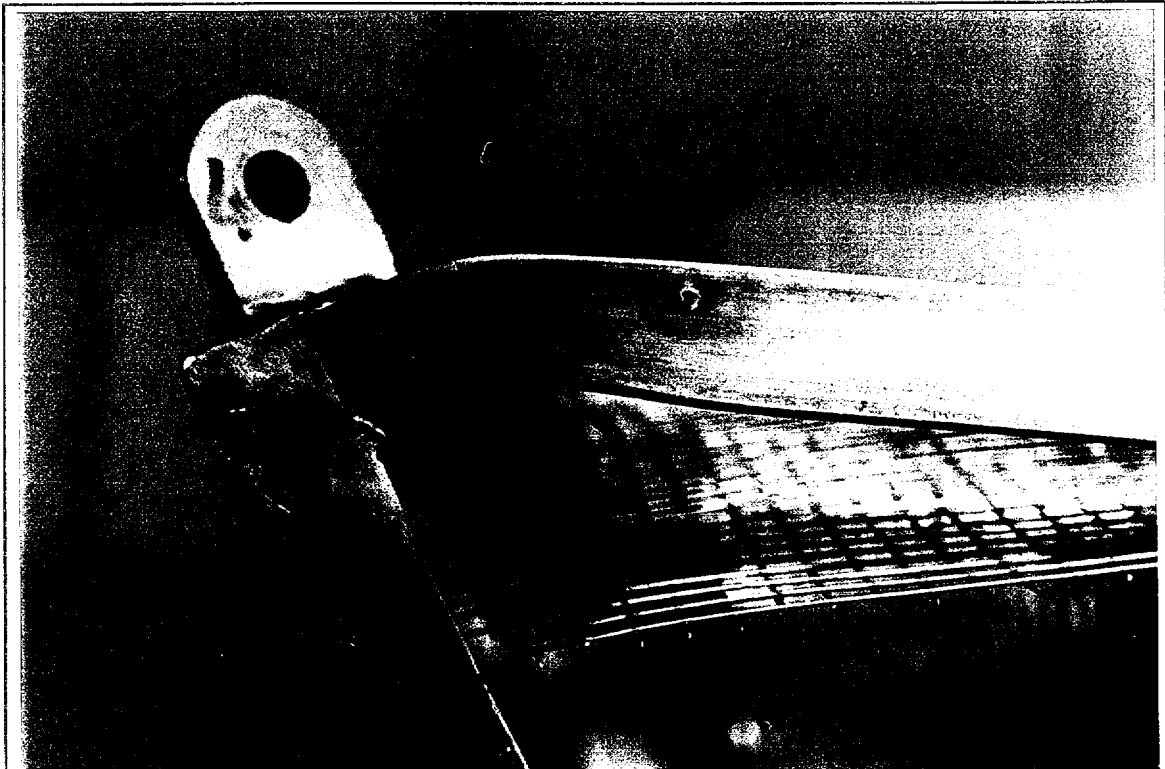
Figure 8: Buckled joint in cage

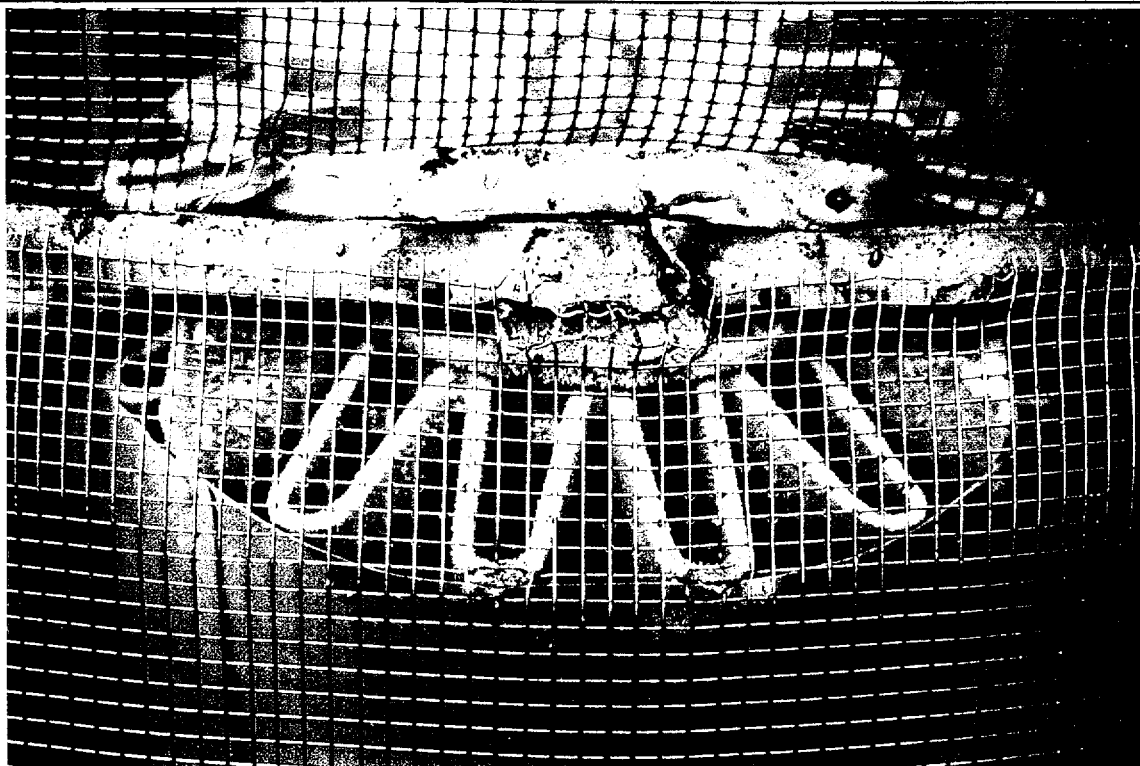
- 4.4.2 Cage: The cage showed relatively little additional damage. The upper half of the cage was twisted sideways at an angle of approximately 32° from the vertical (fig 4). The top mesh panel was largely detached. The upper cross member underneath the impact was flattened over a length of 150 mm and almost severed by two of the closure shock absorbers (figs 5 & 6). Otherwise the cage was undamaged. All twelve pallet screws were undamaged.

Figure 5: Upper cage showing cross member damage and minor bruising to tips of cooling fins

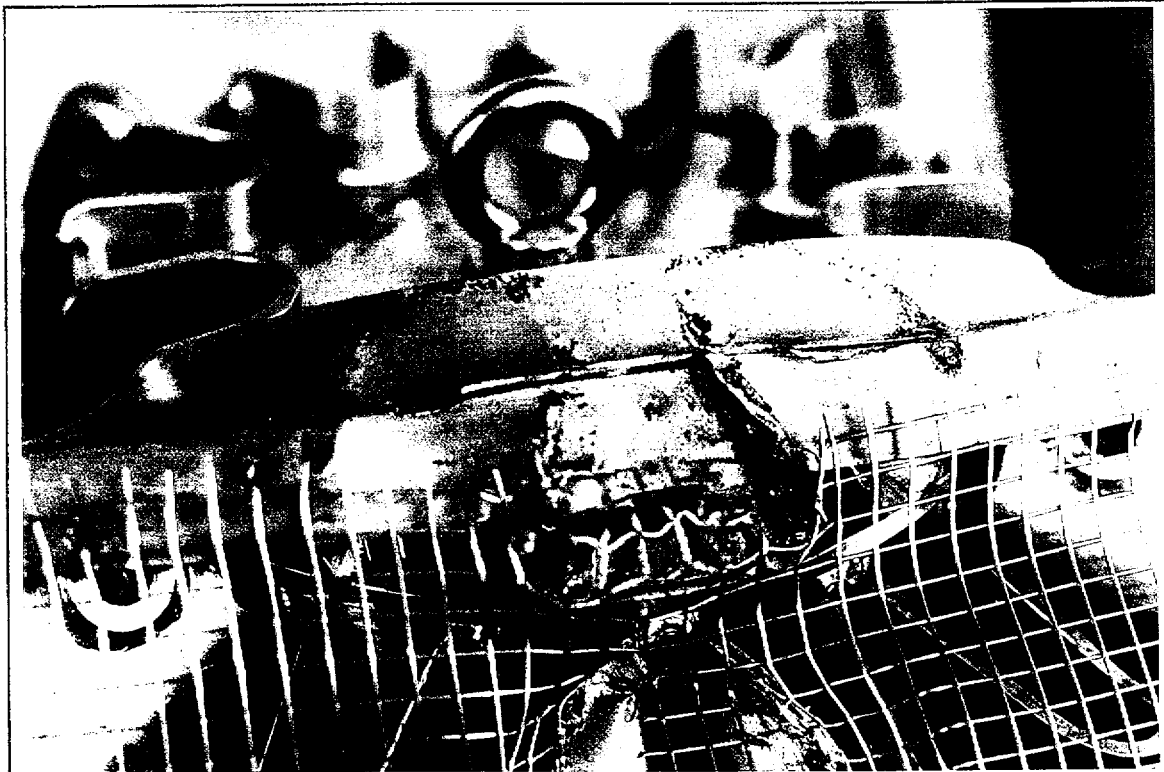
Figure 6: Upper cage showing cross member damage

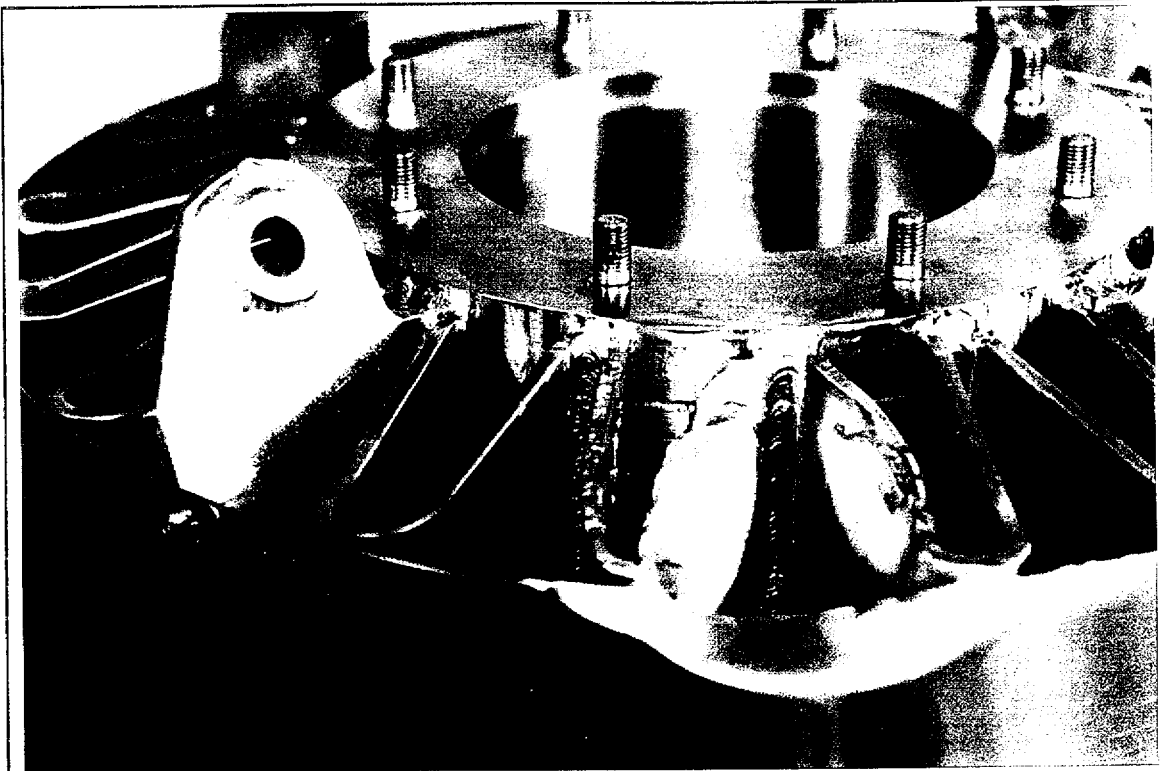
4.4.4 **Cask body:** The inner edges of the two fins hit by the punch were bent over away from each other (figs 5 & 6). The jacket was bent inwards between the two fins. The remainder of the damage was from the 9.0m drop. The lifting points to each side were bent over at 30° and 40° respectively from the vertical (figs 7-9) and were bruised on their top edge. On one of the lifting points a crack had opened on the tensile side of the bend adjacent to the jacket fixing screw (fig 10). The screw and jacket remained quite secure. The body flange had two, smooth-edged, semi-elliptical bruises at its outer edge under the crushed closure shock absorbers (fig 11). The bruises were less than 0.5 mm deep, 10 mm maximum width and extended inwards not more than 5 mm. There was no distortion below, towards the flange-to-shell weld, or inwards, towards the closure studs. There was no other damage to the cask body. All eight closure studs and nuts were undamaged, secure and unscrewed freely. All twelve jacket screws, including the one next to the crack, were undamaged, secure and unscrewed freely.

Figure 5: Cooling fin and jacket damage from punch

Figure 6: Cooling fin and jacket damage from punch

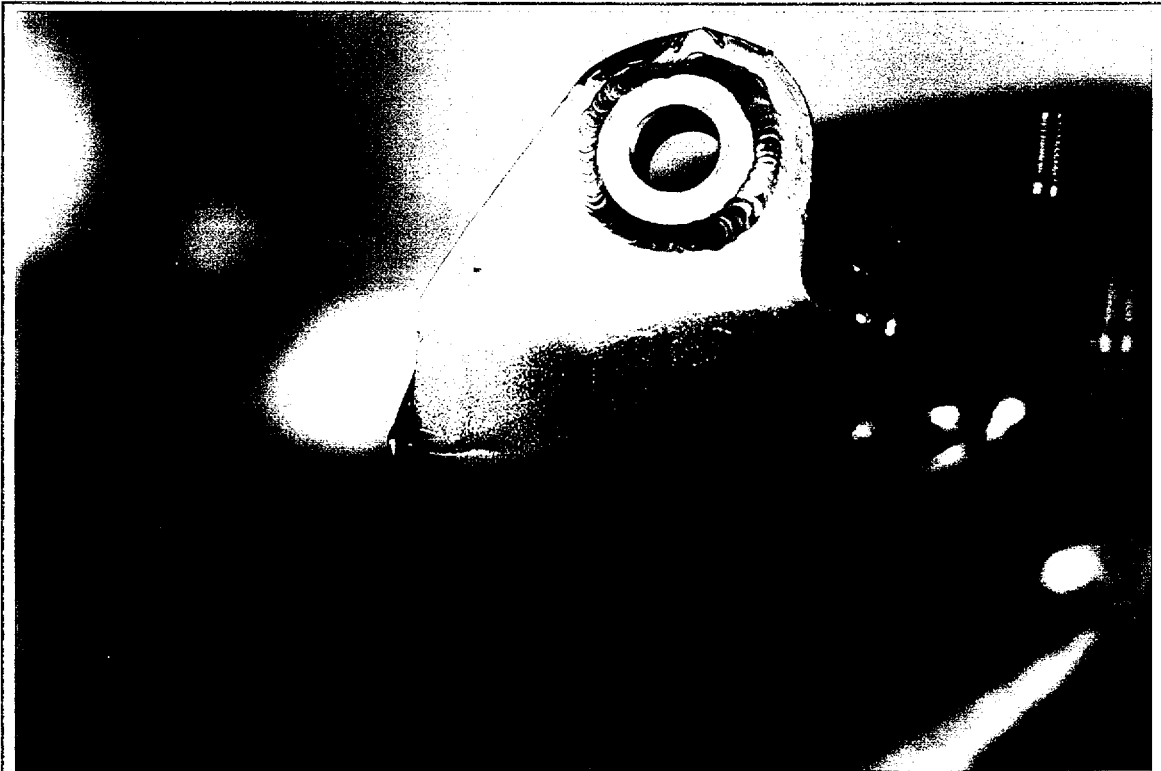
Figure 10: Crack in fin near jacket screw

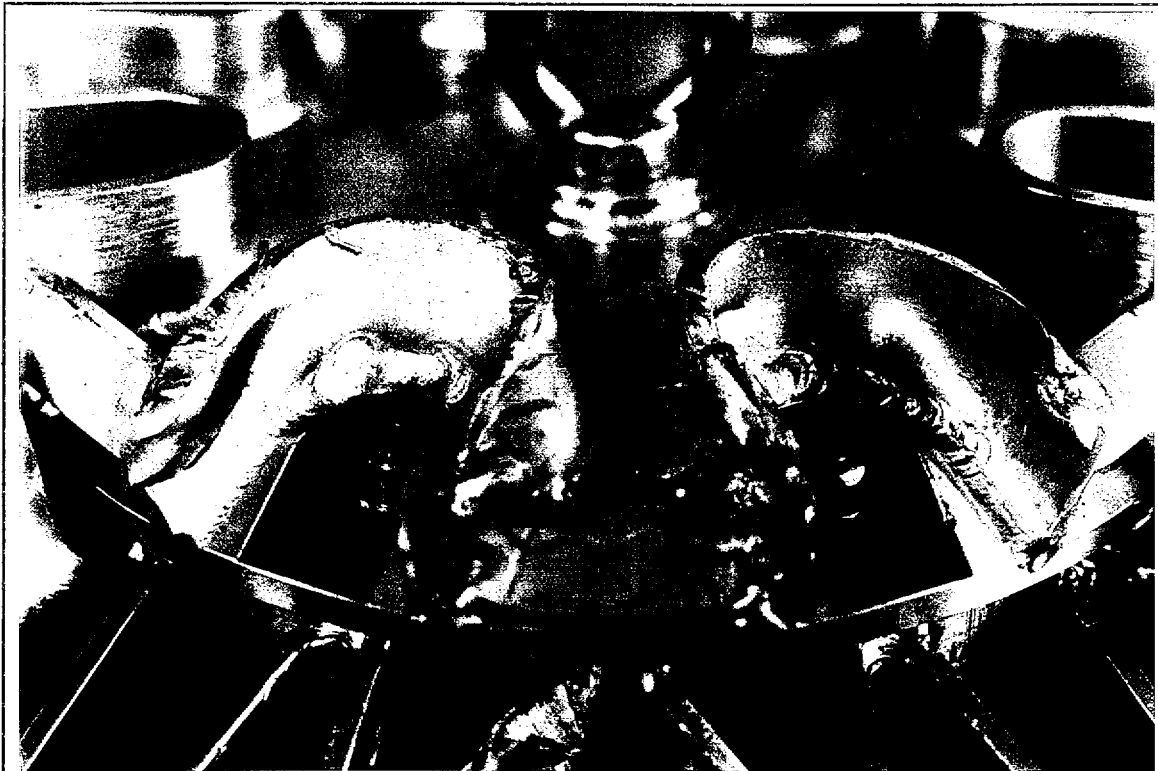
4.4.5 **Cask closure:** The closure disengaged freely from the body. The two fins under the 9.0m impact were crushed flat (fig 12). The two to each side were slightly distorted (figs 13 & 14). Under the inner edges of the two crushed fins the closure flange had taken a gently rippled profile outside the edge of the body flange (figs 15 & 16) creating a lip some 5 mm wide, 60 mm long and 1 mm maximum depth. Other than this the closure was free from damage. There was no evidence of bruising, scratching or distortion to the leak test plug, the closure flange or the underside.

Figure 12: Crushed closure shock absorbers

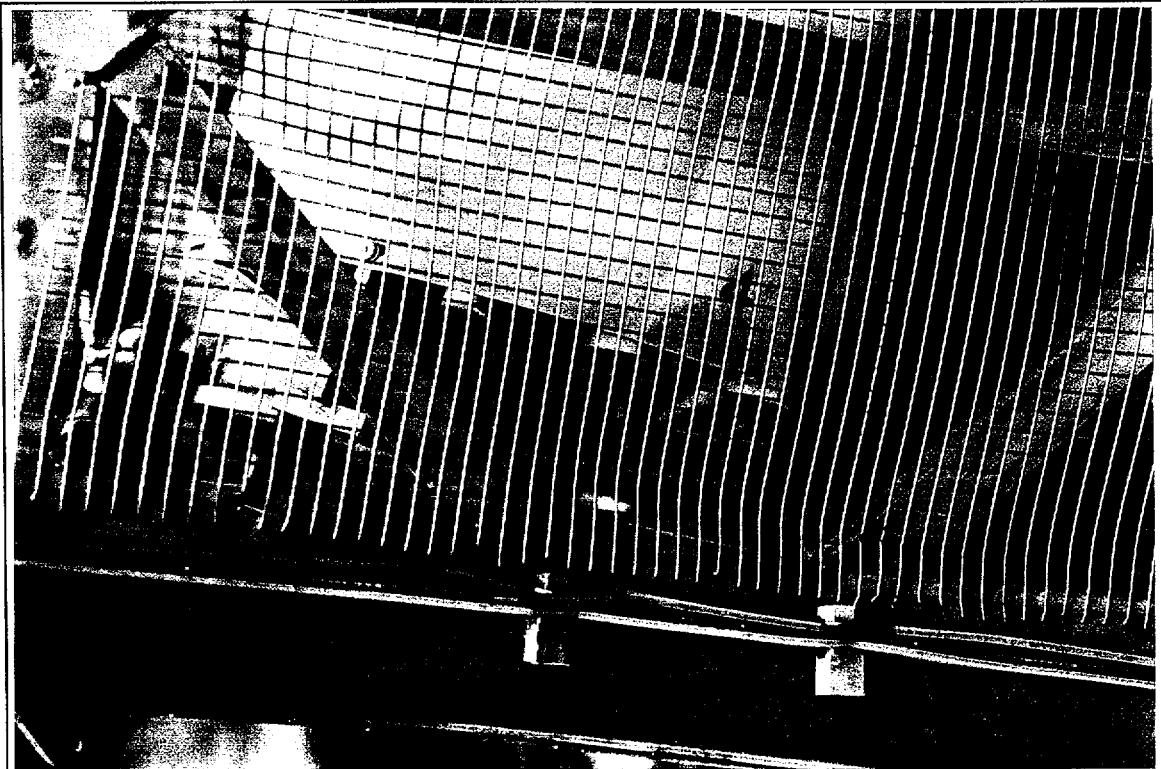
Figure 6: Cage showing yielding around pallet fixings

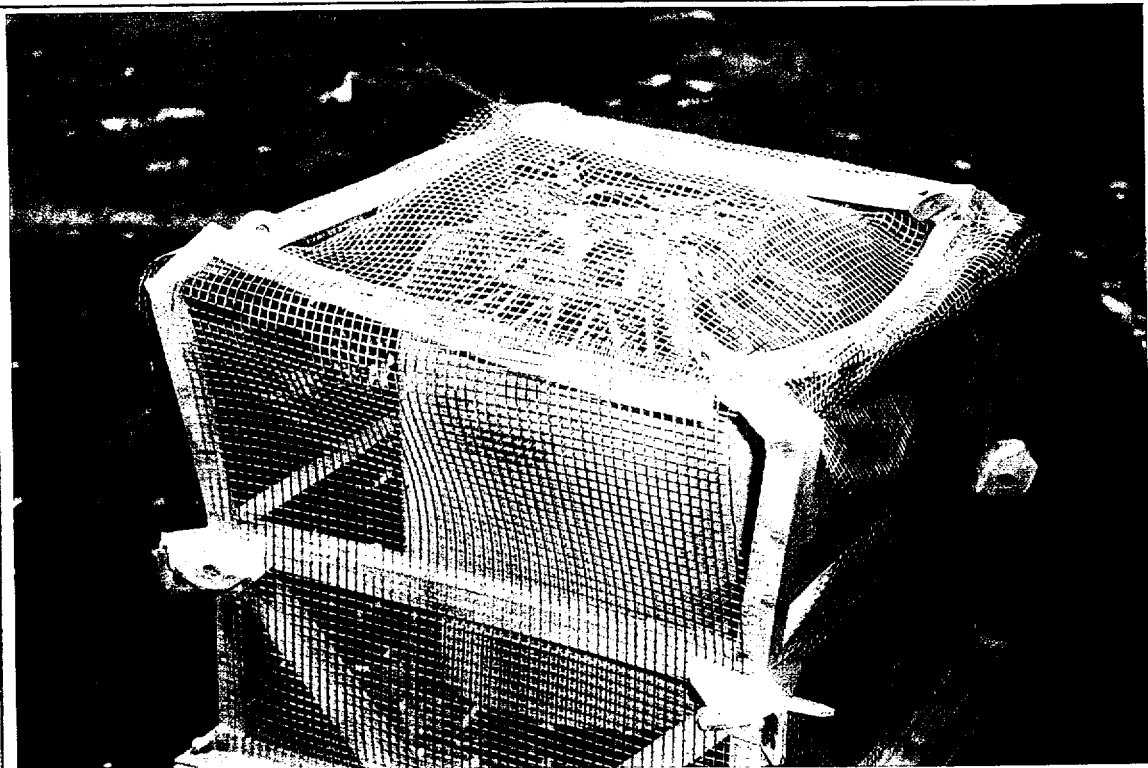
Figure 5: Cage showing compression damage

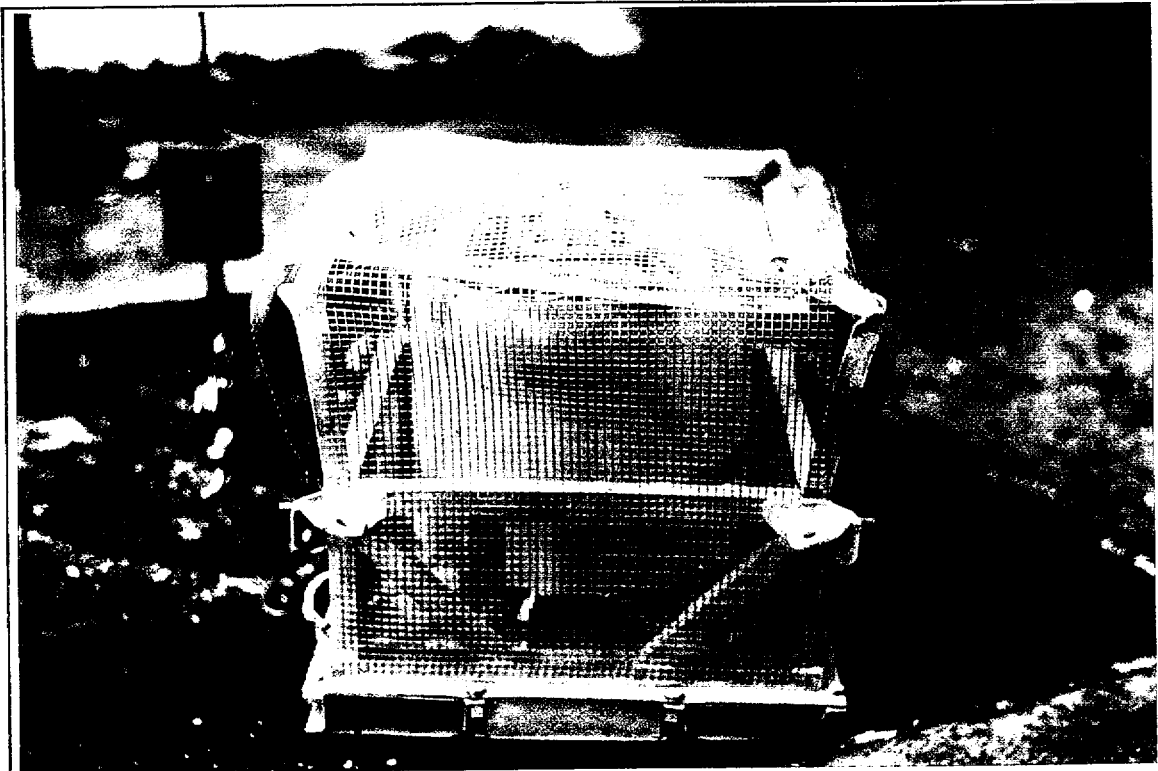
Figure 6: Cage damage and pallet distortion
