Ref: University of California, Davis McClellan Nuclear Radiation Center (UCD/MNRC),
Docket No. 50-607, Facility Operation License No. R-130

Subject: UCD/MNRC Annual Report for CY 2000

2000 ANNUAL REPORT

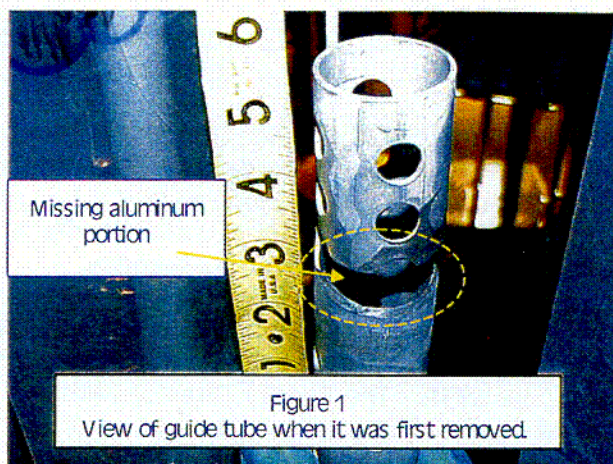
Interconnected shroud tubes extend from the reactor room bridge and terminate at a snubber assembly. The snubber assembly decelerates the transient rod when it is pulsed. The snubber assembly captures the guide tube but does not rest on it. As operations personnel attempted to remove the shroud tubes and snubber assembly from the top of the guide tube the snubber assembly appeared to be stuck on the guide tube. By rotating the shroud tube operations personnel could raise the shroud tubes and snubber assembly in small increments. Operations personnel continued to do this until the shroud tubes and snubber assembly broke free of the guide tube. During the visual inspection of the bottom of the snubber assembly the 1/4 inch connecting rod could be seen protruding out the bottom of snubber assembly when the snubber was clear of the guide tube. In addition, the top several inches of the guide tube appeared bent.

Personnel could see the transient rod's lower connecting rod and Teflon piston in the guide tube. They appeared to be in the full down position. Operations personnel unscrewed and removed the guide tube from the safety plate. The guide tube and transient rod were removed from the reactor core area. Operations personnel continued to raise the guide tube and transient rod to the surface of the reactor tank for visual inspection and to remove the transient rod from the guide tube. Operations personnel noticed that a segment of the guide tube was missing (Figure 1). The missing segment is approximately two inches from the top; ½ inches wide and extended approximately half way around the circumference of the guide tube.

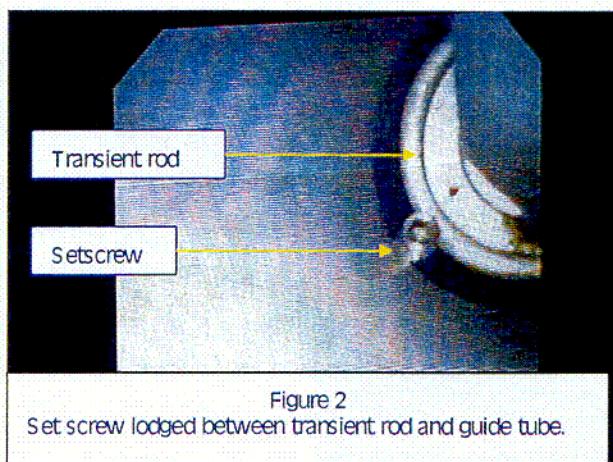
Operations personnel attached a ¼ inch threaded rod through the Teflon piston and into the lower connecting rod. As they attempted to remove the transient rod from the guide tube, it became apparent the transient rod was stuck in the guide tube. The Reactor Manager instructed operations personnel to cut the guide tube approximately two inches below the Teflon piston and insert a fiber optics camera down the guide tube to see if anything was jamming the transient rod in the guide tube.

When operations personnel cut and removed the upper portion of the guide tube they discovered that two setscrews were missing.

One setscrew secures the ¼ inch threaded connecting rod to the lower connecting rod and the other setscrew secures the Teflon piston to the top of the lower connecting rod. Operations personnel inserted the fiber optics camera down the guide tube and discovered a setscrew lodged between the guide tube

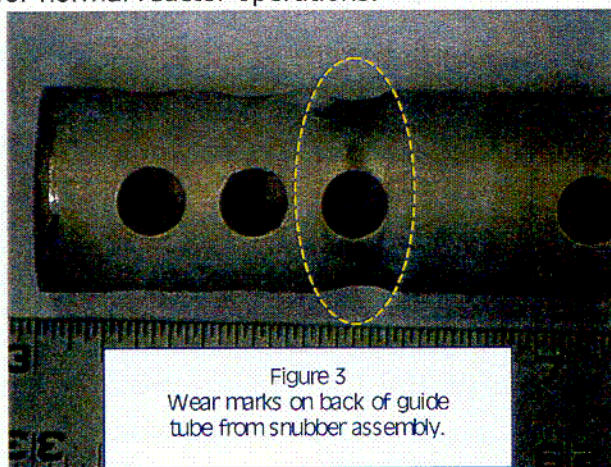
Figure 3
 Wear marks on back of guide tube from snubber assembly.

On a closer inspection of the guide tube, the back (Figure 3) shows wear marks that closely match the inlet bevel of the snubber. On the left side, view (Figure 4) one can observe a beveled line on the cut through the guide tube. This appears to be caused by vibration between the guide tube and the snubber assembly. The vibrations are either from the natural harmonics of the reactor structure or water from the ^{16}N

diffuser causing lateral movement between the guide tube and snubber. The latter seems more likely as the guide tube bent towards one of the ^{16}N diffuser discharge nozzles and the missing section of guide tube is on the opposite side as one of the ^{16}N diffuser discharge nozzles.

To detect and monitor this problem in the future, additional preventive maintenance measures (other than just visually inspecting the transient rod) shall be added to the annual inspection. Operations personnel will perform these additional annual preventive maintenance items:

1. Visually inspect the Teflon piston.
2. Tighten the setscrew on the Teflon piston.
3. Tighten the 1/4 inch threaded connecting rod.
4. Tighten the setscrews on the 1/4 inch threaded connecting rod.
5. Remove and inspect the guide tube for abnormal wear.

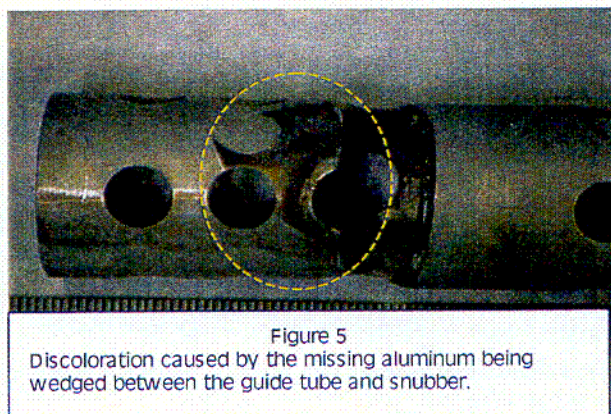
Figure 5
 Discoloration caused by the missing aluminum being wedged between the guide tube and snubber.

Figures 5 and 6 (front and right sides of guide tube) clearly show the missing piece of aluminum. This piece of aluminum could not be located in the reactor tank. Discoloration on the guide tube shows where the missing aluminum had, at some point in time, peeled in an upward direction and lodged between the guide tube and the snubber. This could be a result of the August 1999 fuel

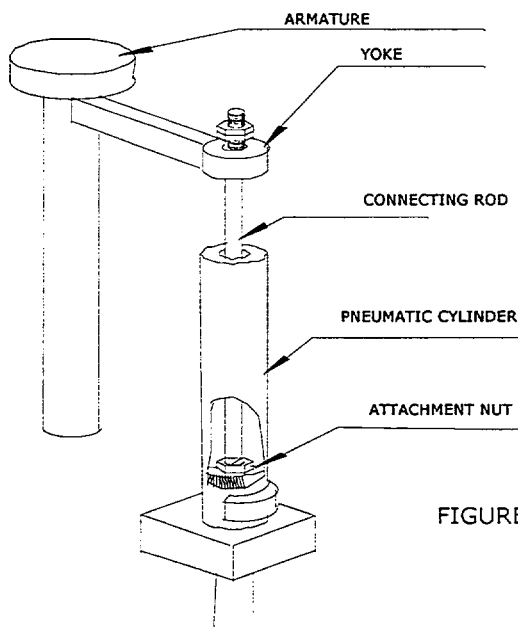
FIGURE 8

9. Operations personnel install a modified beam tube mask in the bay 4-beam tube (SOP 00-03).
10. During square wave testing and training, the transient rod's air cylinder connecting rod started to unthread and became loose. The connecting rod (**Figure 8**) attaches to the top of the pneumatic cylinder's piston and allows the control rod drive to raise the transient rod through a yoke assembly. This allows the transient rod to utilize the same rod drive mechanism as the other five control rods and still maintaining the capability of pulsing and square waving. Operations personnel disassembled the pneumatic cylinder and installed a lock washer at the attachment point of the connecting rod and the pneumatic cylinder piston. After reassembling the transient rod, operations personnel
