**CORRECTIVE ACTION
DOCUMENT
CLOSURE PACKAGE**

TRACKING NO: WBPER950246 R0

A1 Description of Condition: After the completion of the WBN Unit 1 ice loading and weighing, it was discovered that approx 170 ice basket sheet metal screws heads and 32 whole screws were found in the temporary waste ice melt tank.

**WESTINGHOUSE ASSESSMENT OF BROKEN
ICE BASKET SCREWS**

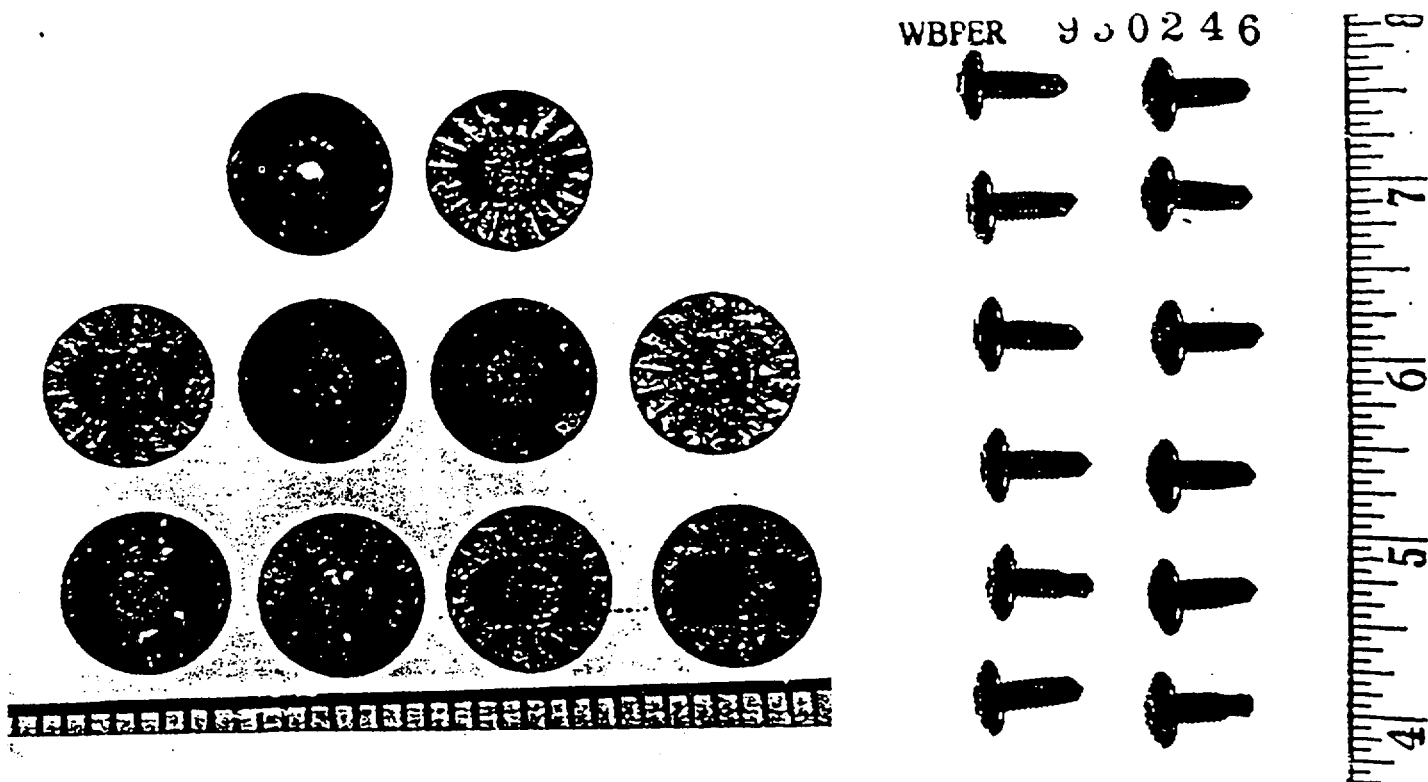
Figure 1 - Ice Condenser Basket Screws, Watts Bar Nuclear Plant, Unit No. 1. Customer Identification No. 95-07. Laboratory Report No. 95-1021.

- Set "A" : Ten fractured screw heads that were in service (seen in the upper left view of Figure 1) , and one whole screw that was not in service (not shown).
- Set "B" : Twelve new screws, seen in the upper right view of Figure 1.
- Set "C" : Two screws removed from service, labeled "Bay '24' Top Ring D-6".
- Set "D" : Two screws removed from service, labeled "Bay '24' Bottom Ring D-6".
- Set "E" : Two screws removed from service, labeled "Bay '12' Top Ring A-6".
- Set "F" : Two screws removed from service, labeled "Bay '12' Bottom Ring A-6".
- Set "G" : Two screws removed from service, labeled "Bay '1' Top Ring A-6".
- Set "H" : Two screws removed from service, labeled "Bay '1' Bottom Ring A-6".

Left: As-received photograph of the fractured screws (set "A"). Note that the unfractured screw from this set is not shown. Right: As-received photograph of the new screws (set "B").

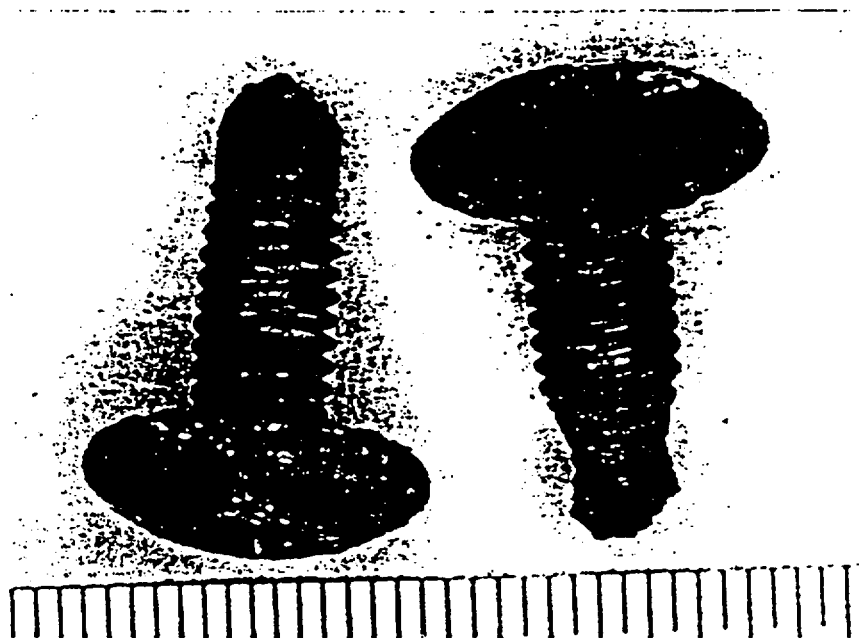
All screws removed from service had varying amounts of corrosion products on them, mostly in the threaded region. The lower view of Figure 1 shows a typical set of screws that were removed from service.

As-received photograph of a typical pair of used screws. Note that each set of used screws (set "C" through set "H") varied in degree of corrosion.

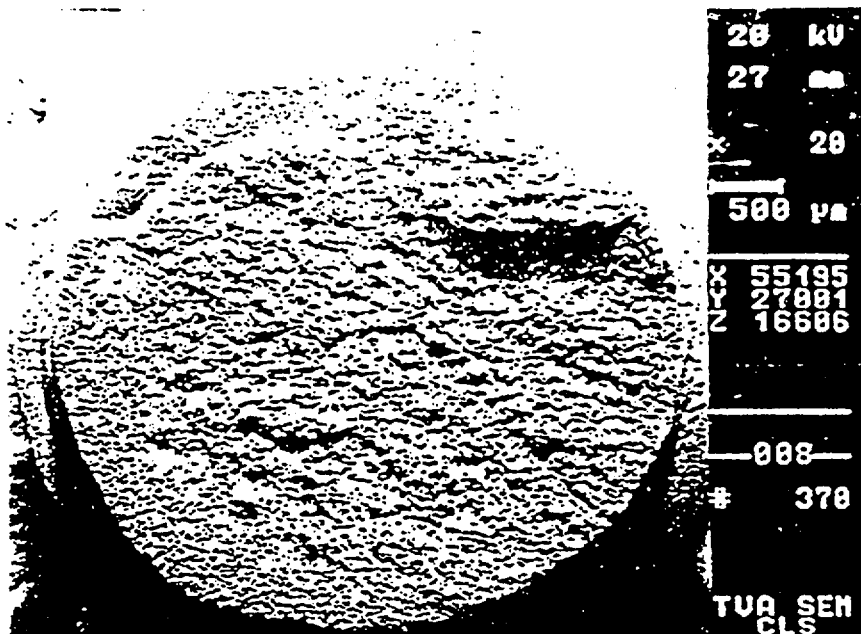
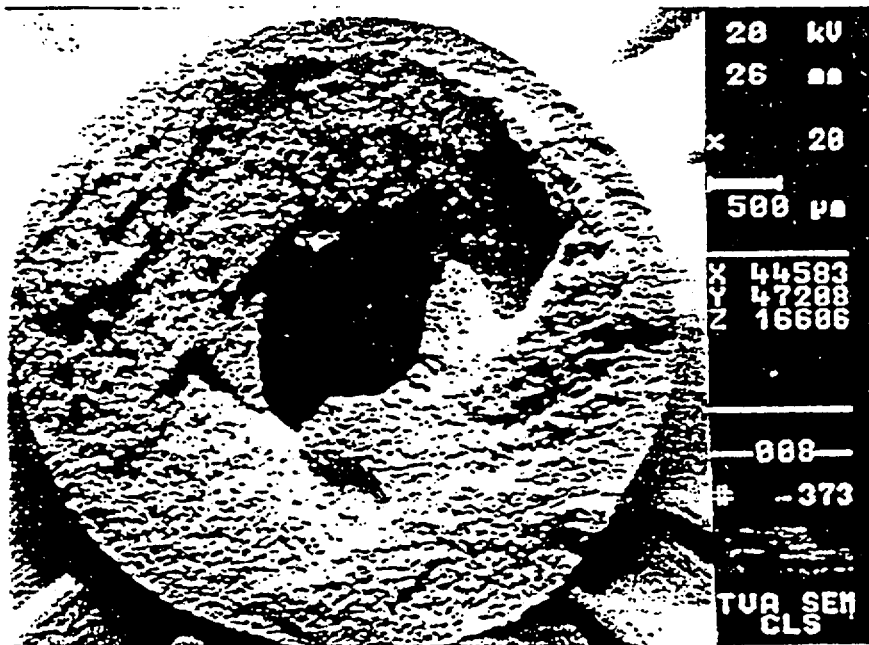
Figure 2 - Ice Condenser Basket Screws, Watts Bar Nuclear Plant, Unit No. 1. Customer Identification No. 95-07. Laboratory Report No. 95-1021.

The fractured screws that were in service in set "A" were examined in a Scanning Electron Microscope (SEM) in order to determine the mode of failure. Figures 2 and 3 show that the screws fractured in a brittle manner

as indicated by the intergranular failure mode seen on the screws that were examined. There was usually a small final-fracture area on the fracture surface near the center of the neck that failed in a ductile manner.

SEM photographs of typical fracture surfaces taken from fractures screws (set "A"). Note that all fractured screws received in set "A" failed in a brittle manner (except for the small final fracture area near the center, which failed in a ductile manner). 20X.

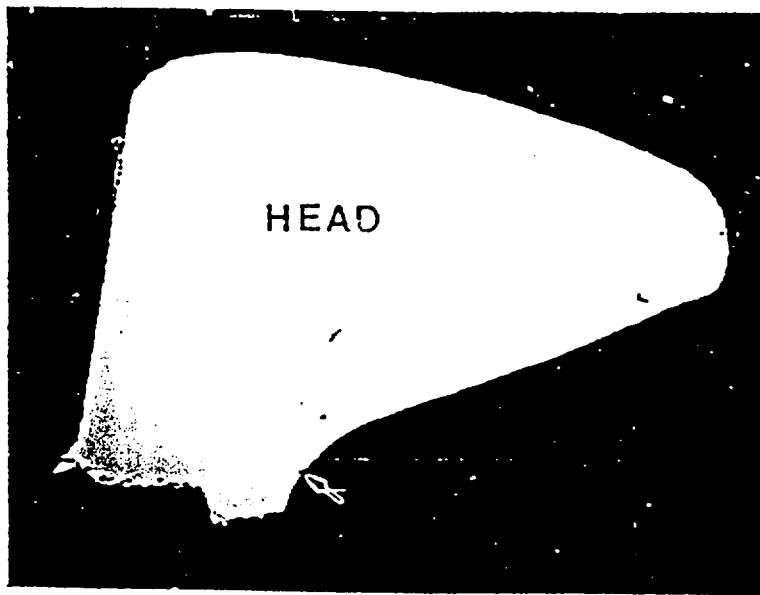
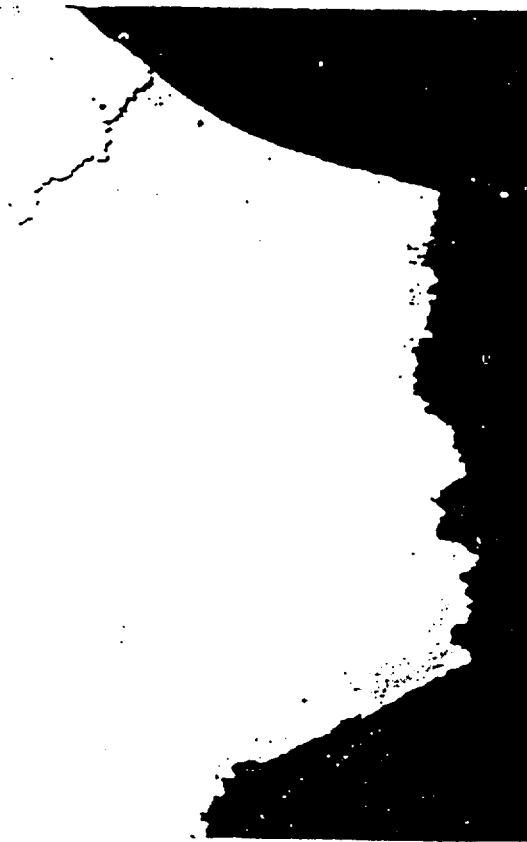
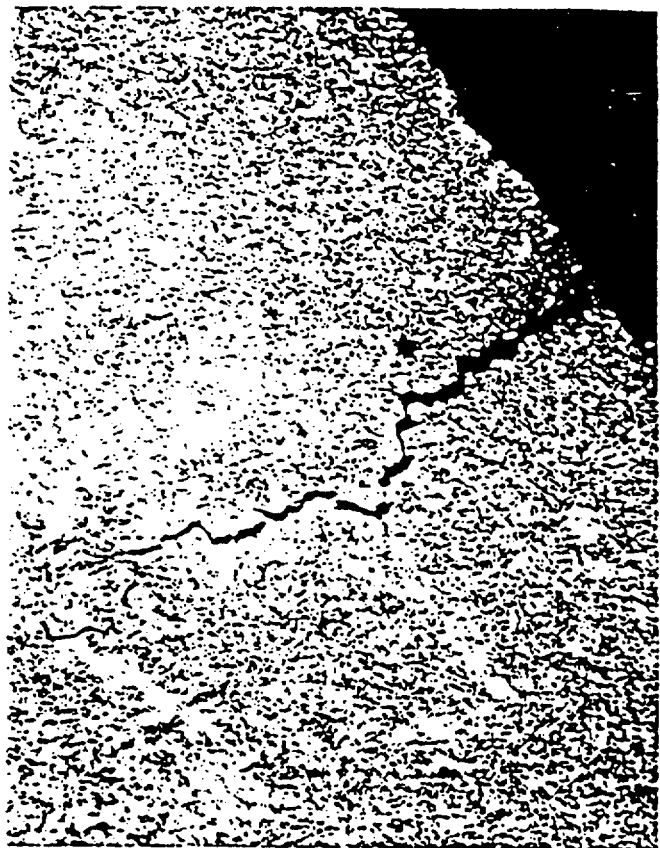
Figure 4 - Ice Condenser Basket Screws, Watts Bar Nuclear Plant, Unit No. 1. Customer Identification No. 95-07. Laboratory Report No. 95-1021.

An arbitrarily selected fractured screw (that was in service) from set "A" was cut so that a longitudinal cross-section through the fracture surface could be examined. Note that a secondary crack of intergranular nature was noticed above the fracture surface as seen in Figure 4. A screw from set "G" was similarly sectioned, and two cracks were found in adjacent thread roots as seen in Figures 5 and 6. Similar intergranular cracks were discovered in a transverse section of the whole screw from set "A" and at the thread roots of a screw from set "H" (Figure 7).

Screws from sets "C", "G", and "H" contained intergranular cracks similar to those seen in Figures 5, 6, and 7. Note that the intergranular crack found in a representative sample taken from a fractured screw in set "A" seen in Figure 4 differed from the intergranular cracks seen in Figures 5 through 7 because it was probably a secondary crack (since it is above the primary fracture and perpendicular to the curved neck of the screw rather than at the thread roots).

Longitudinal cross-section through a fractured screw. The arrow points to a secondary crack above the fracture surface. 20X. As-polished.

Close-up views of secondary crack seen in the upper view of this Figure. Left: As-polished, 125X; Right: Vilella's etch, 400X.

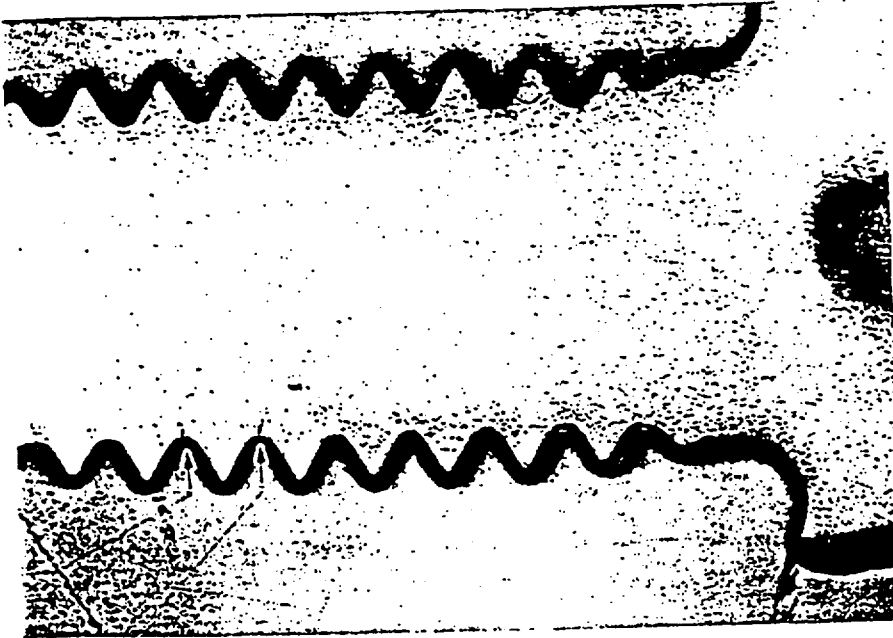
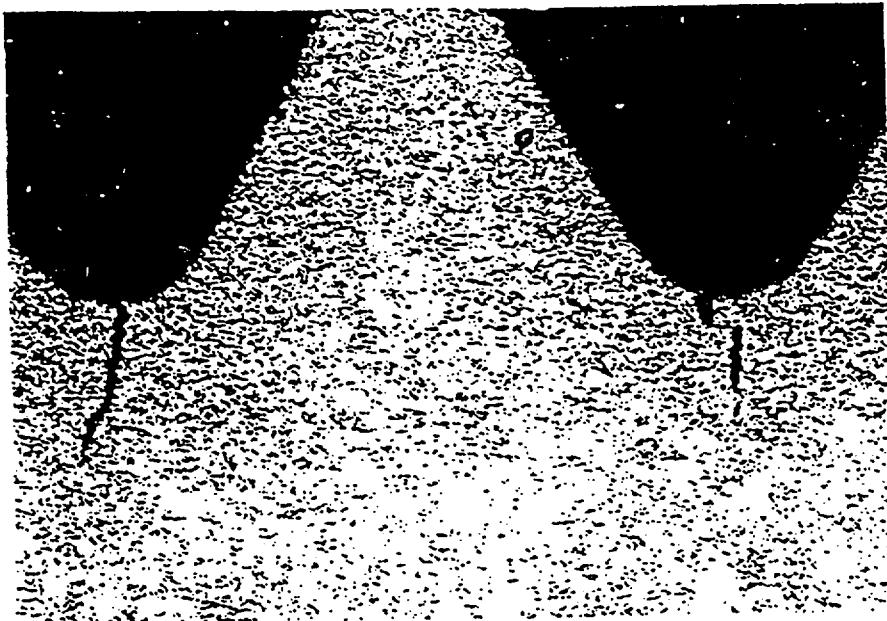
Figure 5 - Ice Condenser Basket Screws, Watts Bar Nuclear Plant, Unit No. 1. Customer Identification No. 95-07. Laboratory Report No. 95-1021.

EDX* analysis of the material in one of the cracks seen in the longitudinal cross section of a screw from set "G" revealed the presence of zinc as seen in Table I. Note in the upper view of Figure 6 that a lapped area was present at the thread roots of a screw from set "G". Similar lapped regions were discovered at the tip, face, and roots of every screw that was examined and is typical of the thread rolling process.

Longitudinal view of cracks present in one of the screws that were removed from service in set "G". Top: 12X; Bottom: 100X.

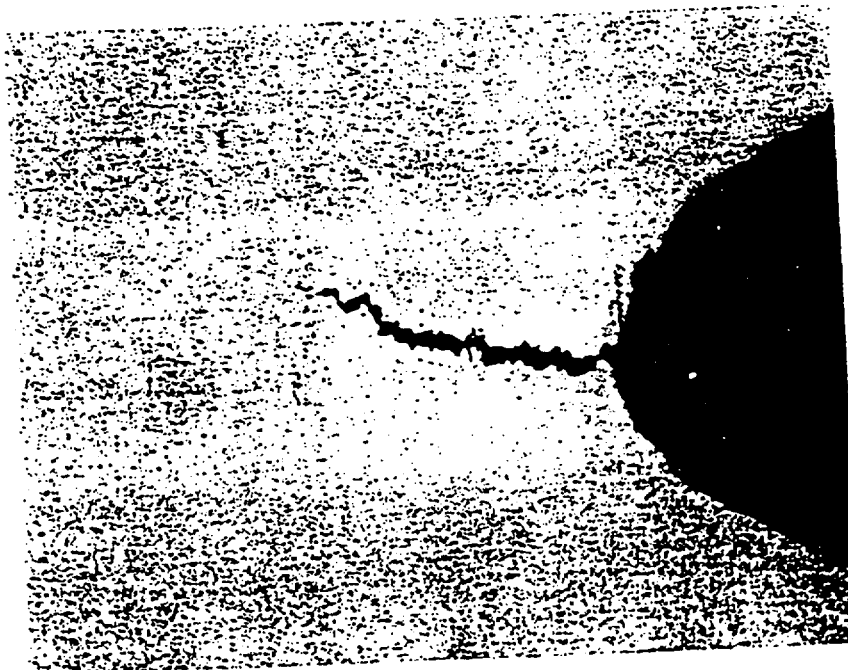
Figure 6 - Ice Condenser Basket Screws, Watts Bar Nuclear Plant, Unit No. 1. Customer Identification No. 95-07. Laboratory Report No. 95-1021.

As-polished, longitudinal view of lapping present at tooth root of a screw that was removed from service in set "G". 200X.

As-polished, longitudinal view of crack present at tooth root of a screw that was removed from service in set "G". 200X.

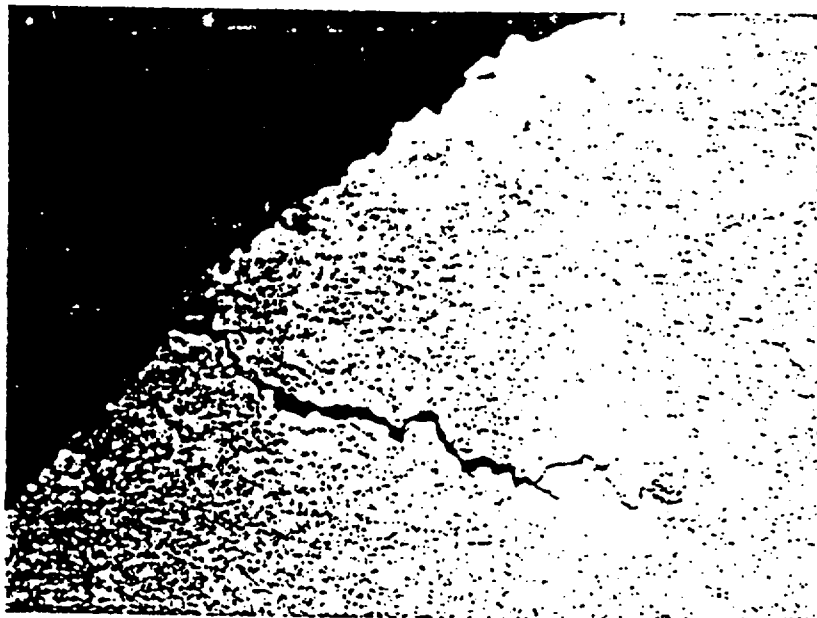
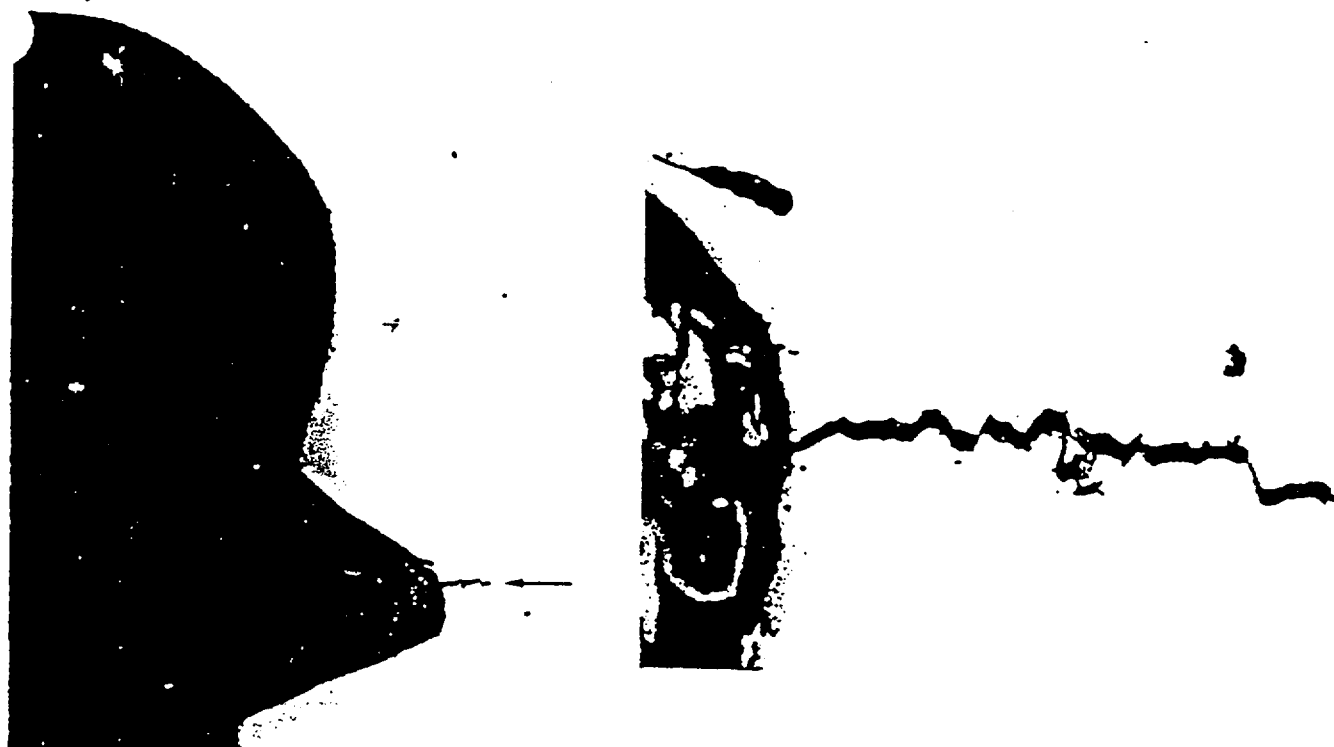
Figure 7 - Ice Condenser Basket Screws, Watts Bar Nuclear Plant, Unit No. 1. Customer Identification No. 95-07. Laboratory Report No. 95-1021.

Transverse cross-sectional view of a crack present in the screw that was not in service from set "A". 400X. Vilella's etch.

Intergranular crack found at thread root of first thread below head in a longitudinal cross section of a screw that was removed from service in set "H". Left: 50X; Right: 500X. As-polished condition.
