SUBJECT: DIABLO CANYON INSPECTION REPORT NO. 50-275/01-03; 50-323/01-03

Facility: Diablo Canyon Nuclear Power Plant, Unit 1 and 2

Dates: April 1 through May 19, 2001

Attachment 2 Auxiliary 1-2 Overheated Joint 309

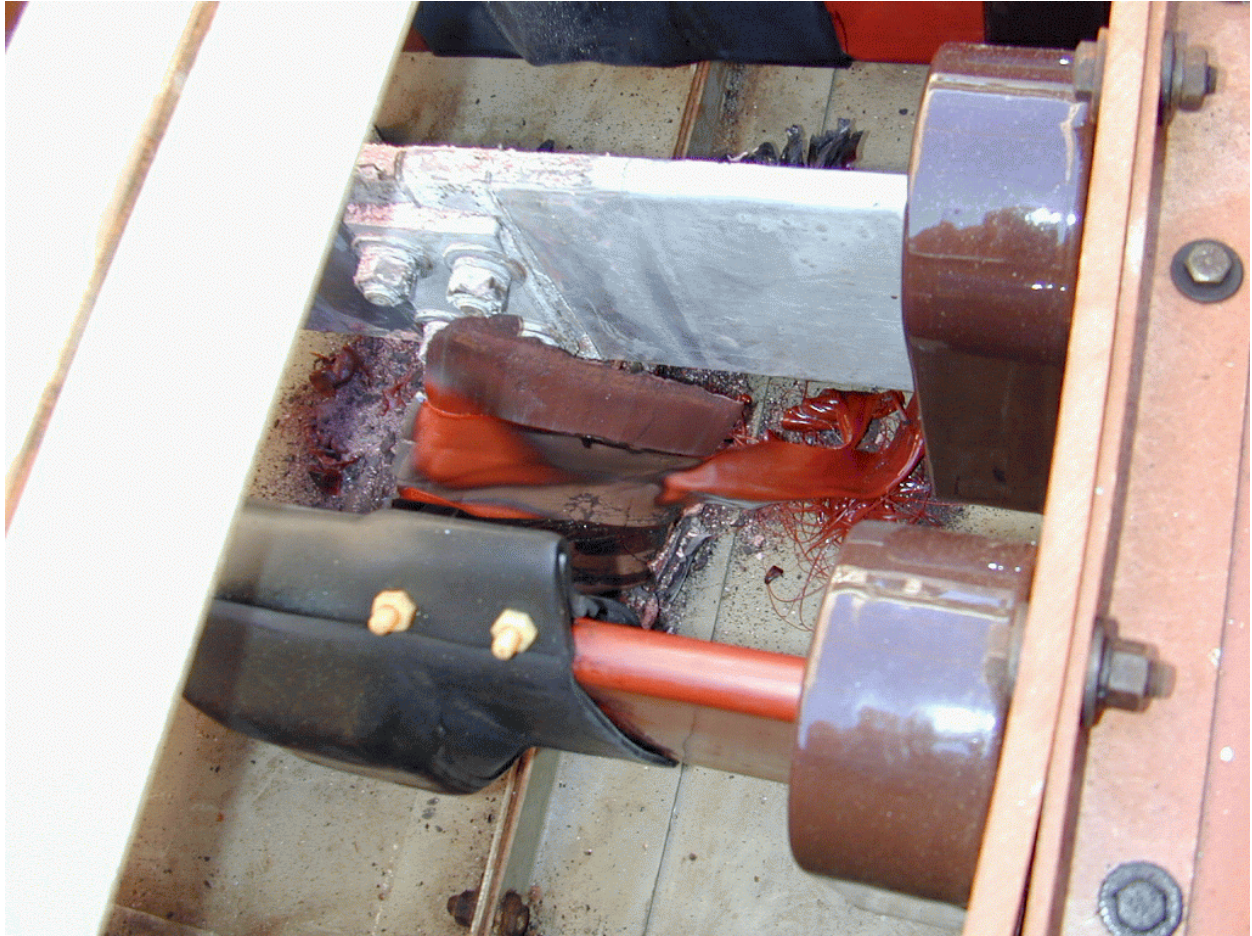
The licensee determined that an overheated splice joint was located on the center phase of the 12 kV bus bar from Auxiliary Transformer 2-1 to Buses D and E. The splice joint was located outside of the turbine building approximately 10 feet from the transformer. The inspectors verified that there were no other bus ducts in close proximity to the bus duct at the degraded splice joint. The inspectors noted that the adjacent joints on either side of the degraded joint had evidence of overheating, as well as the Raychem insulation on the center phase. As seen in Attachment 2, a second Splice Joint (307A) had also degraded because of overheating.

The inspectors noted that the licensee expressed surprise at the amount of overheating and degradation identified at Joint 309. The licensee concluded that the joint would not have lasted another operating cycle without failing. The licensee estimated that the joint could have failed within 4-6 months since the failure mechanism (increased resistance resulted in increased heating that increased the degradation/resistance, et cetera) was increasing exponentially. The inspectors concluded that the licensee had missed a failure by a small margin. The inspectors noted that had a failure occurred that the power supply to the reactor coolant pumps and circulating water pumps would have tripped. An anticipatory reactor trip would have occurred. The event would have

View 1 of BUS 309 Showing degraded Insulation on Bus Bar.

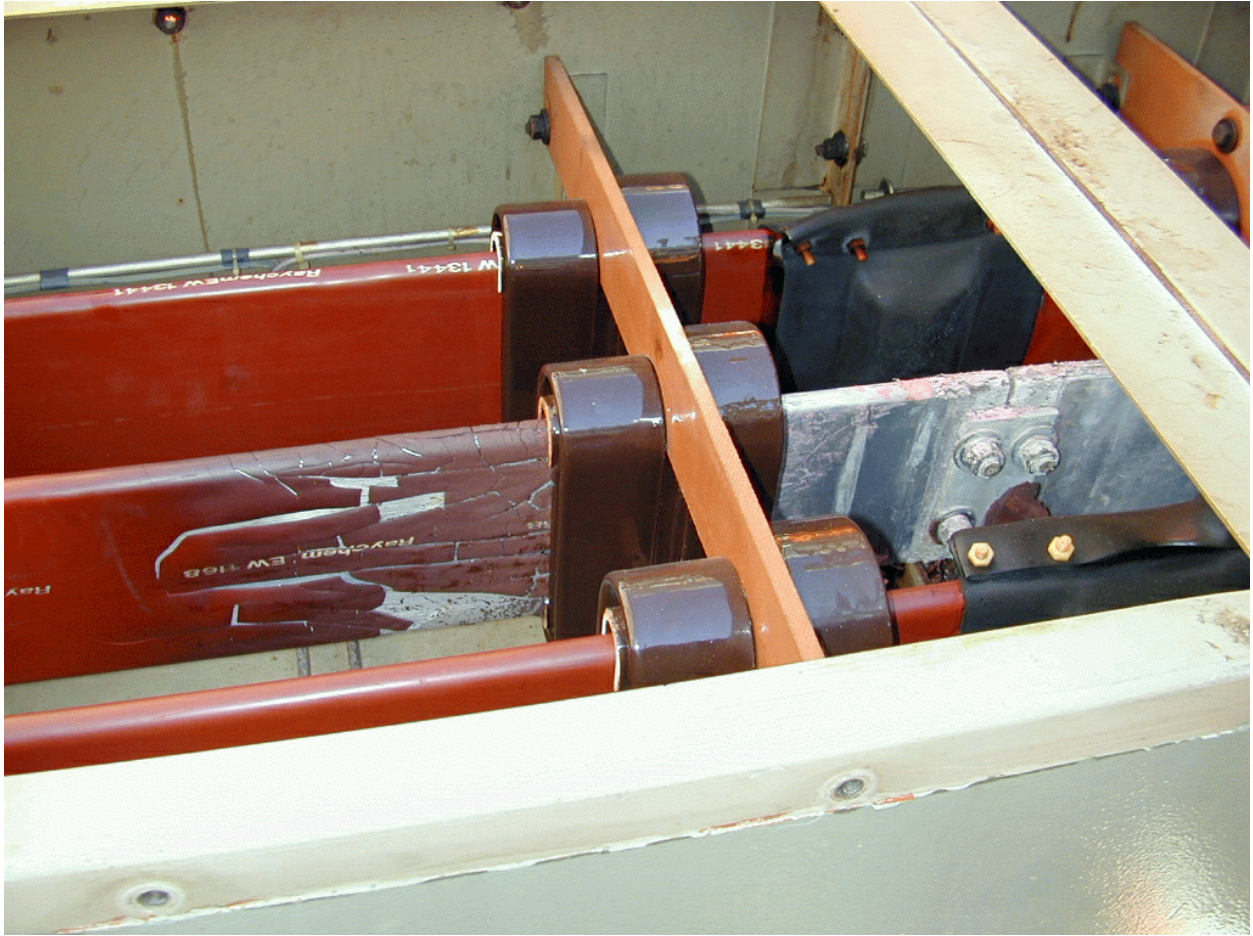
View 2 of BUS 309 Showing degraded Insulation on Bus Bar

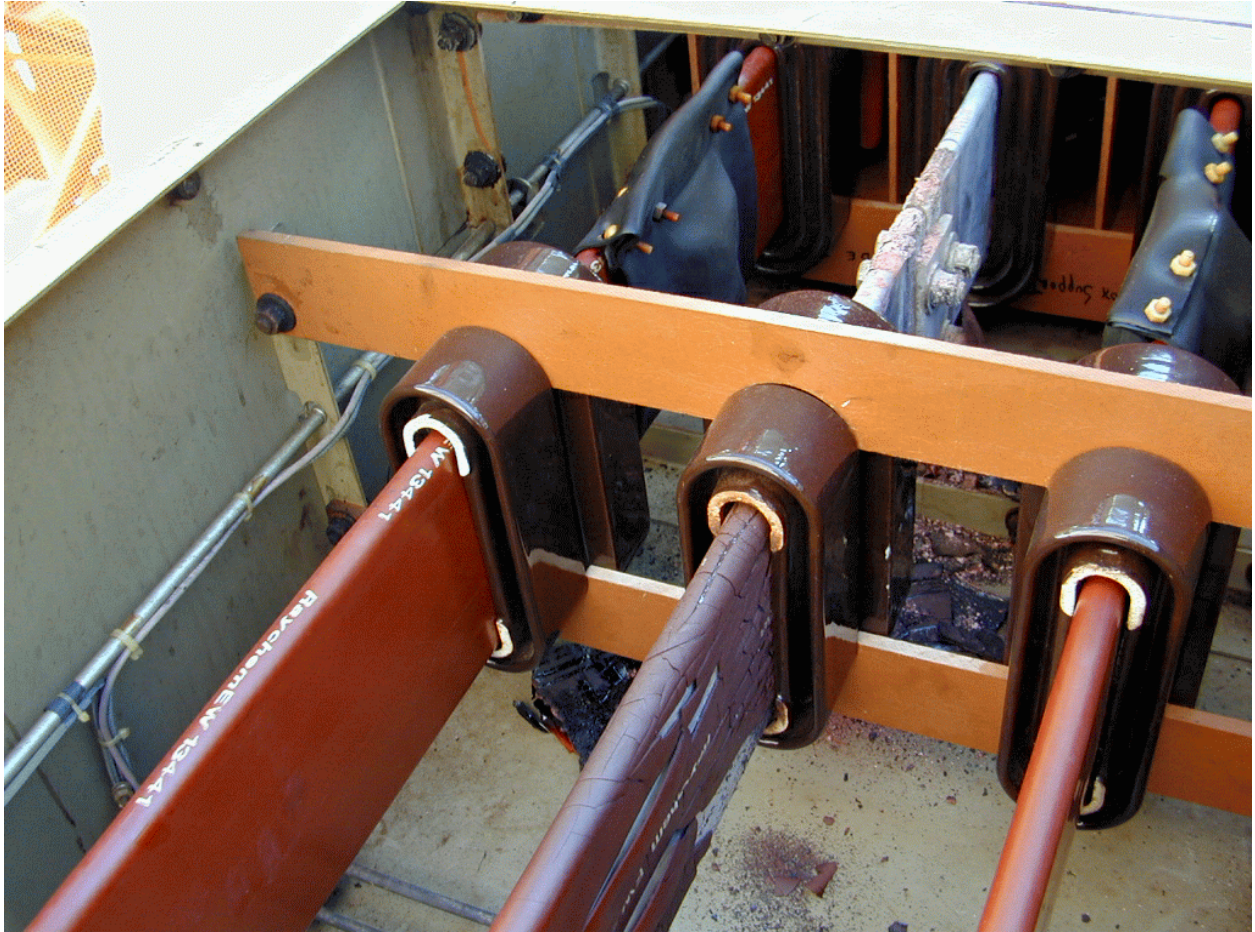
View 1 of BUS 309 Showing degraded Insulation on Bus Bar
