**Pacific Gas and
Electric Company**

Docket No. 50-275, DPR-80
Docket No. 50-323, DPR-82
Diablo Canyon Units 1 and 2
Monthly Operating Report for May 2001

Report of Breakwater Survey Inspection Required by Diablo Canyon Power Plant
Equipment Control Guideline 17.3

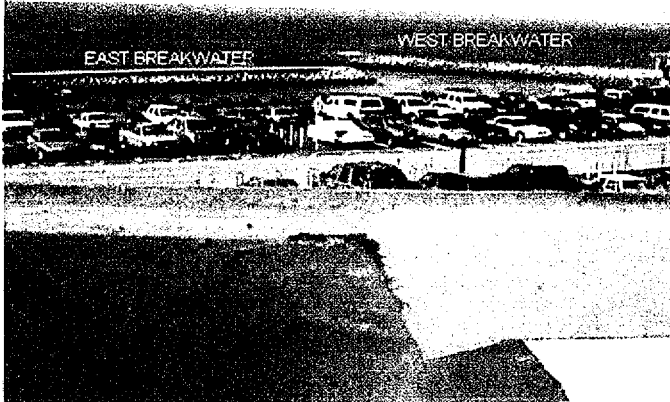
PHOTO 1
OVERVIEW OF EAST & WEST BREAKERWATER

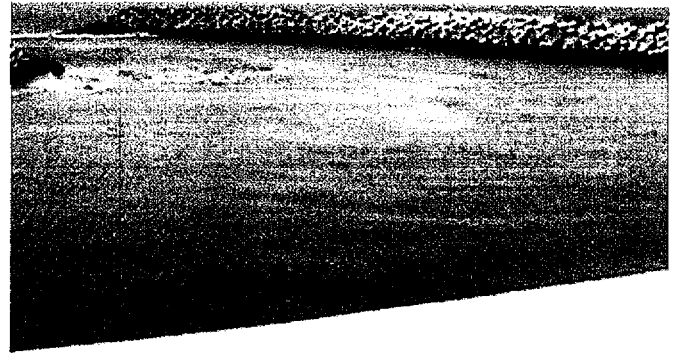
PHOTO 2
OVERVIEW OF WEST BREAKWATER FROM TOP
DECK OF INTAKE STRUCTURE

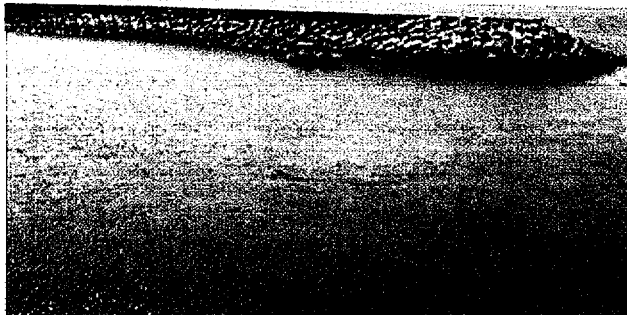
PHOTO 3
OVERVIEW OF EAST BREAKWATER FROM
TOP DECK OF INTAKE STRUCTURE

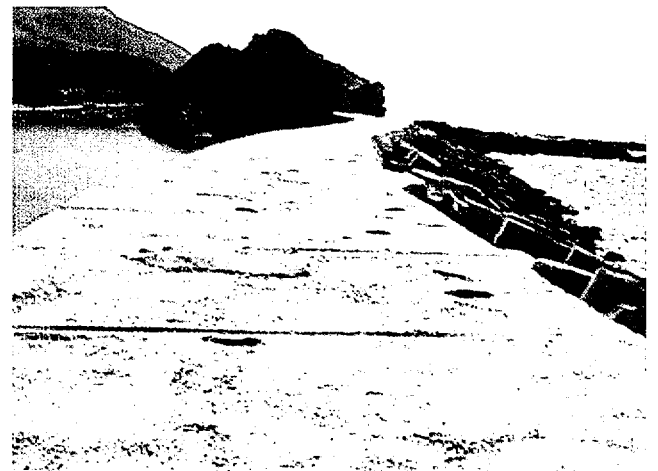
PHOTO 4
EAST BREAKWATER VIEW FROM END OF CAP

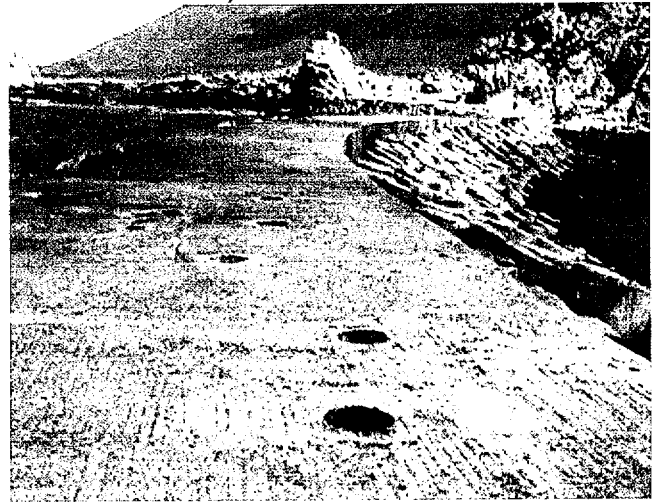
PHOTO 6
WEST BREAKWATER VIEW FROM END OF CAP
