Subject: Borg-Warner 3" and 4" Swing Check Valves

10 CFR PART 21 NOTIFICATION

(Reference No. CFRN-9301)

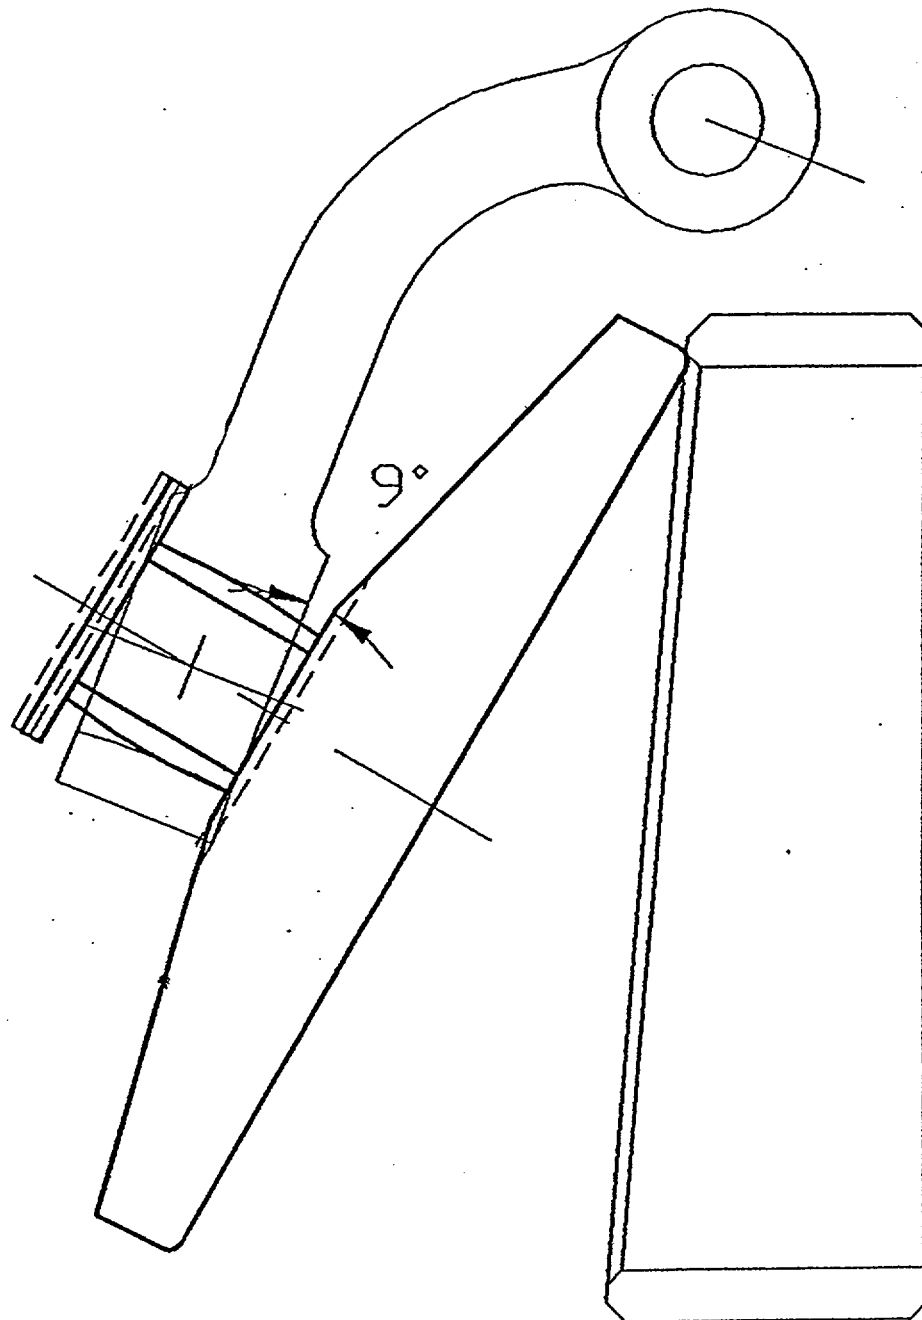
Required Angle of Disc Rotation and Axial Gap for Interference

Valve 2CC-0697 did not fully close during pre-operational testing. Radiographs taken at the time of failure show the disk positioned at approximately 21° from the full closed position. The valve was disassembled. The top of the disk was found to be lodged under the seat lip preventing full closure. Valve 2CC-0693 subsequently failed testing in a similar manner. Both valves are located in the Component Cooling Water return lines from the Reactor Coolant Pump Motor Coolers and do not serve an active safety function. However the failure mechanism could apply to other valves that do provide a safety function.

Evaluation of the basic component by BW/IP indicates the root cause of the failure to close is due to the configuration of the attachment weld between the disk to the stud. Prior to 1977, this weld was placed on the back surface of the stud and extended into the bushing bore. In disks manufactured after 1977, the weld was recessed into the back surface of the disk and a final machine cut made to assure a flush surface.

On May 31, 2001, Arizona Public Service Co. advised Flowserve that they recently encountered the same problem on a 4"-1500# pressure seal swing check valve. Because of this, Flowserve decided it would be prudent to notify or re-notify all customers who purchased 3" or 4" swing check valves or disc assemblies in 1977 or earlier of the potential problem. We recommend the valves be inspected at the earliest convenient time and if evidence of interference is found, replace the disc assembly. The enclosed sketch depicts the potential problem if there is excessive disc angular movement.

Corrective action is complete with the disk design modification identified above.

Licensees with valve installations effected by this notice should install a new disk component or refurbish the existing disk.
