Risk Methods Insights Gained From Fire Incidents

Sandia National Laboratories

U.S. Nuclear Regulatory Commission
Office of Nuclear Regulatory Research
Washington, DC 20555-0001

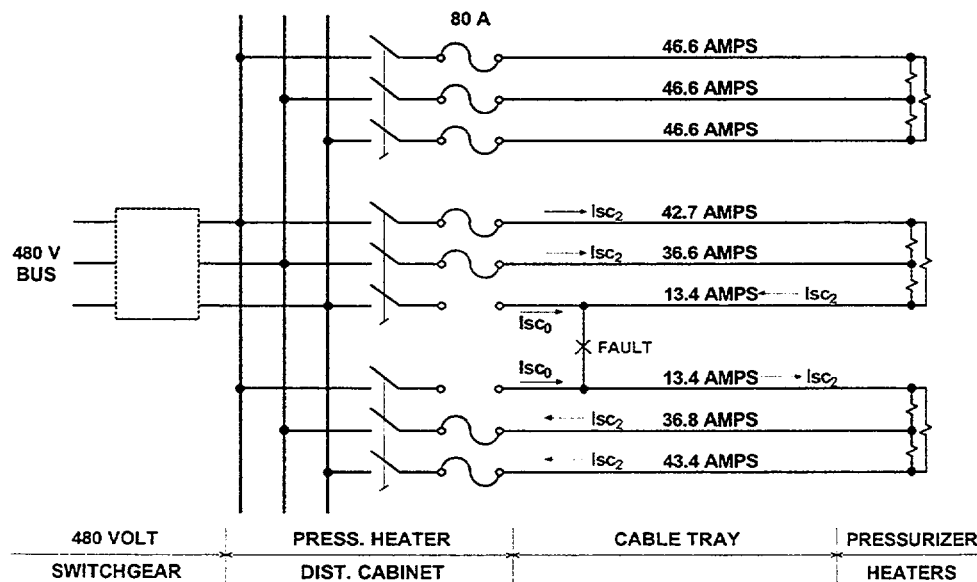
Figure A1-1: Schematic of Pressurizer Heater Circuits.

In terms of the fire cause, there are many similarities between the two incidents. The investigation concluded that the most probable cause of both fires was thermally and mechanically stressed cables, coupled with the use of individual fuses to provide for clearing of faults on each phase of the three-phase 340-volt circuits. It also appears that the cables were undersized for their design current loads under their actual installations conditions.

The initial fault is thought to have been a cable-to-cable, phase-to-phase hot short involving two separate power feeds from the same three-phase power bus. The fusing configuration allowed back-feeding of fault current through the un-faulted phases of each power feed which led to an even more severe over-current condition for the conductors. Figure A1-1 provides a schematic of the power circuit for the pressurized heaters. In that figure, I_{SC0} depicts the initial short circuit after cable failure and I_{SC2} is the subsequent short circuit current back-fed through the heaters. Note that the portion of I_{SC2} passing through the intact fuses is below the continuous rating of each fuse.

Both incidents involved self-ignited cable fires. They are important because they are the earliest fire incidents at a nuclear power plant where self-ignition of cables resulted in extensive equipment damage and loss of operability of equipment. While the first incident saw little or no fire spread, the second incident saw fire spread to three cable trays that were “totally burned for 15 feet.” Investigation of the incidents led to recommendations that urged industry to re-examine cable qualification and to raise the standards for establishing cable ampacity limits and for improving the flammability behavior of cables. Since the time of this fire, cable ampacity standards have improved substantially and now explicitly address cable tray applications. Cable ampacity standards are now widely recognized and applied. Further, a flammability standard was incorporated into IEEE-383, the general nuclear cable qualification standard [Ref. A1-2]. Most cables used in current U.S. reactors are required to meet this standard.

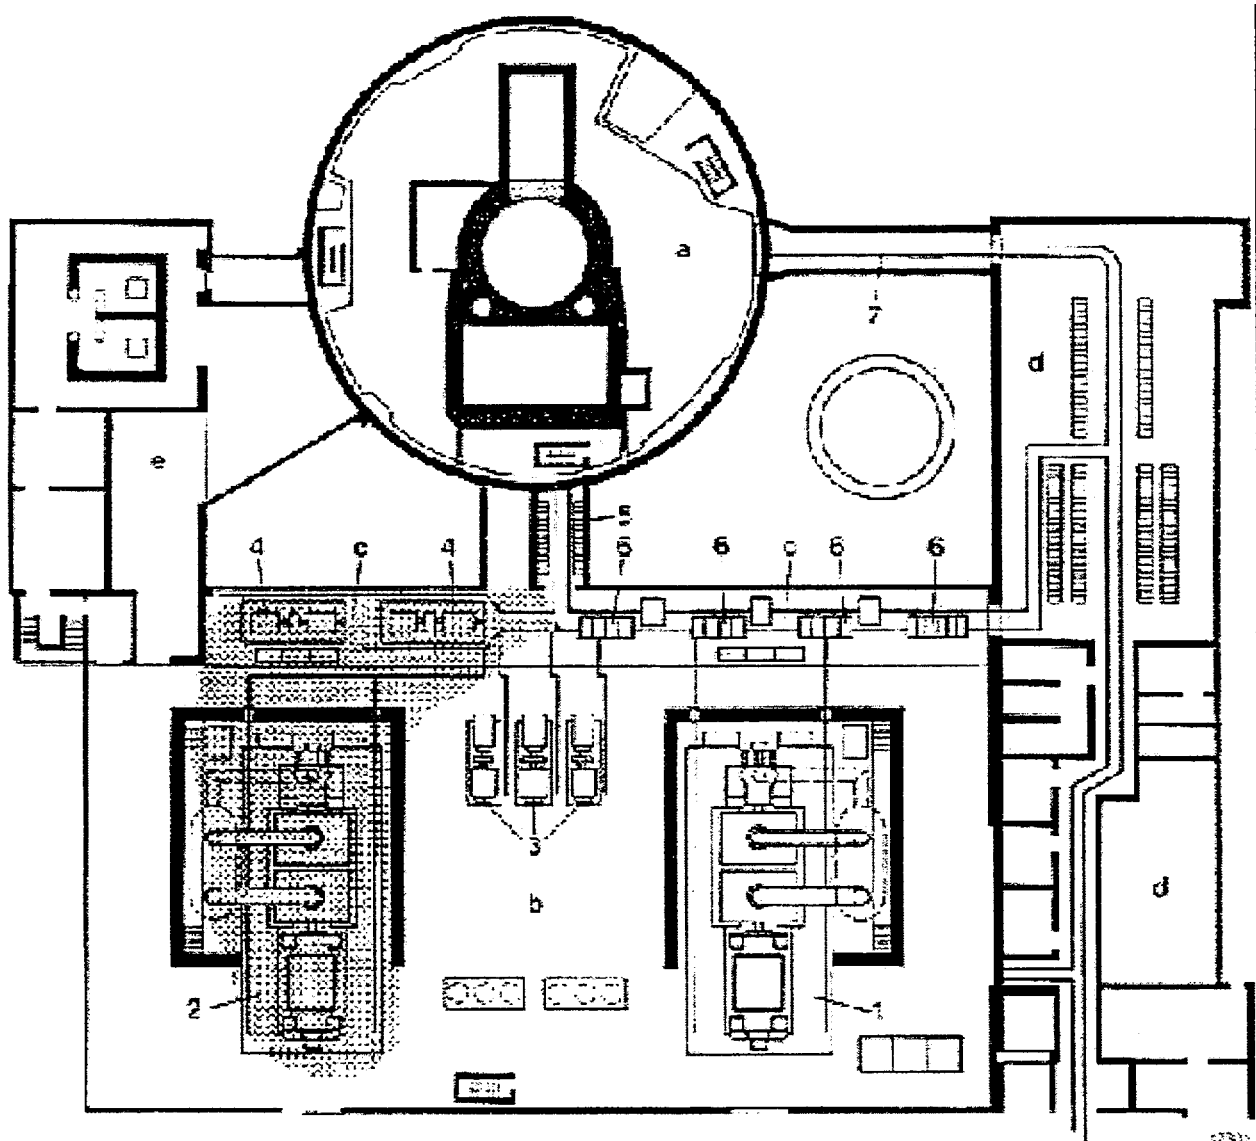
Figure A2-1 Location of Fire at Mühleberg (from Reference [2-1])

Figure A2-1 is a simplified layout drawing of the plant that shows the area where fire occurred. Note that the single lines extending between various items depict cable routes. Item 2 in that figure is the turbine-generator B, item 4 is the two motor generator sets, items 5 and 6 are the non-safety switchgear and item 7 is the cable "bridge" (as noted in Reference [A2-1]) between the reactor and turbine buildings.

Extensive damage was inflicted on the turbine building itself. It is estimated that 75% of the roof

covering, 60% of the windows and 50% of the paintwork were severely damaged. Some of the purlins of the building were deformed, concrete surfaces near the turbine B, a number of gratings and wall insulation slabs were damaged. Aside from cables and electrical equipment, little direct damage was sustained by major mechanical equipment. Some peripheral items, insulation and piping were found to be damaged. However, the cables and electrical equipment sustained extensive damage. Turbine instrumentation, control panels, lighting equipment and 3000 kg of PVC cables were found to be severely damaged.
