SUBJECT: TECHNICAL ASSISTANCE REQUEST - REVIEW OF GROUNDWATER
TEST RESULTS SUBMITTED BY VIRGINIA POWER CO. FOR ITS
CATEGORY I SERVICE WATER POND DAM AT NORTH ANNA

Project: Dam Safety Inspection - North Anna Category I Service Water Pond Geochemistry

RITS/TAC No: 201112E/A10277

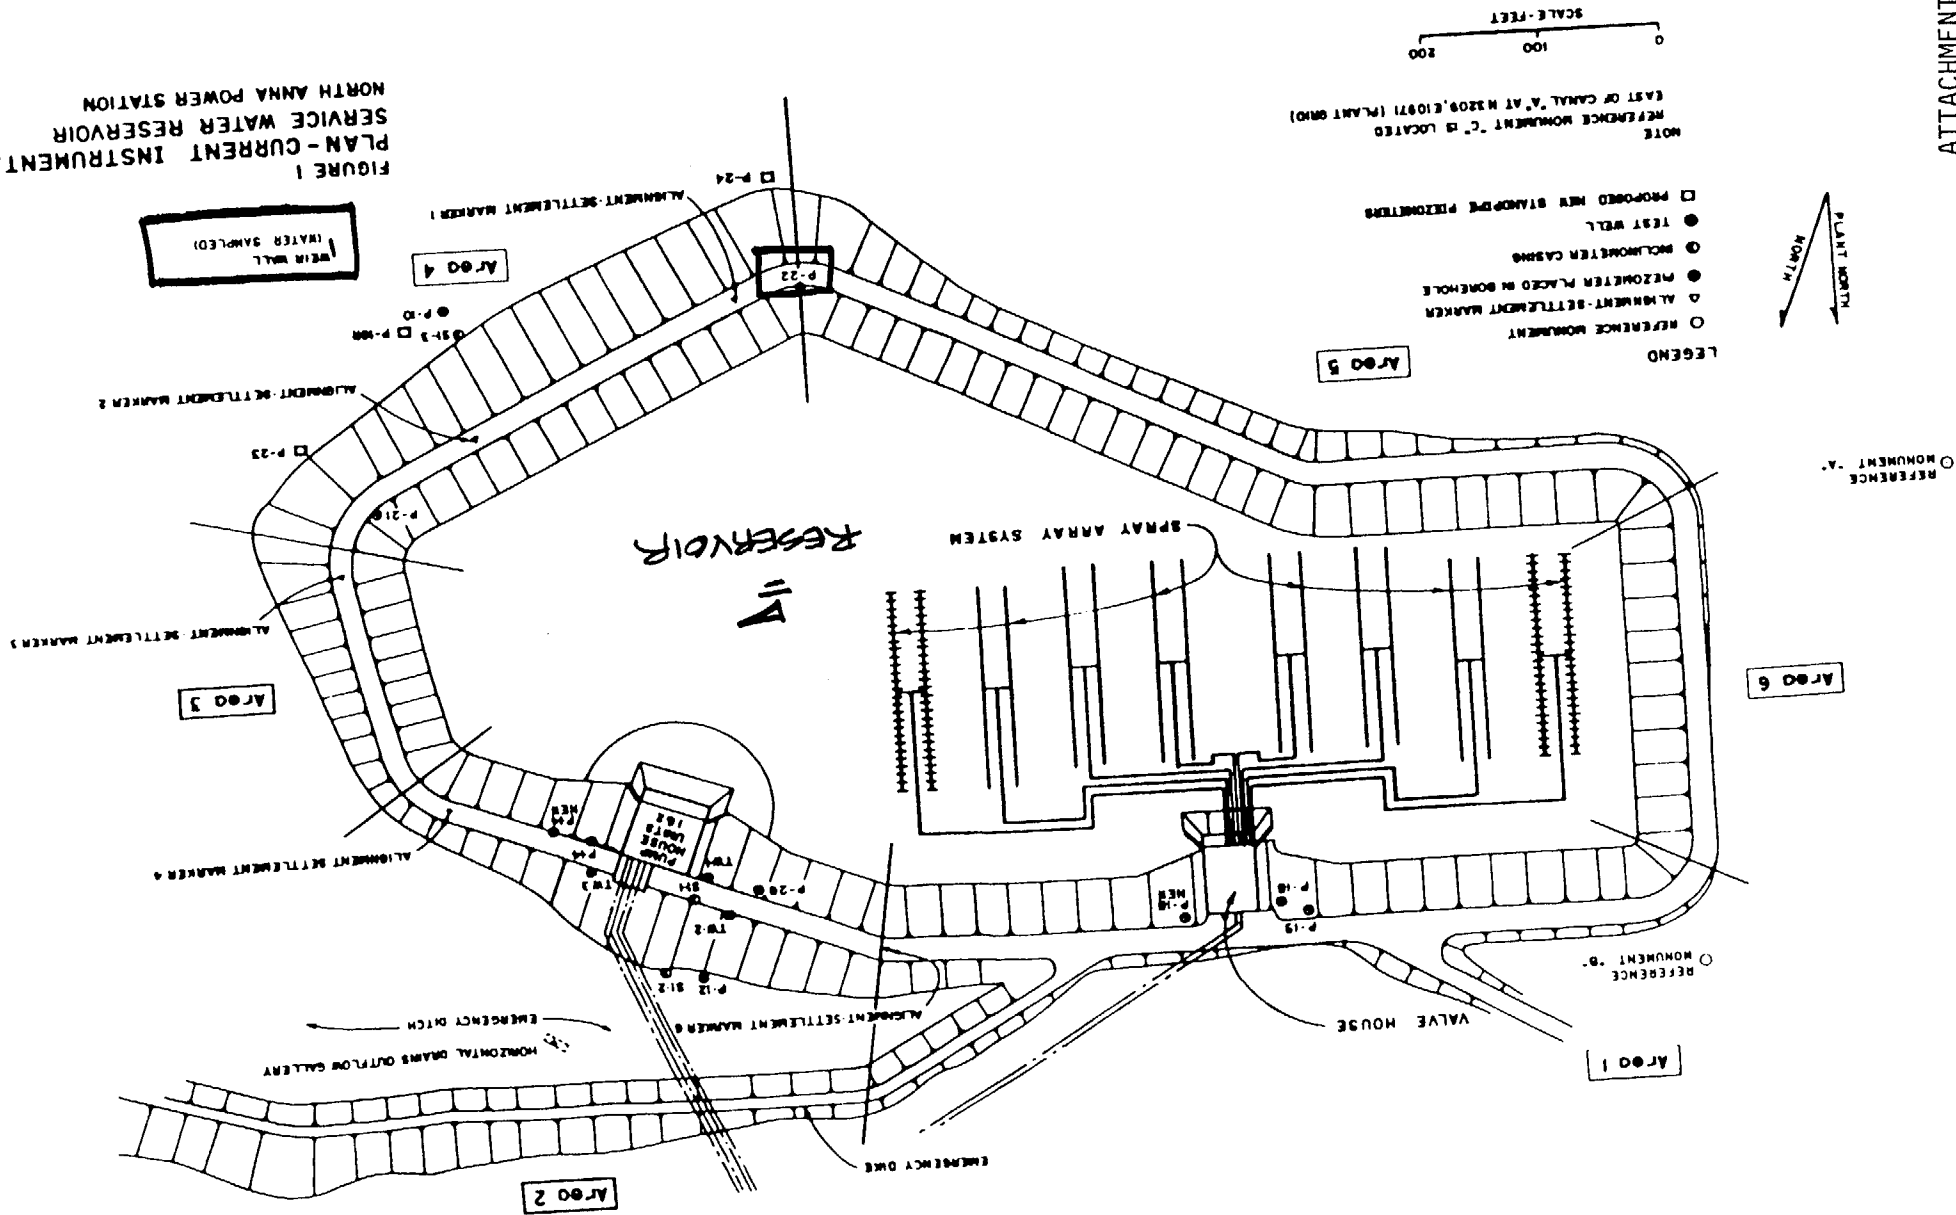
FIGURE 1
PLAN-CURRENT INSTRUMENTATION
SERVICE WATER RESERVOIR
NORTH ANNA POWER STATION

Background: In 1997, 1999, and 2001, NRC has observed apparent seepage water below the SWR embankment. VPC has stated that the water is runoff, unrelated to seepage. On January 12, 1998, VPC took water samples from the SWR, piezometer P-22, and ponded water below the SWR dike. VPC ran conductivity tests and concluded that the water from P-22 and below the SWR dike did not originate from the reservoir. A technical review of the test results and conclusions is requested.

Action: Water samples were taken from three areas around the SWR on January 12, 1998 to measure conductivity. These included water from the service water reservoir, water from piezometer P-22 casing during bailing, and ponded water at the weir wall in the wet area below the SWR dike and adjacent roadway (Attachment 2, Figure 1).

Piezometer P-22	99 micromhos
Weir Wall	123 micromhos
Service Water Reservoir	922 micromhos

Conductivity is a measure of a solution's capacity to conduct electric current and depends on the presence of ions. The more dissolved salts/ions that are present in the solution the higher the conductivity that would be expected. The substantially higher conductivity values obtained from the SWR sample is due to the biocidal and other chemical treatment used in the reservoir.

These conductivity tests clearly indicate the water obtained from piezometer P-22 and the drainage area did not originate from the reservoir and therefore are not the result of seepage from the reservoir. As a comparison, the conductivity of distilled (de-ionized) water ranges from 0.05 to 2.0 micromhos.

4. Virginia Power Corporate staff indicated that analysis of seepage water could determine whether seepage was from the SWR. Once the weirs are operational, water samples should be taken to see if the water source is in fact the SWR.

5. Reactivate weirs for flow measurements. Those that cannot be made functional should be removed and new weirs established.

Action: Results of the conductivity tests on a water sample taken from the weir wall which is located downstream or downgradient from the other weirs, clearly indicates that the water did not emanate from the reservoir. Therefore, reactivating weir flow measurements would only measure runoff and groundwater movement which would provide extraneous data not pertaining to SWR seepage or stability. In our opinion, such effort is unwarranted.
