**Pacific Gas and
Electric Company**

PG&E Letter DCL-01-099

Diablo Canyon Units 1 and 2
Licensee Event Report 1-2001-002-00
System Actuation: Unplanned Diesel Start Due to Loss of Startup Power

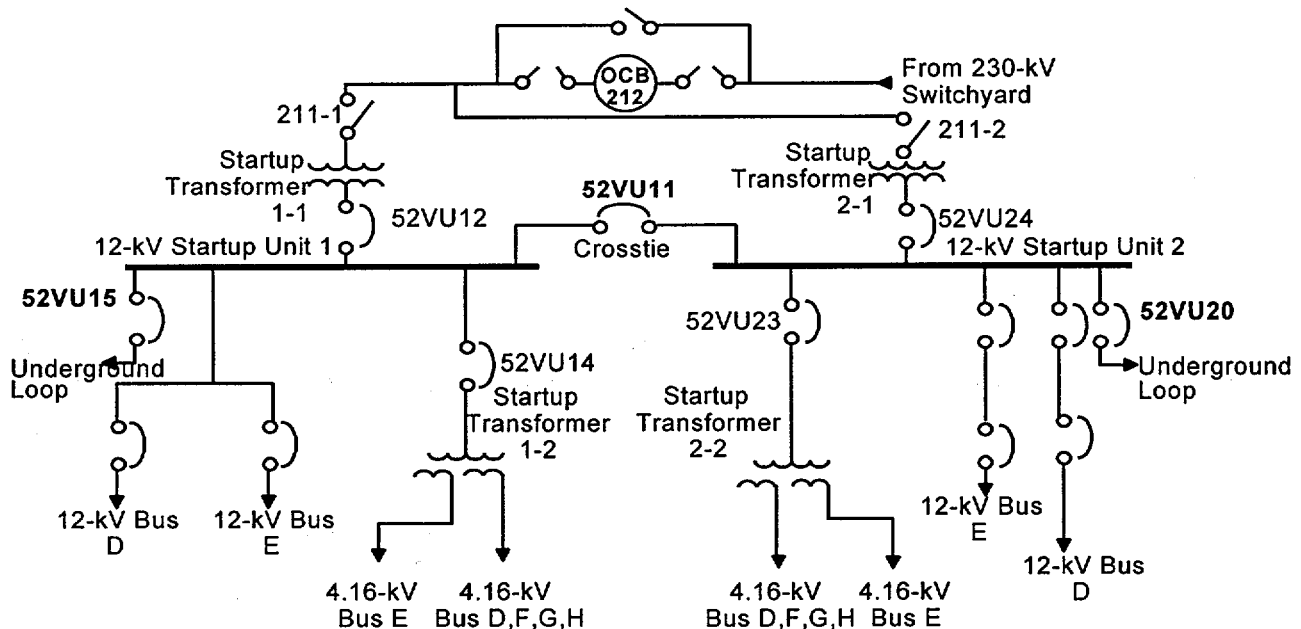
Figure 1: Startup Power Diagram

Oil Circuit Breakers (OCB) are used in the 230kV switchyard to connect and disconnect the 230kV system from the plant. The 230kV system provides power through OCB 212 to Startup Transformers (SUT) 1-1 and 2-1 (230kV to 12kV) [EA][XFMR]. SUTs 1-1 and 2-1 then distribute power to the Unit 1 and Unit 2 Startup Buses, respectively. The Unit 1 and Unit 2 Startup Buses then feed SUT 1-2 and SUT 2-2 (12kV to 4160 V) [EA][XFMR], respectively. SUTs 1-2 and 2-2 can then supply power to each unit's 4160 V vital and nonvital buses. Figure 1 provides additional detail of the startup power system.
