Dry Cask Storage Characterization Project—Phase 1: CASTOR V/21 Cask Opening and Examination

Idaho National Engineering and Environmental Laboratory

U.S. Nuclear Regulatory Commission
Office of Nuclear Regulatory Research
Washington, DC 20555-0001

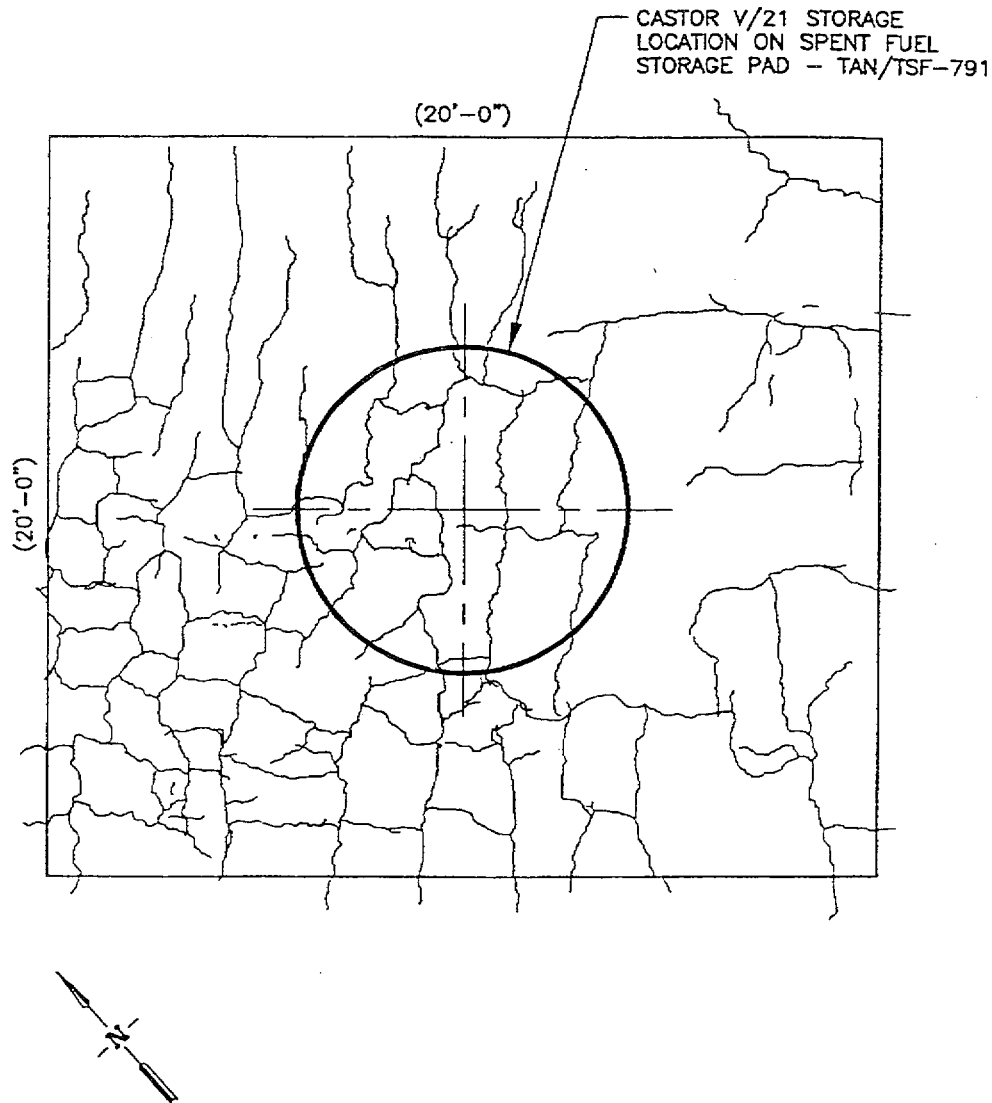
The pad was also visually inspected for evidence of degradation and structural failure. The surface of the whole pad did not exhibit any evidence of structural failure of the concrete, such as open cracks or cracks with displacements in elevation of the surface. The surface of the concrete did not exhibit any evidence of spallation of the surface, exposed aggregate, or aggregate pop-out from the surface. The surface was solid and exhibited only minor wear and environmental weathering, well within the extent of weathering expected for the cold and windy climate of Idaho. The broom-finished unpainted surface exhibited only a network of faint, fine surface shrinkage cracks (Figure 2-3), less than 0.8 mm (1/32 in.) wide and of superficial depth, and a few rust stains under the cask from lightly rusted bolts on the cask. Similar cracks were prevalent across the entire surface of the pad, and were not associated with the cask locations. Tests with a straight taught line across the 6.1 m \times 6.1 m (20 \times 20 ft) grid indicated that there was no sag or vertical displacement in the concrete associated with the crack network; measurements with a straight edge and the taught line indicated only localized variations in the elevation of the concrete that were less than 3.2 mm (1/8 in.). The localized variations in elevation were not associated with the location of the cask and were most likely an artifact of the screeding and finishing when the concrete was originally poured.

Figure 2-3. Shrink crack indication of CASTOR V/21 concrete pad storage area.

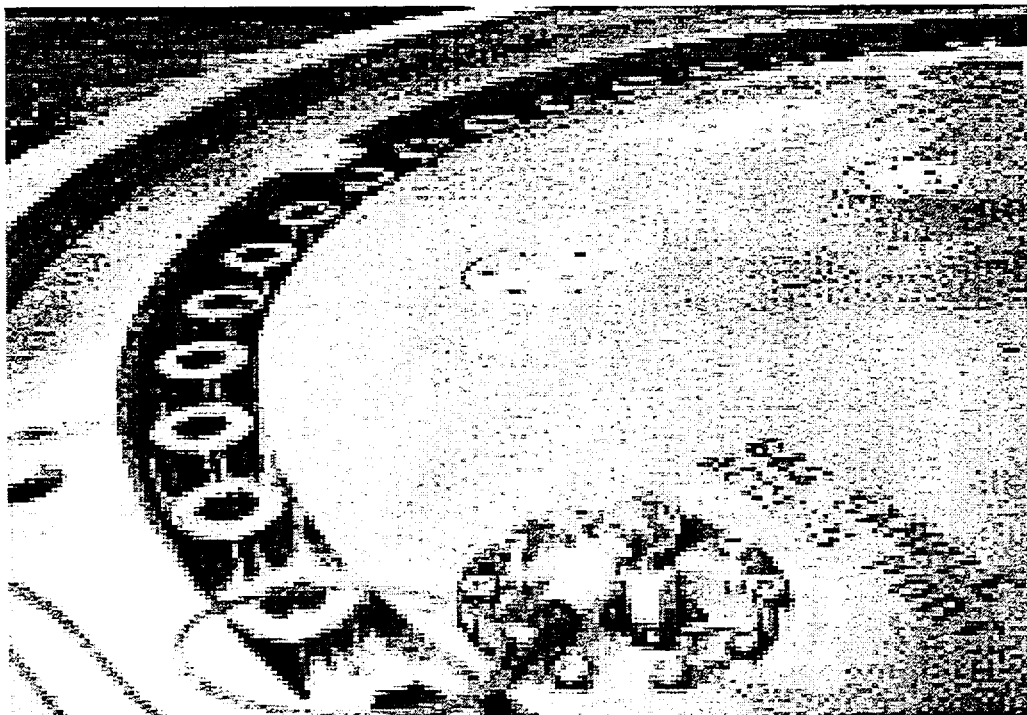
All bolts were in satisfactory condition. The exposed portion of all bolt heads were found to be in very good condition. None of the primary lid bolts as shown in Figures 2-6 and 2-7 had any indications of

Figure 2-7. Cask primary lid bolts prior to removal.

pitting or general corrosion, cracks, thread damage, discoloration, or any defects or indications of potential failure. All bolts had a deposit of graphitic thread lubrication over the threaded area of the shaft. Nine of the bolts also had a residue of a light gray/white material on the threads that resembled tape residue, and a residue of a red compound, probably a thread compound.

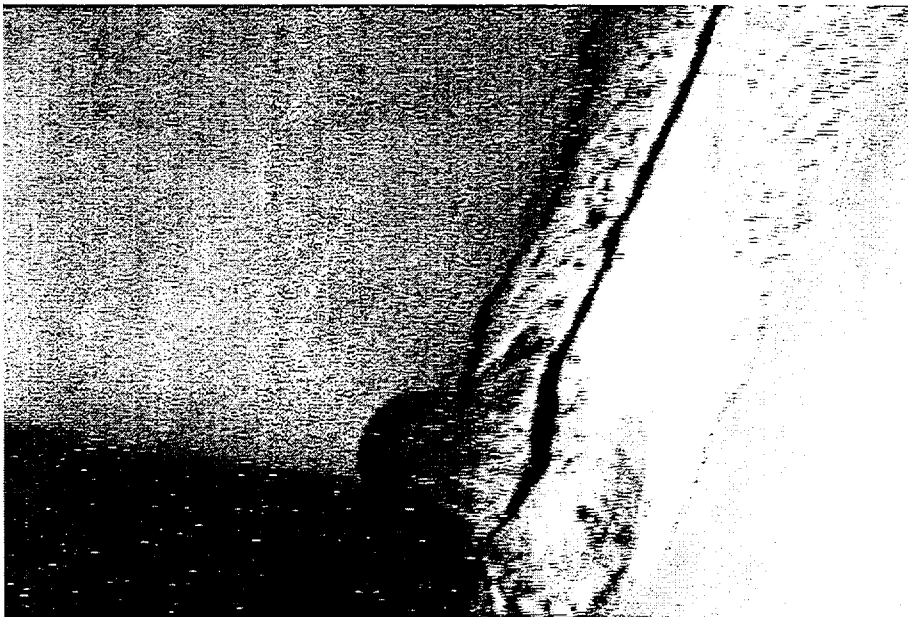
Figure B-8. Bottom weld crack at location 12 identified in Figure B-19.
(Triangular air channel between fuel tube B7 & B8)

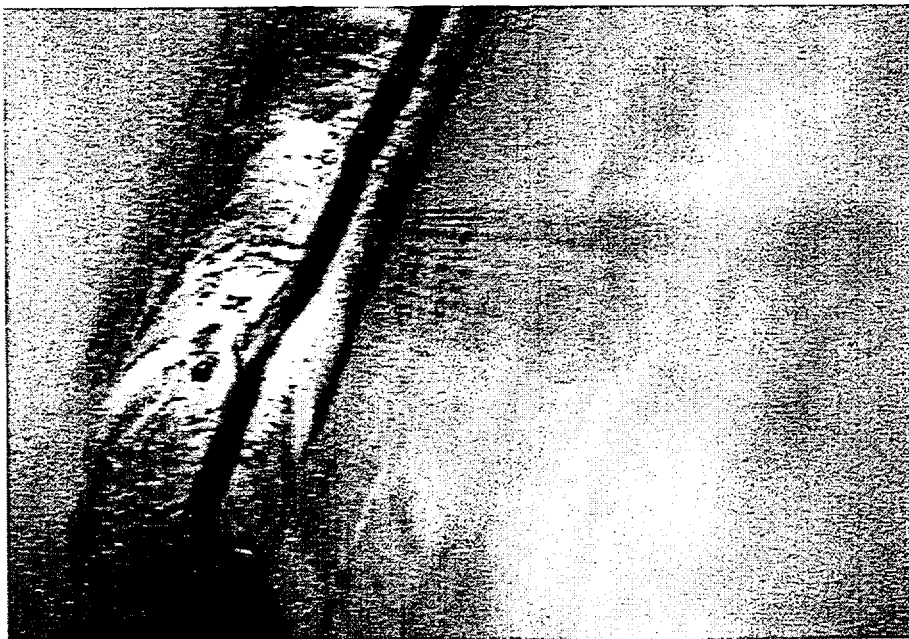
Figure B10. Bottom weld crack at location 13 identified in Figure B-19.
(Triangular air channel between fuel tube B7 & C8)

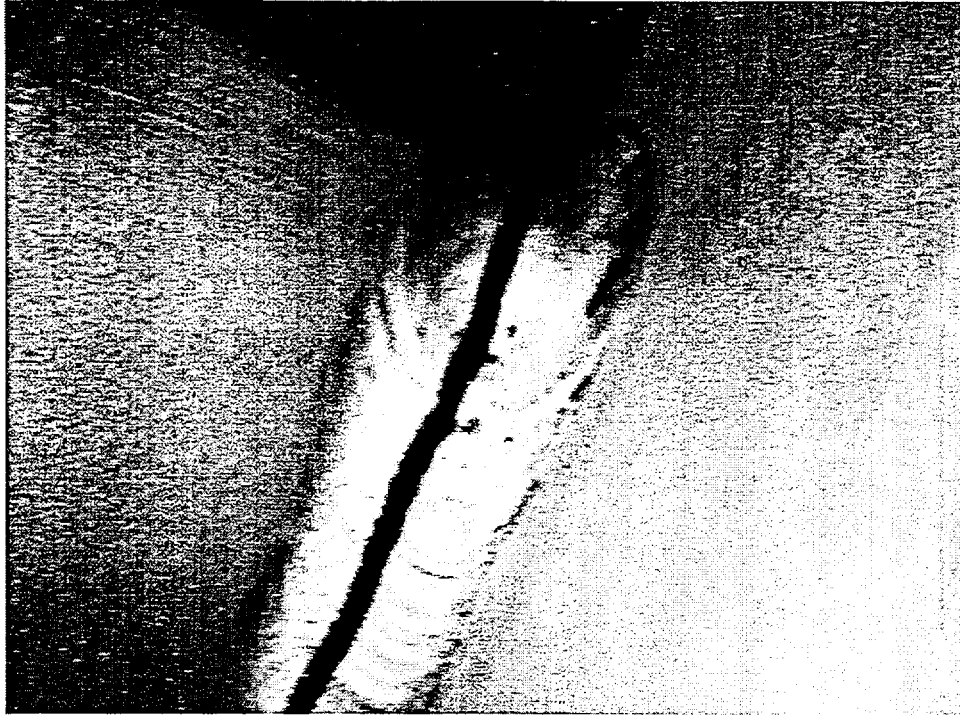
Figure B-11. Top weld crack at location 14 identified in Figure B-19.
(Triangular air channel between fuel tube C6 & D3)

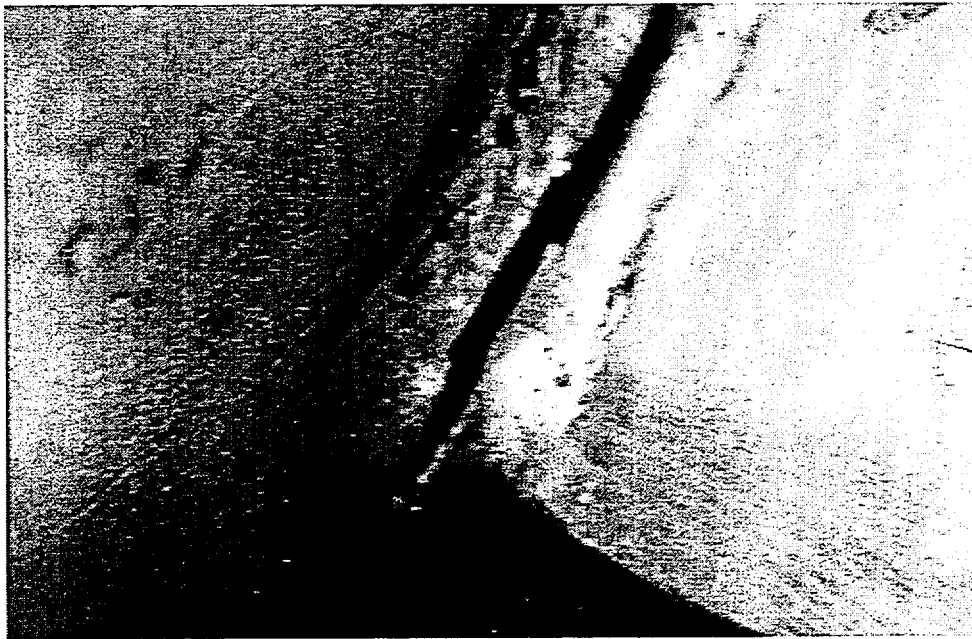
Figure B-14. Bottom weld crack at location 15 identified in Figure B-19.
(Triangular air channel between fuel tube D3 & D6)

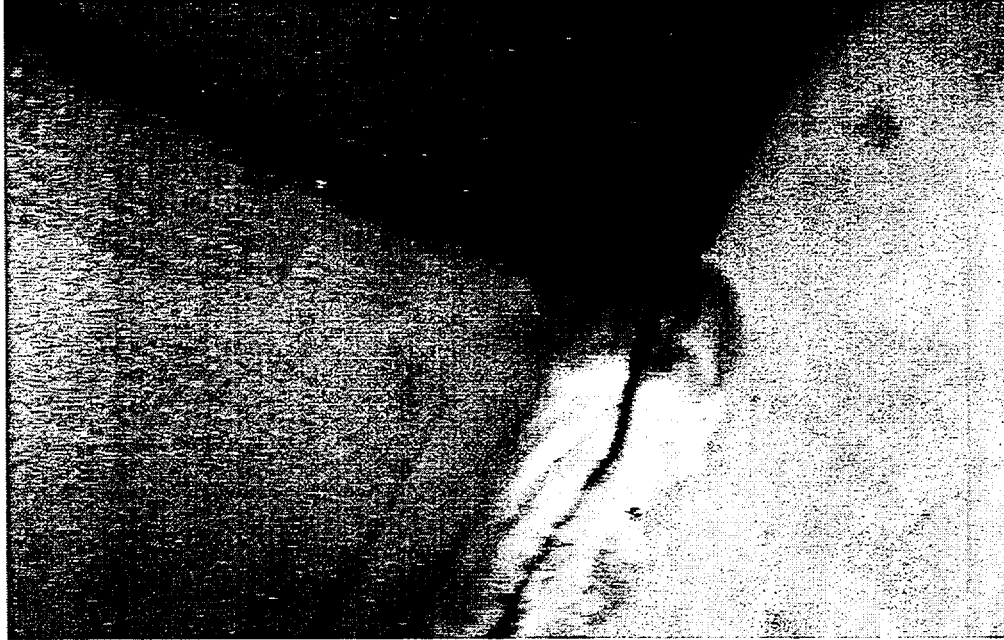
Figure B-15. Top weld crack at location 16 identified in Figure B-19.
(Triangular air channel between fuel tube A7 & D8)

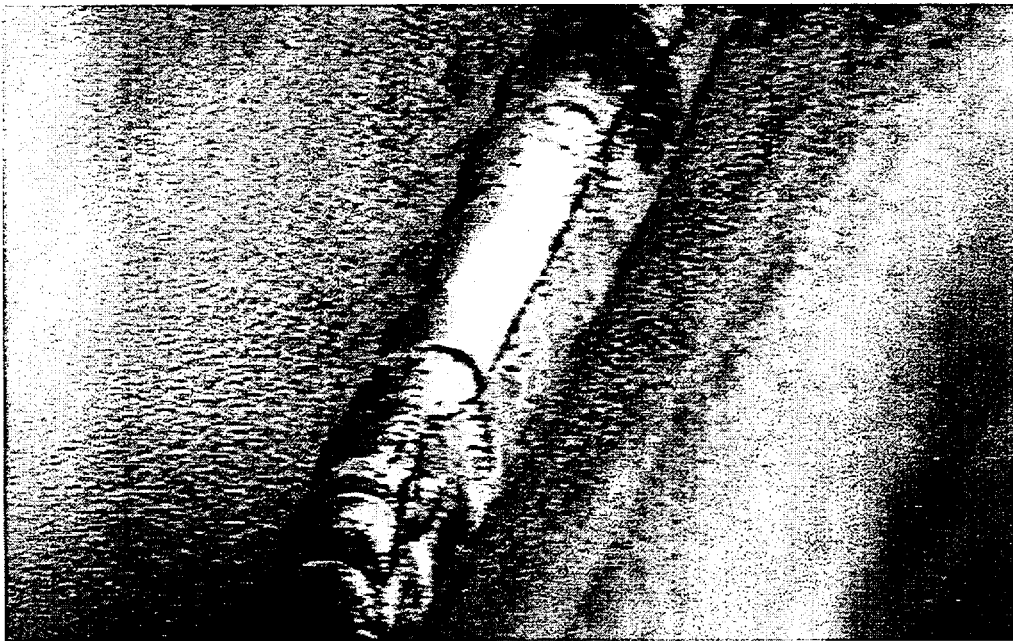
Figure B-16. Bottom weld crack at location 16 identified in Figure B-19.
(Triangular air channel between fuel tube A7 & D8)

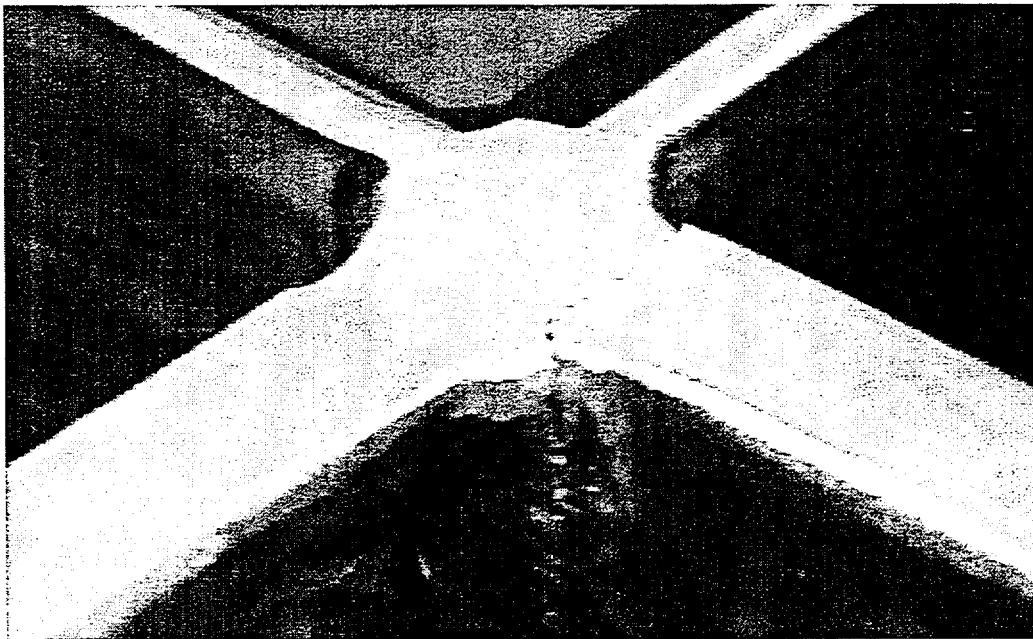
Figure B-18. Same as Figure B-17 with complete view of existing weld crack 4 identified in Figure B-19.

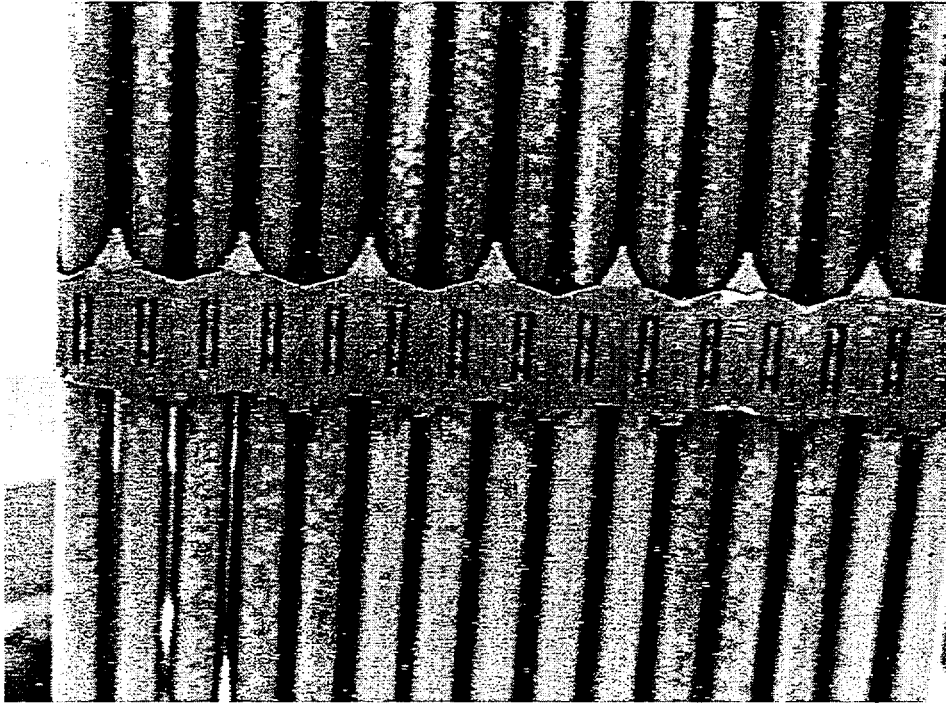
Figure C-3. Oxide mottling noted around spacer #5 on fuel assembly V-05.

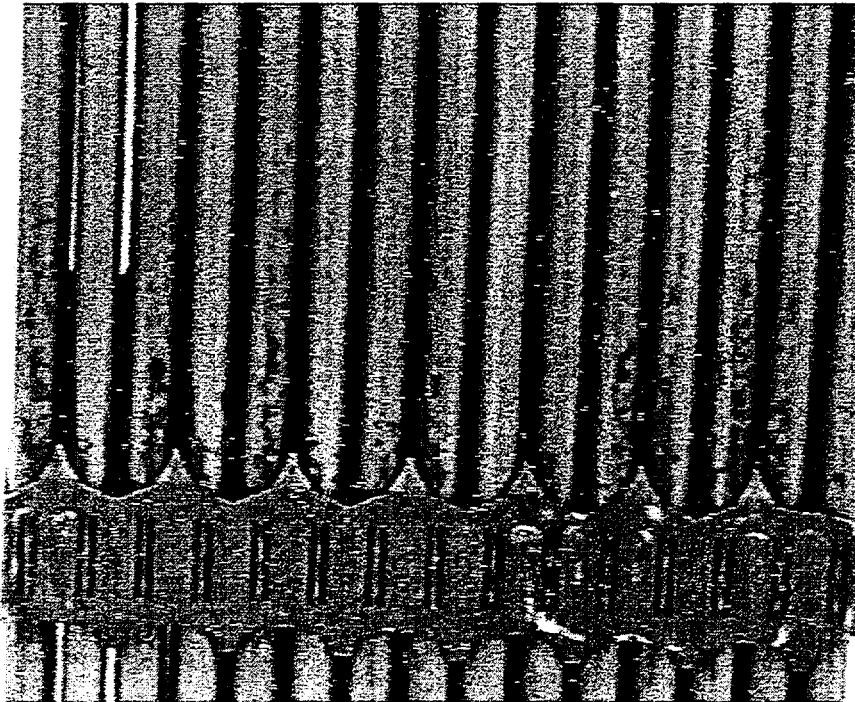
Figure C-4. Oxide mottling noted around grid spacer #6 on V-05.

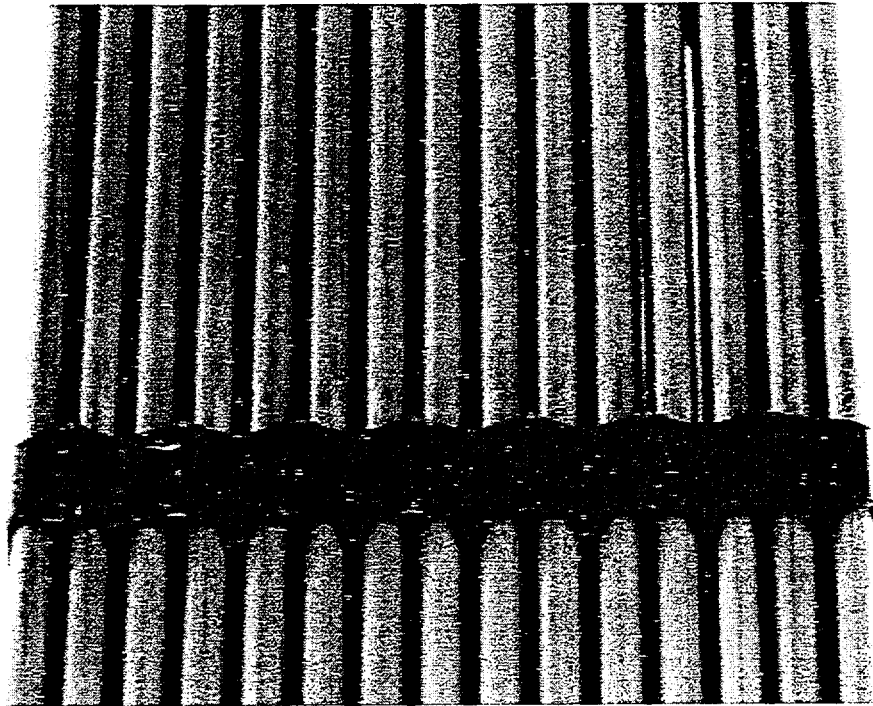
Figure C-5. Fuel assembly V-05—area around upper grid spacer—rods clean and minimal bowing noted.

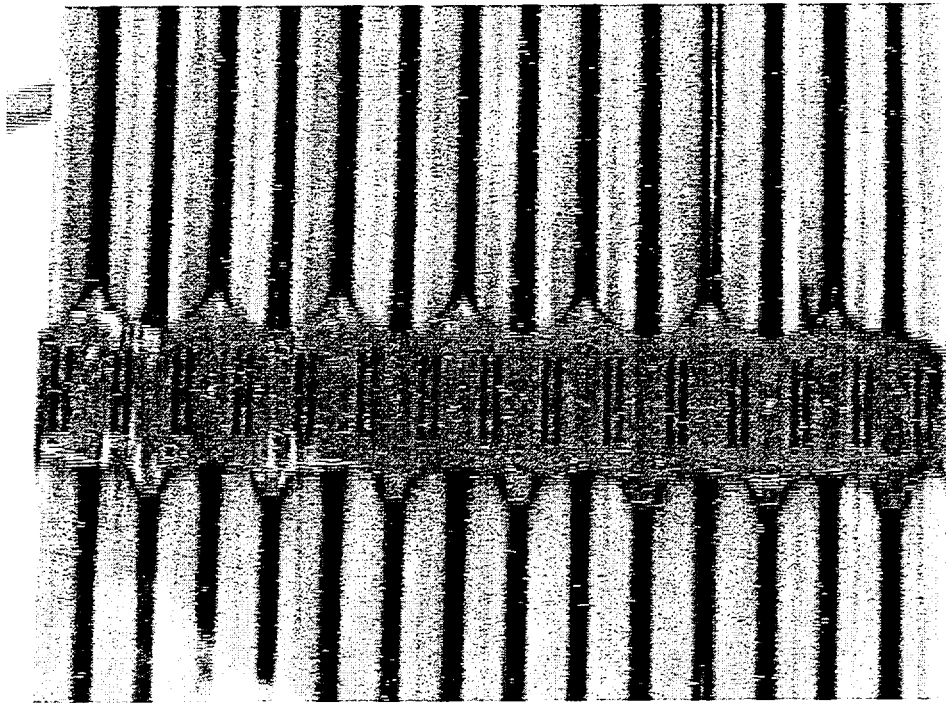
Figure C-6. Fuel assembly V-05 area around third grid spacer—noted light abrasion marking on spacer.

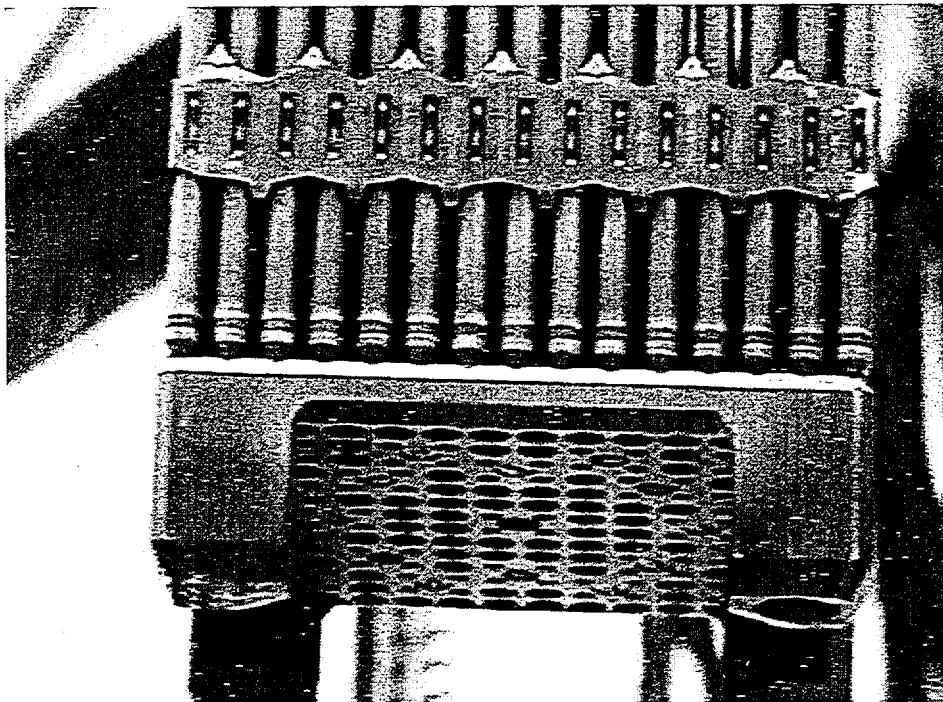
Figure C-12. Fuel assembly V-05—bottom left nozzle—noted mechanical fasteners searing guide tubes.

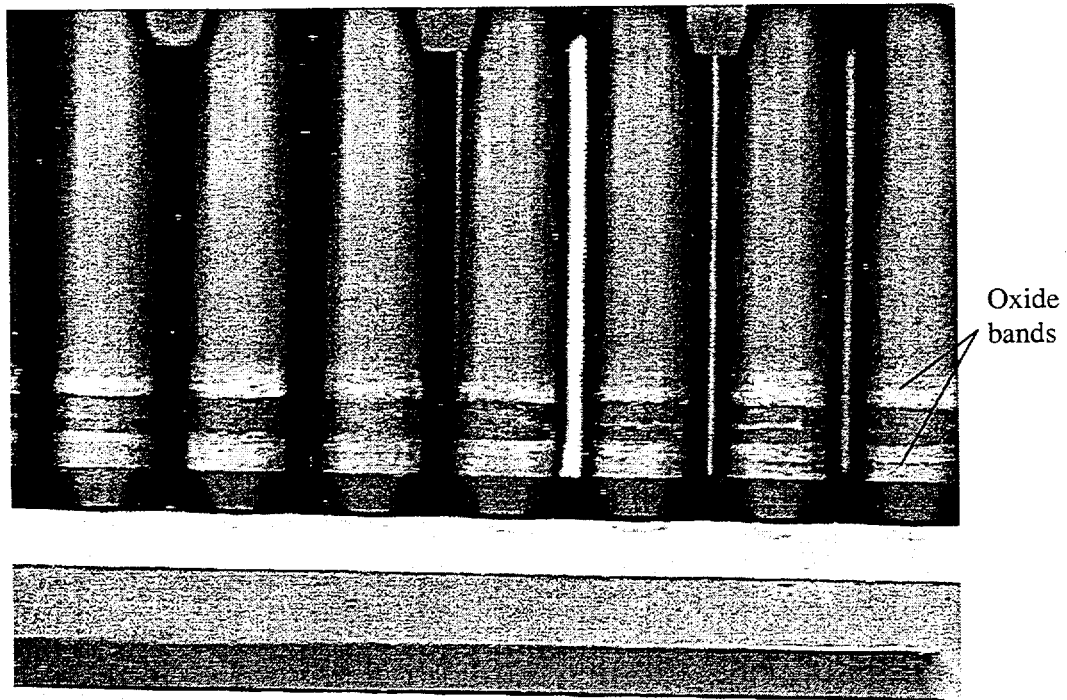
Figure C-13. Fuel assembly V-05 looking for loose "crud"—non was evident.

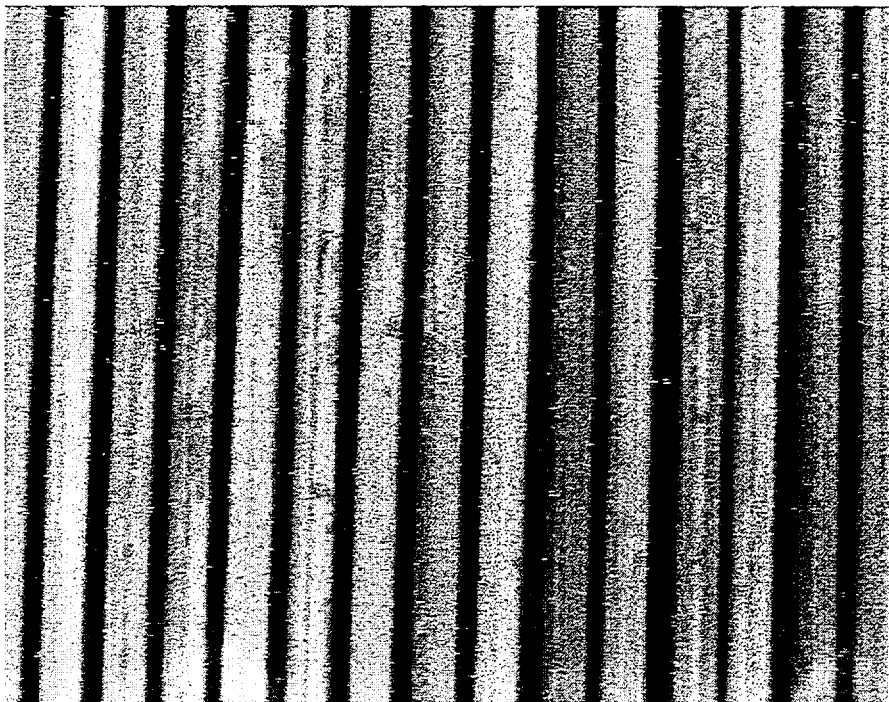
Figure C-16. Element T-03 midpoint of assembly noted oxide density increases as we go lower on the element.

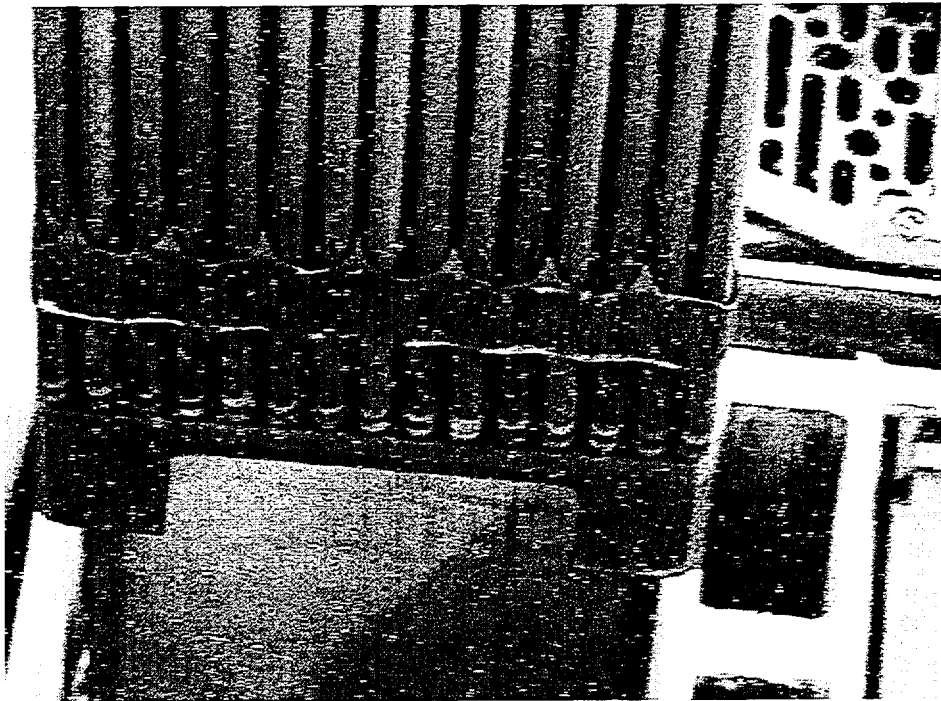
Figure C-18. Element T-03 bottom of fuel element—light oxide—no loose material obvious on surfaces.

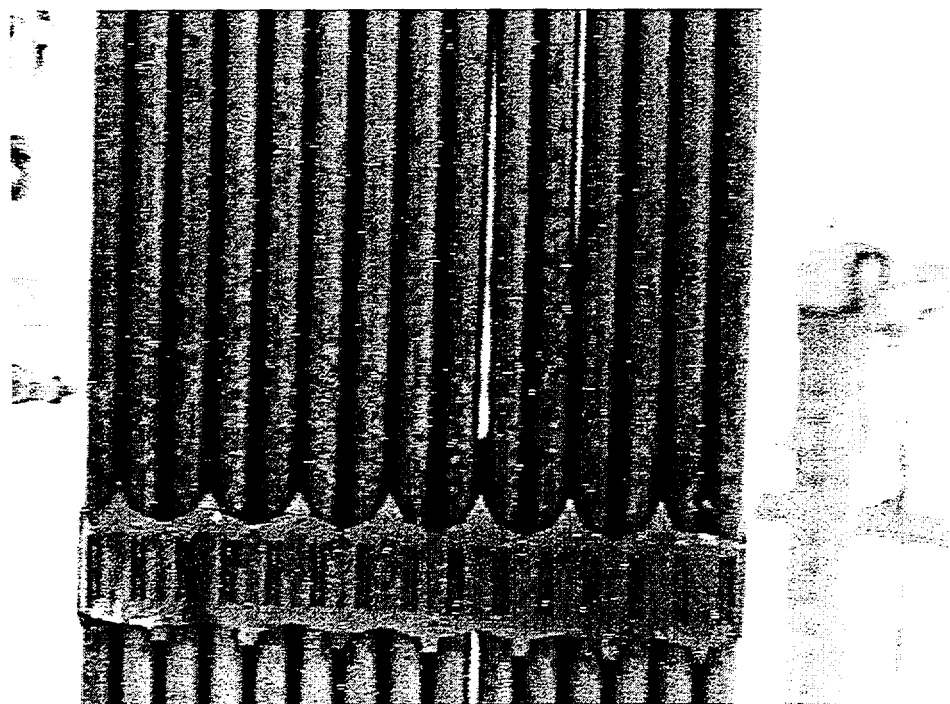
Figure C-22. Fuel assembly V-27 oxide mottling noted.

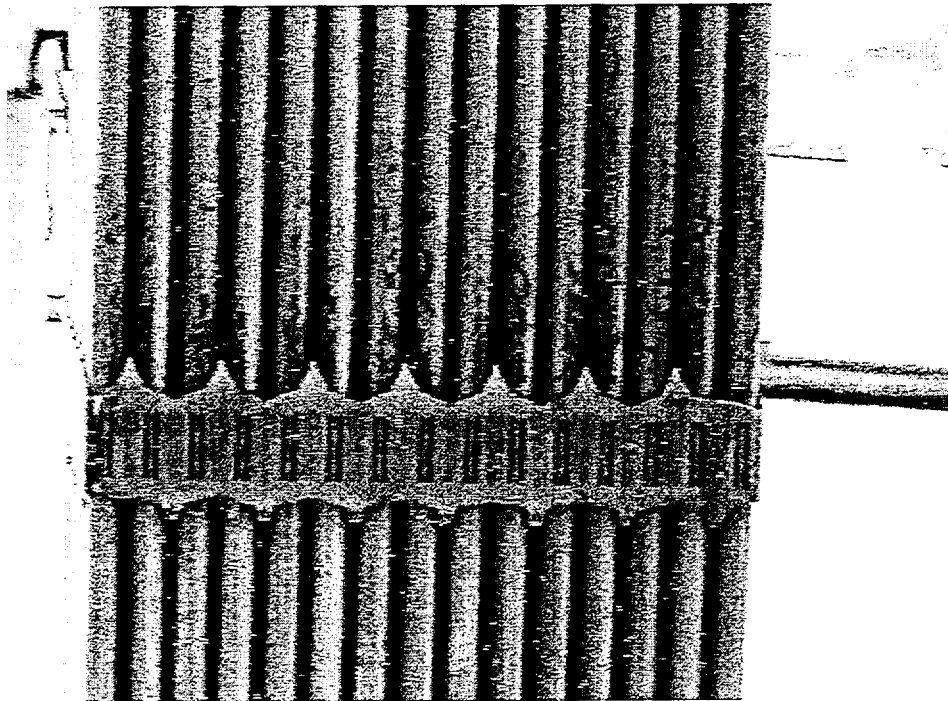
Figure C-66. Fuel assembly V-04 mottling at fifth grid spacer.

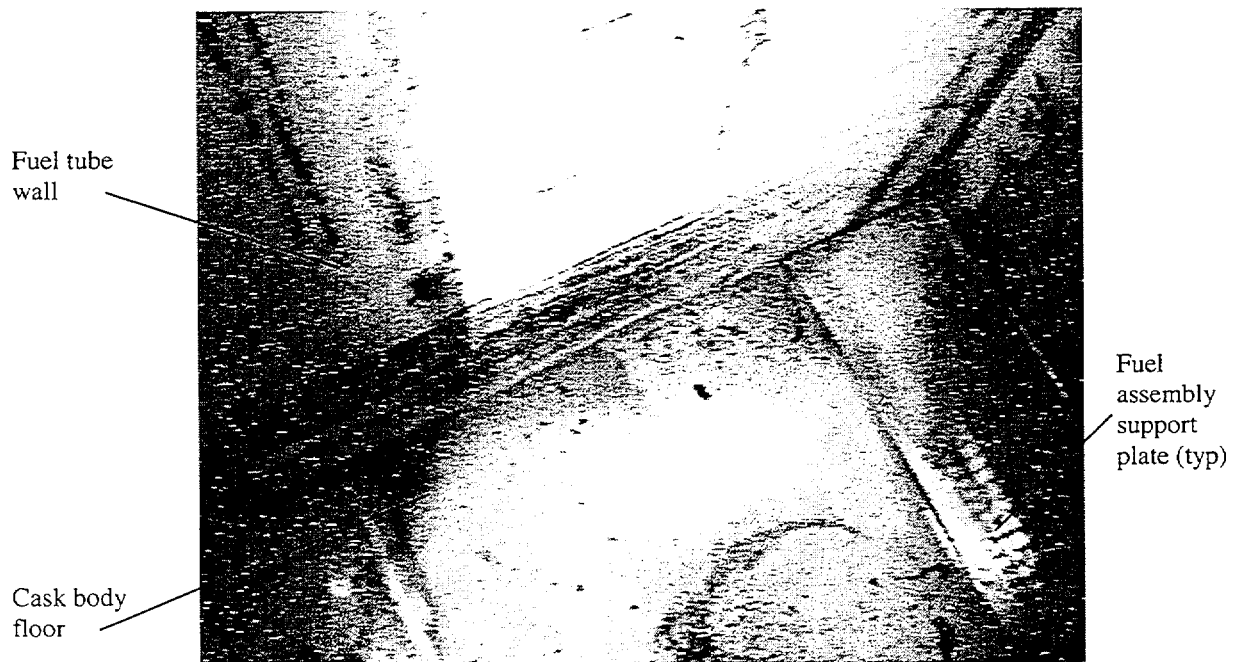
Figure D-2. Fuel Tube A-1 – Close up of bottom – minor debris noted.

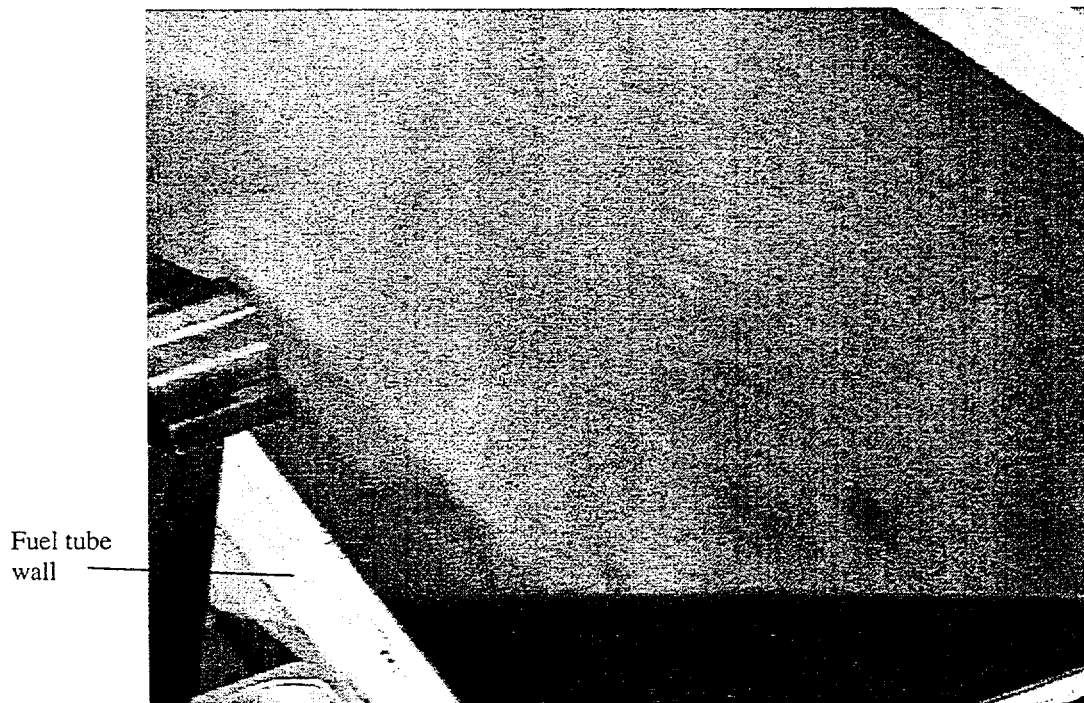
Figure F-2. Cask inner wall at top—typical surface condition.

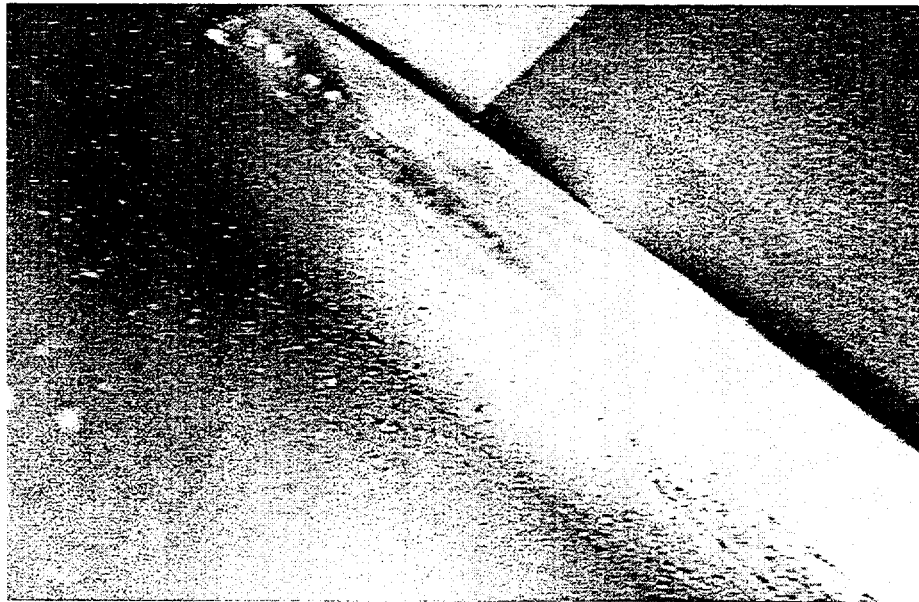
Figure F-8. Cask floor below fuel tube A3—reflective surfaces free of corrosion—minor granular debris on floor.

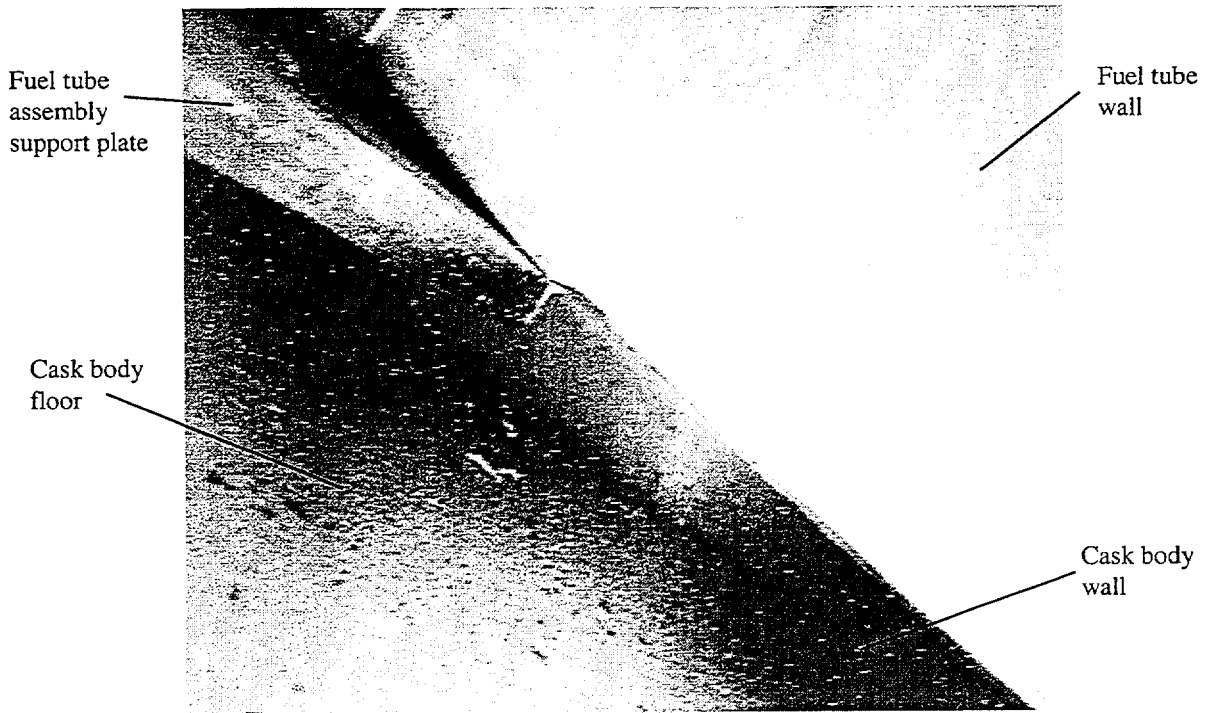
Figure F-9. Cask floor below fuel tube B6—reflective surfaces free of corrosion—minor granular debris on floor.
