## SCALE FORMATION IN AN EARLY NUCLEAR POWERED STEAM GENERATOR

Robert H. Leyse

Thermally-Induced Accelerated Corrosion of BWR Fuel

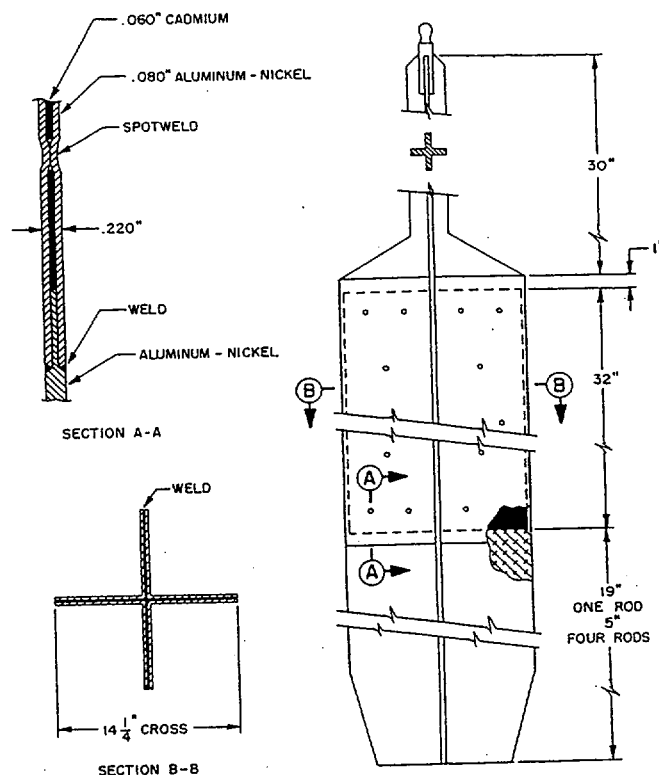
Zinn opened his testimony by citing Report IDO-19311 (Final Report of the SL-1 Recovery Operation, General Electric, July 27, 1962). However, there is pertinent data in a subsequent report by General Electric. (IDO-19313, Additional Analysis of the SL-1 Excursion, November 21, 1962). This later report describes the examination of an unirradiated SL-1 control rod that had been used in an underwater mockup of rod withdrawal rates. Pertinent features that clarify the following discussion are in Fig. 4. The investigators observed: "The blade, upon sectioning, was found to be full of water. Considerable corrosion attack was evident in the cadmium and on the aluminum during cladding. Only one of the spot welds was holding."

Several sections from damaged control rod blades were examined with ingenious apparatus in the site radioactive materials laboratory (RML): "The blades examined in the RML were also noted to have few spot welds holding. It was first thought this had been caused by the incident, but the indication is that many of the spot welds may have been very weak to start with. .... Many of the edge welds of the post-incident blades were either cracked or split open. .... The existence of water in between the aluminum clad material would contribute to the corrosion observed on the cadmium blades and the clad material."

Fig. 4 Aluminum clad control rod. Note the spot welds.
